**Local Government Energy Program
Energy audit report**

***Union County Educational Services Commission (UCESC)
Hillcrest Academy South & Lambert's Mill Academy
1571 Lamberts Mill Rd
Westfield, NJ 07090***

Project Number: LGEA17

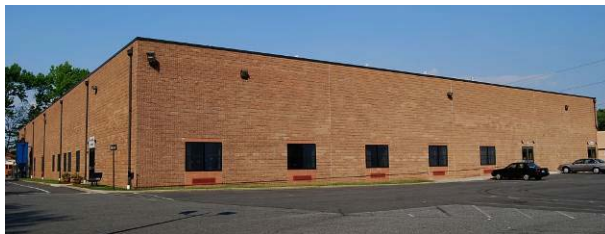
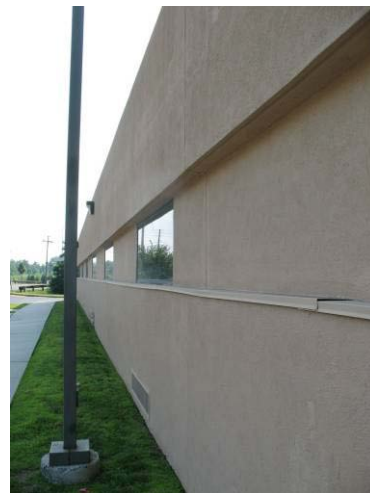
Typical Partial Exterior Elevation

Overall, exterior and interior wall finishes of the envelope were found to be in age-appropriate, good condition with no major signs of unusual water, air leakage or other energy compromising damage.

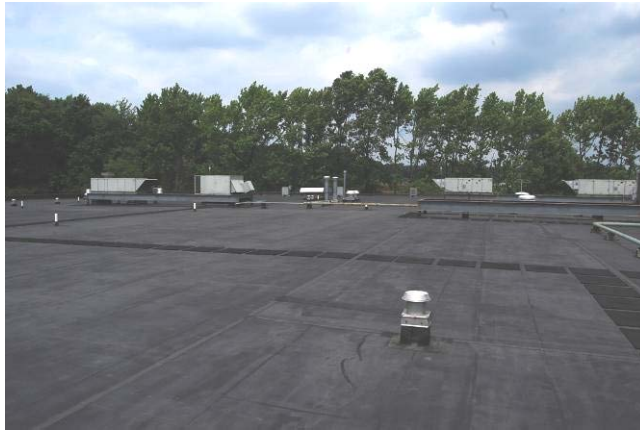
The flat roof of the building was recently replaced with a dark colored EPDM rubber membrane. The roof surface appeared to be in age appropriate, fair-good condition overall. No leaks were mentioned to the auditors at the time of the field visit and no signs of roof leakage were detected. In an effort to get the maximum life expectancy out of the roofing material installed, SWA recommends following/continuing the installer's or manufacturer's recommended maintenance and inspection schedule. Due to warm temperature conditions at the time of the field visits, insulation levels could not be verified with help of infrared technology. If desired, the school could contract a separate envelope inspection during cooler months.

EPDM rubber membrane roofing in fair condition

- Replace roof and add insulation – SWA recommends that as part of a capital improvement plan, that UCESC replace the roof of the entire building. Approximately 6 inches of rigid insulation (or a minimal insulation value of R-38) should be added in order to help prevent the loss of warm conditioned air from the building. A light colored, reflective surface should be installed in order to reduce the amount of solar heat gain that penetrates into the building. The rigid insulation should form proper drainage planes so that standing water is not allowed on the roof surface. The parapet as well as all mechanical equipment should be sealed well to the roof surface to prevent future water leaks.

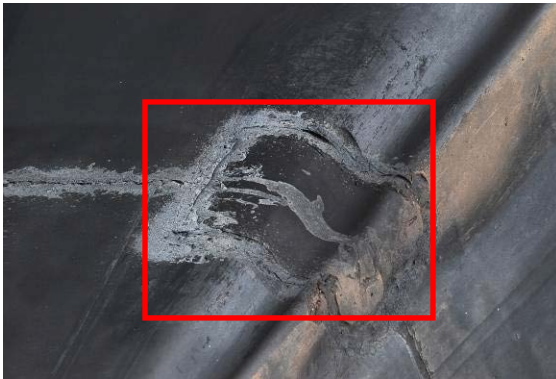
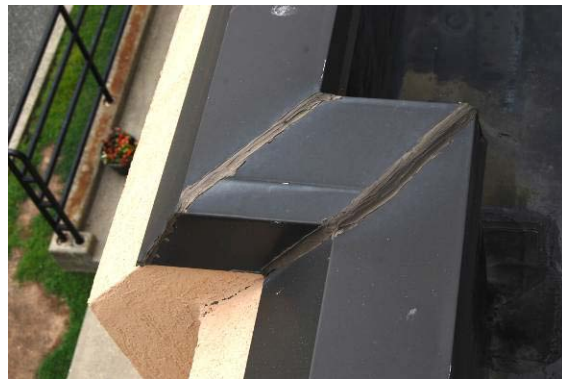
Aluminum Corner Flashing/ EPDM Detail

Close-Up View

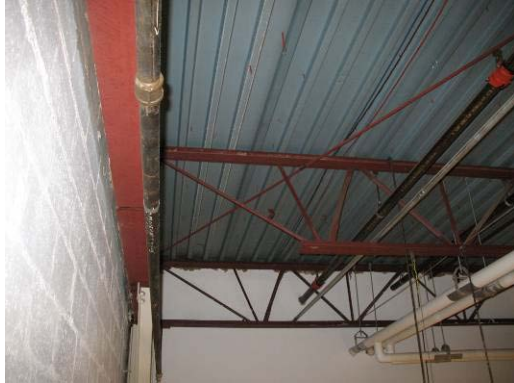
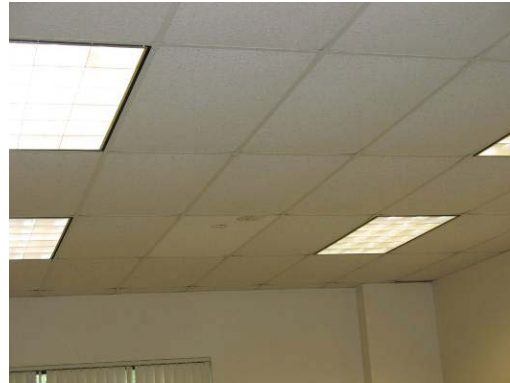
Additional roof/ ceiling related issues: Due to the change of use from warehouse to a single story school, there is a significant ceiling cavity large enough to accommodate an entire second floor. There was no insulation detected between the steel decking and the ceiling tiles. This contributes to substantial temperature differences between the ceiling cavity and conditioned space. Even though the cavity could be considered semi-conditioned due to the lack of ceiling tile insulation, the amount of air within the cavity is large enough to act as a heat sink. Because the roof assembly reaches high temperatures as the dark EPDM membrane attracts the sun, there is a great temperature differential between the cooled rooms below and the space above the ceiling tiles. As a result the ceiling tiles are buckling due to the change of temperature and humidity on either side of the ceiling surface. Besides aesthetics, there is an extraordinary heating and cooling loss due to the lack of an air barrier

Plenum between roof and ceiling tiles Image showing ceiling tiles buckling from humidity

Building maintenance staff pointed out that a majority of ceiling tiles appear to be sagging and are unsure of the cause. It appears that the "sagging" of the ceiling tiles is due to ceiling tiles becoming

saturated from humidity and ultimately sagging in their frame due to the excess weight. Part of the problem is also that the ceiling plenum is not currently insulated. Large differences on either side of the ceiling can create condensation that is also absorbed by the ceiling tiles. There are two options to correct the problem of humidity and stale air in the building:

and necessary insulation. SWA recommends insulating the roof to a total R-38 in addition to condition the ceiling cavity area to prevent future tile buckling.

- SWA recommends a second option which would address and correct many of the inherit problems of the building. SWA recommends that the entire building is converted to rooftop units to supply heating, air-condition and ventilation to each space via ductwork. This would include removing all unit ventilators and properly sealing any penetrations on the exterior walls from these units. It would also include replacing any rooftop units that are no longer performing as intended, adding more units to supply air to each room, adding exhaust fans to properly exhaust stale air and also adding ductwork to be sure that each space is supplied with air as well as exhausted of stale air. One major benefit of this second option would be that the roof itself could also be addressed at the same time. As each section is retrofitted, rigid insulation could be added to the roof in order to form a better thermal seal on the building. A reflective roof surface could also be added to prevent solar heat gain and also seal all equipment properly. Equipment that still operated appropriately could remain and still be used. This option would be considerably more expensive than the first option; however it would also address many major energy problems as well as comfort problems that the building is having.

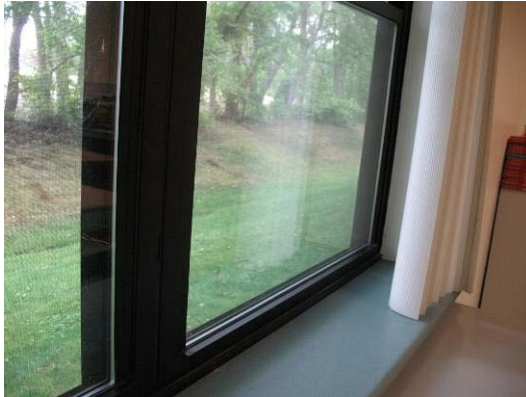
The double-pane windows appear to be in good condition with no obvious penetrations and with sufficient caulking and sealing around the frame.

Double Pane Windows in good condition

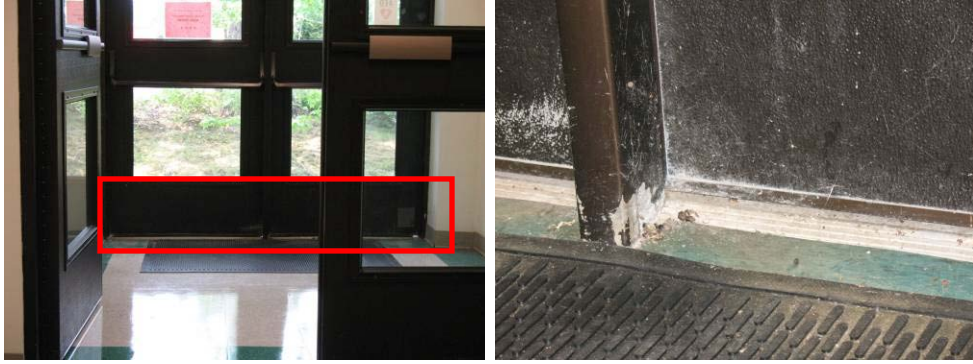
The entrance ways for the Hillcrest Academy South and Lambert's Mill Academy building consists of a mixture of insulated steel doors set on a metal frame or double pane glass doors with insulated metal frames. The frames of these doors are poor insulators and allow expensive, conditioned air to leak out of the building. The door frames appeared to be in good conditioned. SWA recommends maintaining weather-stripping around all of the doors of the building in order to prevent conditioned air from leaking outside of the building. Weather-stripping should be checked at least once a year and replaced as soon as signs of deterioration start to show.

Double doors in good condition, in need of weather-stripping

- **Weather Stripping/Air Sealing** - SWA observed that exterior door weather-stripping was beginning to deteriorate. Doors and vestibules should be observed annually for deficient weather-stripping and replaced as needed. The perimeter of all window frames should also be regularly inspected and any missing or deteriorated caulking should be re-caulked to provide an unbroken seal around the window frame. Any other accessible gaps or penetrations in the thermal envelope penetrations should also be sealed with caulk or spray foam.

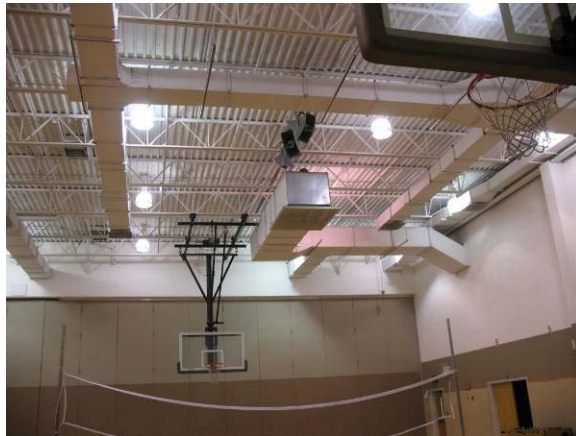
Interior Lighting – Most of the lighting within the Hillcrest Academy South and Lambert’s Mill Academy building consisted of efficient T8 lighting with electronic ballasts. Lighting in the gymnasium in both schools can be updated from metal halide bulbs to the more efficient T5 fluorescent lighting, while increasing quality of light. The gymnasium is often used for events such as assemblies or graduation. The color of lighting in the gymnasium is not consistent, with some lights glowing pinkish and providing poor quality of lighting at the floor. SWA recommends that T5 fluorescent lighting is installed to reduce energy savings but also increase the quality of light. Due to ductwork located below the ceiling that blocks some light and also causes large shadows to be cast, SWA recommends that new light fixtures are hung slightly lower to overcome the obstruction from the ductwork.

Gymnasium Metal Halide lighting

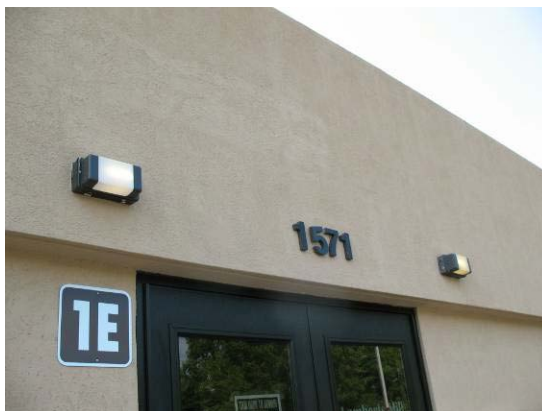
Exterior Lighting – The lighting for the exterior of the building was observed on the day of the audit and would not be cost-effective to upgrade at this time. Exterior lighting is controlled by one timer located in the mechanical room in the basement. The timer is set to turn the lights on at 8pm and off at 9pm in the summer and 5pm to 9pm in the winter. SWA recommends checking timers on all lighting to verify these hours are correct. Exterior lighting was on during SWA’s visit, as noted in the image below.

Exterior lighting on during daylight hours
