New Jersey Small Wind Turbine Failure Analysis: Xzeres 442 Wind Turbine, Villas, New Jersey

Technical Report

NREL/TP-5000-56660

June 2013

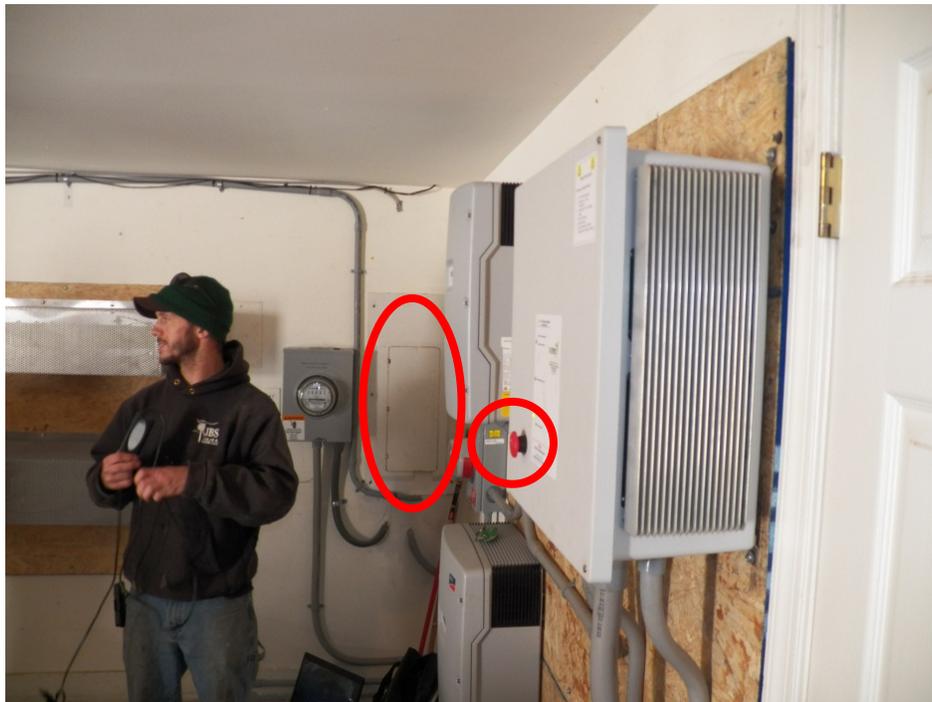
Figure 2. Turbine control box with the emergency stop button in the foreground

On January 7, 2011, the Cape May area (near Villas, New Jersey) experienced sustained high winds (30–50 mph gusting to perhaps as much as 80 mph). At approximately 12:30 a.m. on January 8, 2011, Dennis Hasson, owner of the Xzeres wind turbine, was alerted to a burning smell in his house by a guest. Mr. Hasson entered the residence's garage where he found flames and smoke coming from the turbine controller. He also noticed that both diversion loads (seen on the back wall in Figure 2) were glowing red.

Mr. Hasson attempted to disable the turbine by first pressing the emergency stop (E-Stop) button on the controller (Figure 2), and then by turning off circuit breakers that feed the turbine controls and the two SMA inverters that are part of the wind system (see Figure 4 for details). The circuit breaker panel can be seen in the center of Figure 2, with the two SMA Windy Boy inverters just to the right, behind the turbine controller.

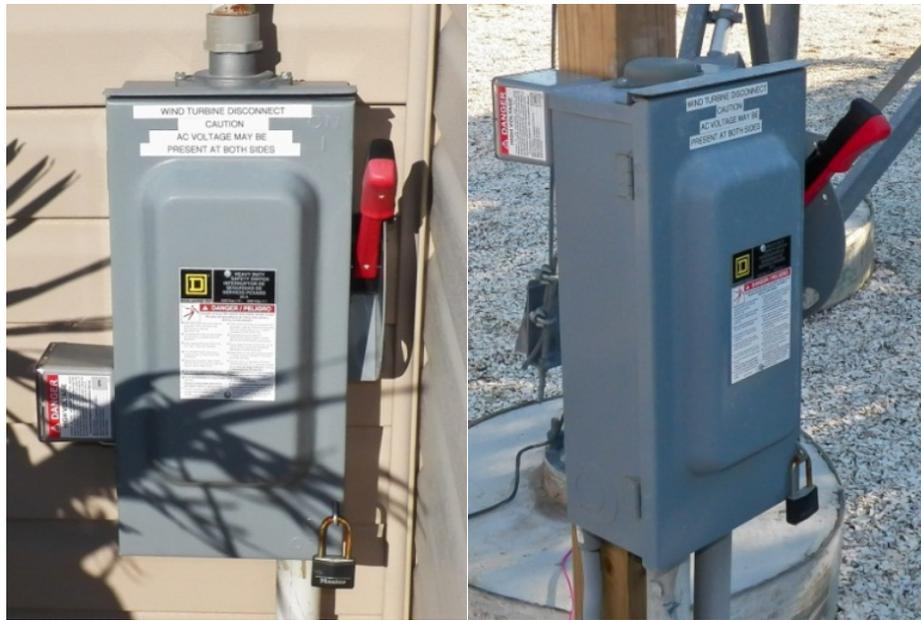
Figure 3. External turbine disconnect switches

Mr. Hasson then went outside and opened both turbine disconnect switches (one on the house and one at the base of the turbine tower). These switches are shown in Figure 3.

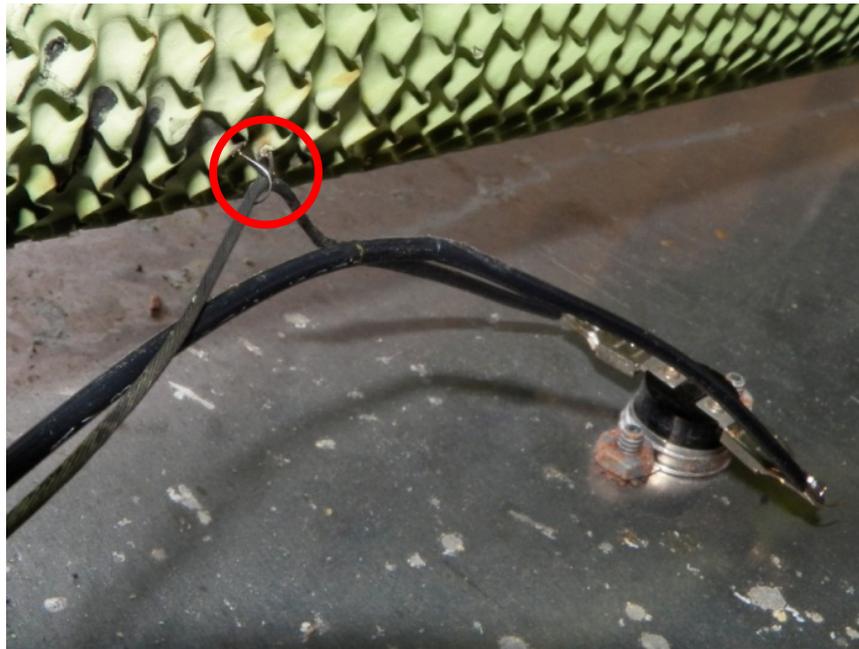
Figure 5. Thermal sensor in diversion load with control wire welded to resistor body
(Photo by Lee Jay Fingersh, NREL)

The root cause of the incident, as determined by Xzeres and the authors of this report, was an accidental contact between a 24-volt (V) control wire used to detect over-temperature in the turbine's diversion load and a load resistor that was connected to high-voltage DC at the time. The control wire actually welded to the load resistor as can be seen in Figure 5, which also shows the thermal sensor.

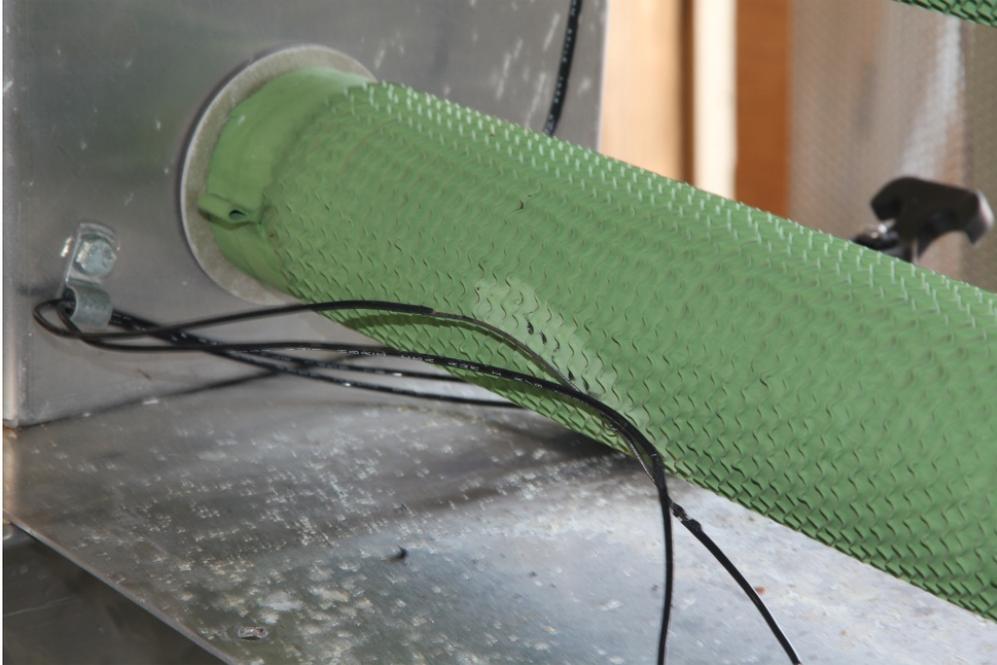
Figure 6. Lack of wire restraint in the diversion load
(Photo by Lee Jay Fingersh, NREL)

The thermal sensor wiring in the turbine diversion load is suitably rated for the temperatures expected in the diversion load, but was not adequately restrained to ensure that it could not contact the resistor body (Figure 6).

There were reports of a heating, ventilating, and air conditioning (HVAC) contractor working around the diversion loads and deforming the case, causing this problem. We did observe deformation of the case, but it is unlikely that it contributed significantly to the problem. The fact remains that the wires were inadequately constrained.

Xzeres has taken several steps to remedy this problem in current production. For example, right-angle connectors are now used on the thermal sensor and additional wire restraints are used to ensure that contact with the resistor body cannot occur (Figure 7 shows the interior of the replacement diversion load now installed at the Villas site).

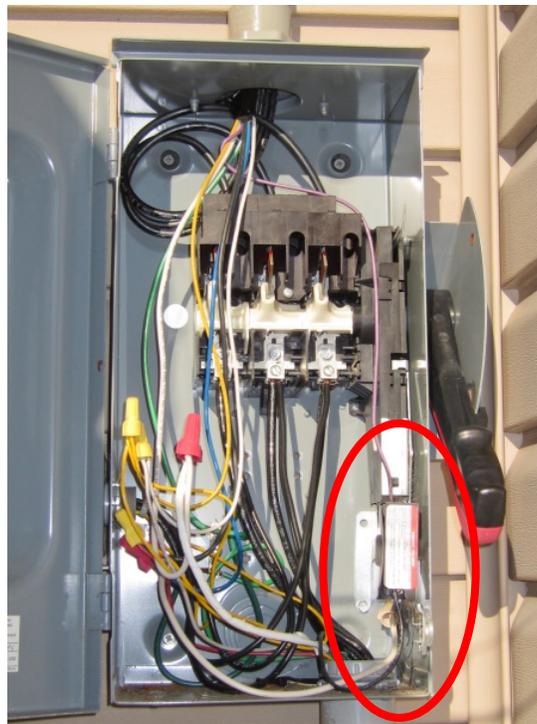
Figure 9. Turbine disconnect with interlock (lower right) installed
(Photo by Lee Jay Fingersh, NREL)

Discussions with the installer and the Xzeres internal incident report both identified the installation of turbine disconnect switches without brake interlock contacts as a potential safety hazard. As described above, the Xzeres 442 uses electrical braking with up-tower resistors and a normally closed contactor (also in the turbine nacelle). Removal of 24 VAC power from the contactor coil causes the brake to apply; this turbine installation (prior to the replacement) did not have these installed.

The Xzeres manual provides similar language for additional disconnect switches. This installation omission did not, but could have, caused a problem. The redundant speed control (i.e., furling tail) of the Xzeres 442 turbine would have limited rotor speed in the event of a switch being opened. This potential problem has been resolved; both disconnect switches now have brake interlock switches installed (Figure 9).

The lack of interlocks in the turbine disconnects had no impact on the incident in question as all AC power was removed from the turbine and controls prior to the disconnect switches being opened. This should have operated the turbine’s internal electric brake.

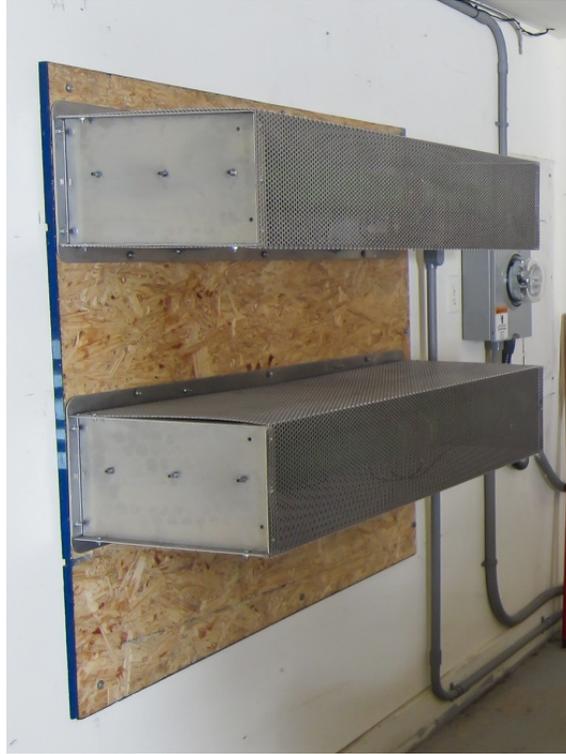
Figure 10. Mounting of diversion loads
(Photo by Lee Jay Fingersh, NREL)

The present installation of diversion loads does not comply with the manufacturer's installation instructions, both in top clearance for the bottom load and the side-by-side requirement (Figure 10). This lack of compliance could have contributed to the incident as high temperatures could have caused a wire to droop.

It is recommended that the diversion loads in the current installation be re-mounted according to the manufacturer’s instructions, or if that is not possible due to wall space limitations, re-arranged according to the manufacturer’s direction regarding sufficient spacing and clearance.

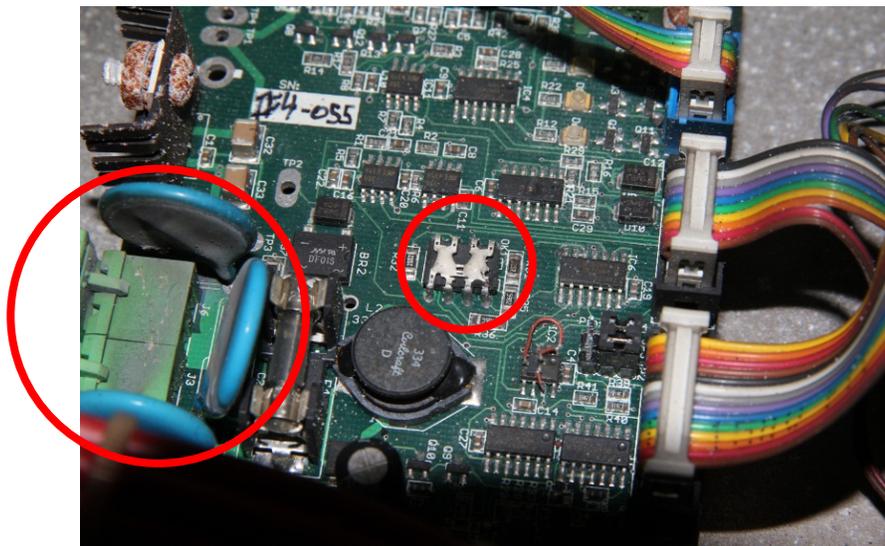
Figure 11. Damaged controller board
(Photo by Lee Jay Fingersh, NREL)

The operating DC bus voltage for the system is about 350 V. Contact between the diversion resistor and the over-temperature sense wire resulted in high voltage being fed into the central controller PC board. Examination of the controller showed clear HV damage: to an opto-isolator, various burn marks were on the board, and material ejected from over-current devices (Figure 11).

The optical coupler in the center of Figure 11 is used to detect the state of the diversion load thermal switches. It had its top blown off. The transient absorber (on the left) caused a burn mark on the green connector below it.

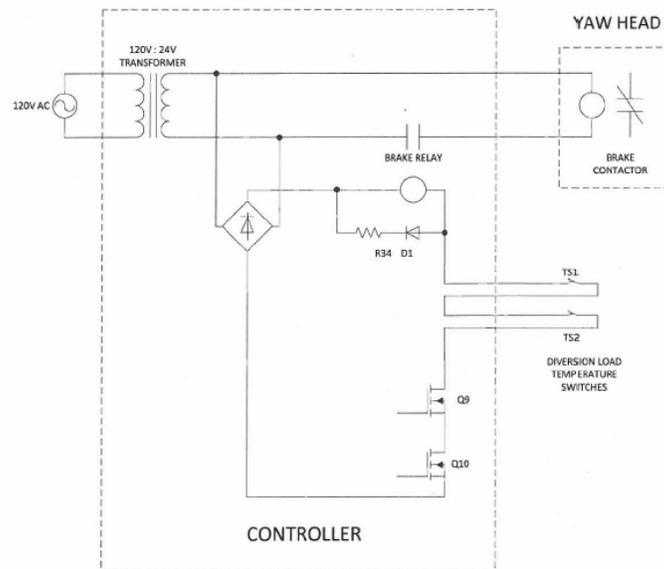
Figure 12. Simplified turbine brake control schematic

The two diversion load thermal switches are wired in series with a normally open relay in the controller that supplies power to the up-tower normally closed brake contactor (Figure 12). Two bipolar transistors are also included in the relay control loop. They allow brake operation by the turbine controller microcomputer and the E-Stop button. Unfortunately, when HV made contact with the diversion load temperature sense wiring, it most likely caused these transistors to fail in the “on” state. The result was that the up-tower brake could not engage, despite a pending over-speed condition. For the same reason, the brake would not engage when the E-Stop button was pressed.

- e. Consider including circuitry in the nacelle (possibly a relay with passive components, or an SCR circuit) to engage the up-tower brake in the event of turbine over-speed or over-voltage. By doing so, the up-tower brake will engage even if the turbine output conductors are severed, or if a control failure occurs (similar to the incident in Villas).

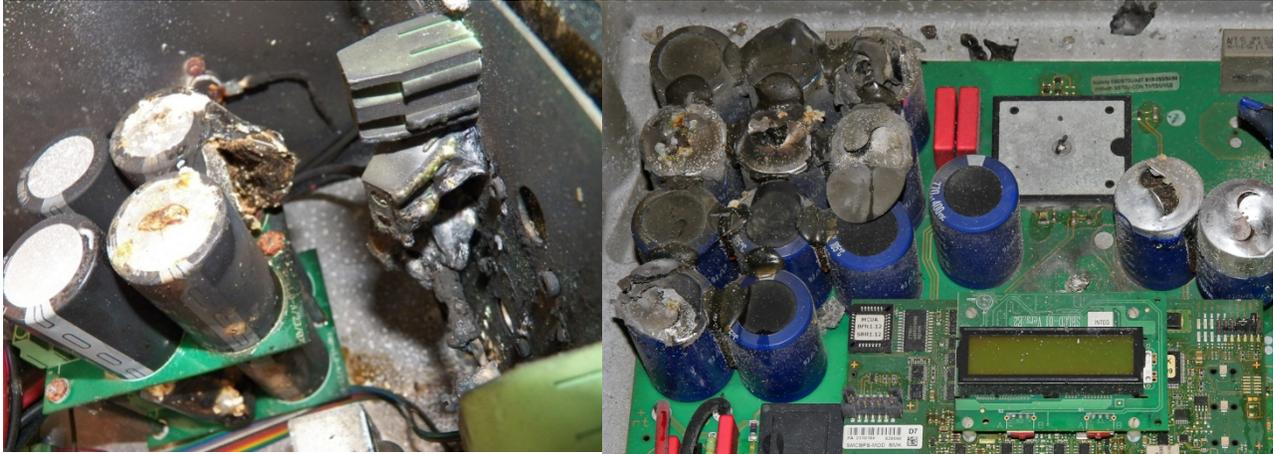
Figure 13. Capacitor failure in the turbine controller (left) and inverters (right)
(Left photo by Rob Wills, Intergrid, LLC, right photo by Lee Jay Fingersh, NREL)

The unloaded turbine generated voltages in excess of 800 VDC. This caused electrolytic capacitors in the turbine controller and inverter to fail (Figure 13).

This failure spread conductive material over the rectifier and load chopper boards, causing them to fail.

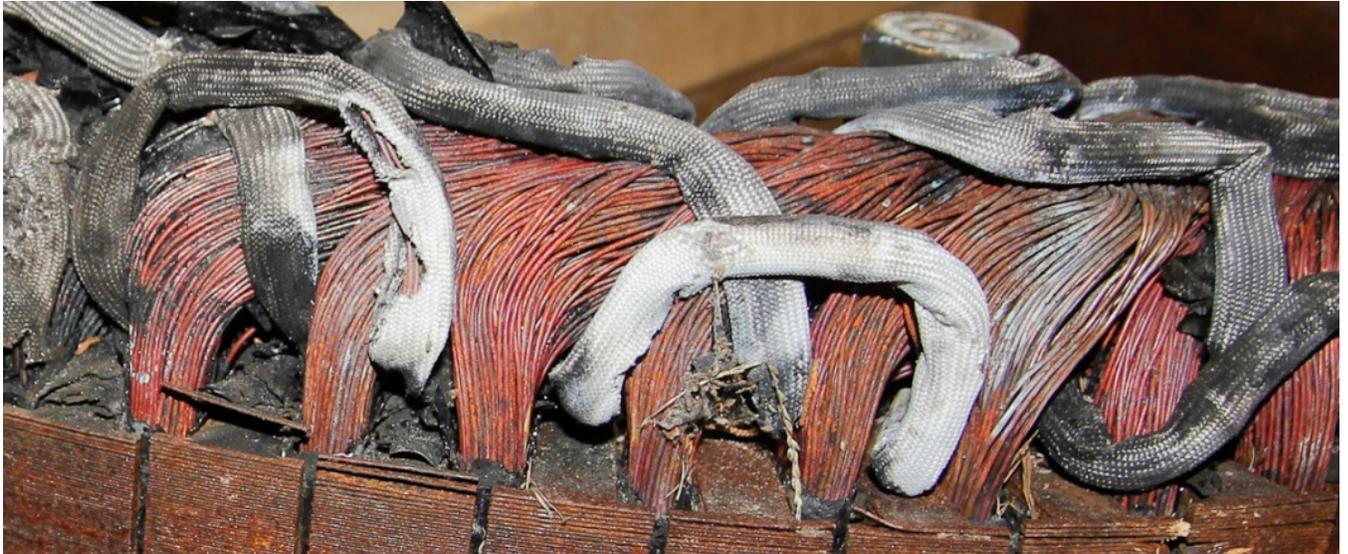
Figure 14. Alternator stator windings with the varnish burned off
(Photo by Lee Jay Fingersh, NREL)

High alternator currents caused the turbine stator to overheat. The alternator shorted internally, thereby reducing output voltage but increasing up-tower power dissipation.

The fire continued throughout the night, as stator winding varnish vaporized and burned. The investigators saw no evidence on the stator that heating and fire were caused by mechanical rubbing or disintegration of magnets in the alternator gap.

This sequence of events agrees with the Xzeres internal analysis, although they did not mention magnet weakening. However, Xzeres did identify the likelihood of a shorted stator (Figure 14).
