**Local Government Energy Program  
Energy Audit Report  
FINAL; May 20, 2010**

***Frankford Township School  
Branchville, NJ 07826***

***Project Number: LGEA52***

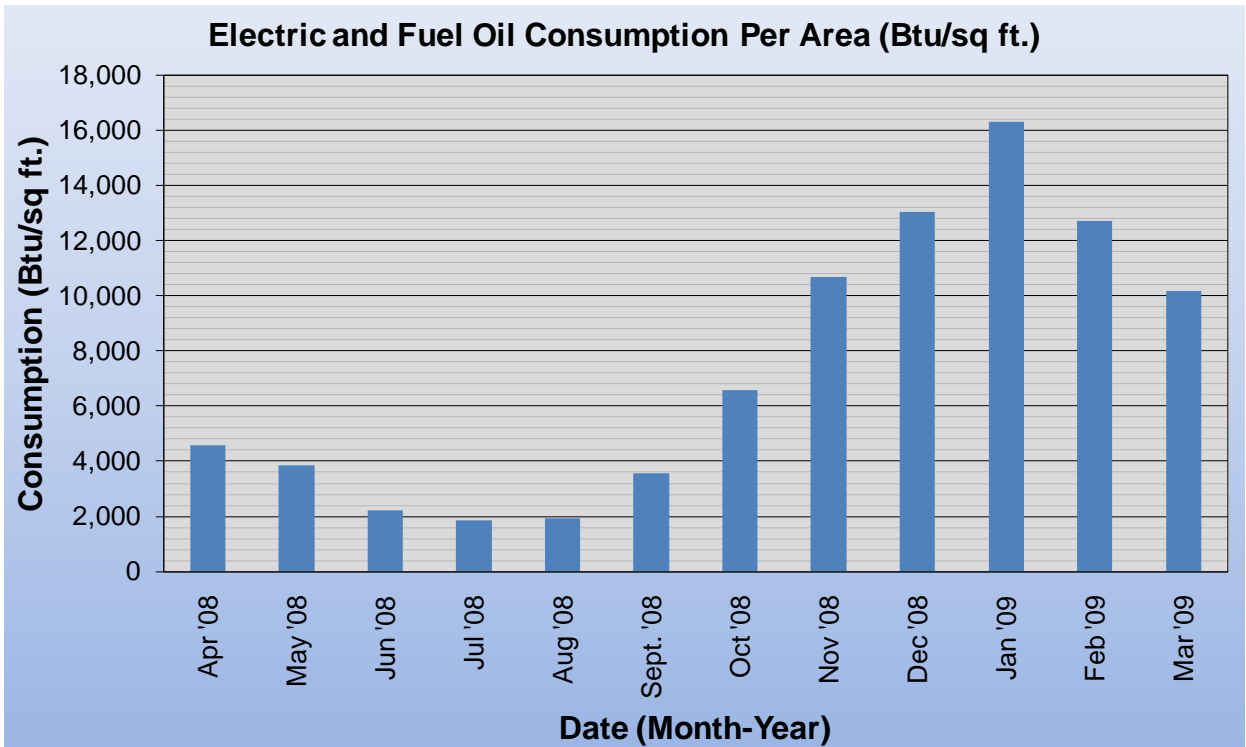
The following chart shows combined fuel oil #2 and electric consumption in Btu/sq ft for the Frankford Township School building based on utility bills and oil receipts for the 12 month period of April 2008 to March 2009.

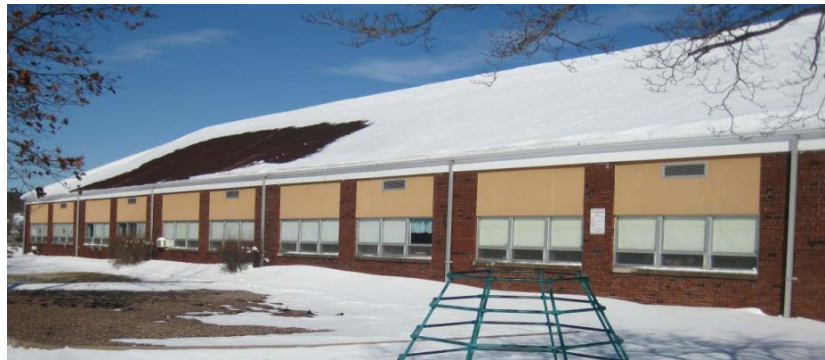
The exterior wall assemblies consist of a brick veneer (with EIFS above certain windows), aluminum framed window wall panels with certain sections containing 2x6 wood framed walls or with CMU (Concrete Masonry Unit) walls. Interior wall finishes are a mixture of lath and plaster, tile, painted CMU and gypsum wall board. During the next major renovation, SWA recommends insulating the exterior walls to the current local building code by adhering 2" polyiso boards (Polyisocyanurate) together with furring strips and gypsum wall boards to the inside of the painted CMU walls.

*Exterior wall assembly (portion of Elementary School)*

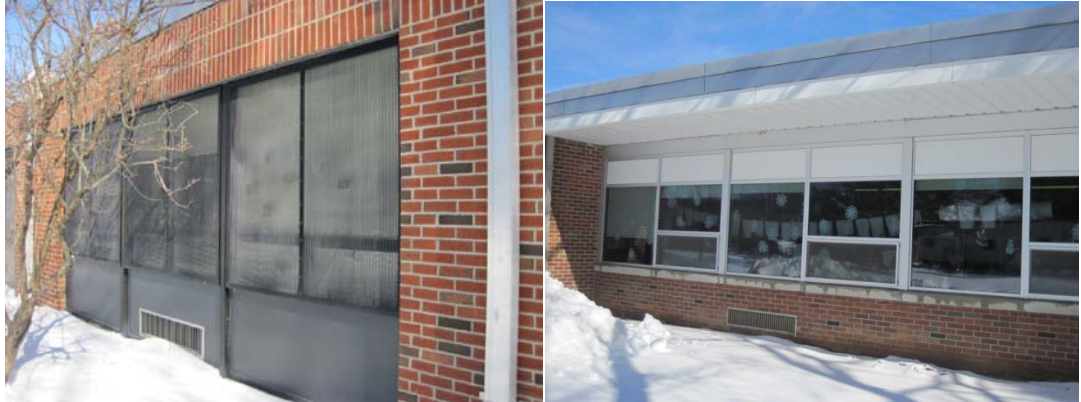
*Exterior wall assembly types*

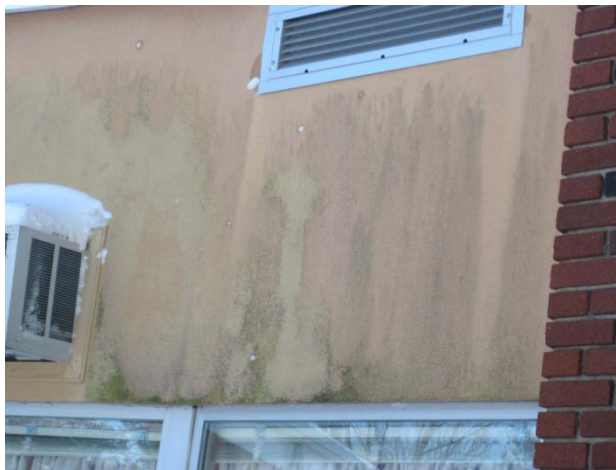
*Water damage EIFS*

Overall the exterior wall assemblies of the building appear to be in excellent condition with no major issues of concern. There were no additional areas of concern mentioned to SWA at the time of the building audit. SWA recommends regular maintenance to exterior walls, re-pointing brick veneer, caulking around windows or doors, and removing all damage due to insects or rodents. Attention and maintenance should be given to these areas as uncontrolled roof water runoff can potentially penetrate exterior walls and cause energy losses and structural damage. Special attention should be given to roof drainage to avoid water damage to exterior wall assemblies.

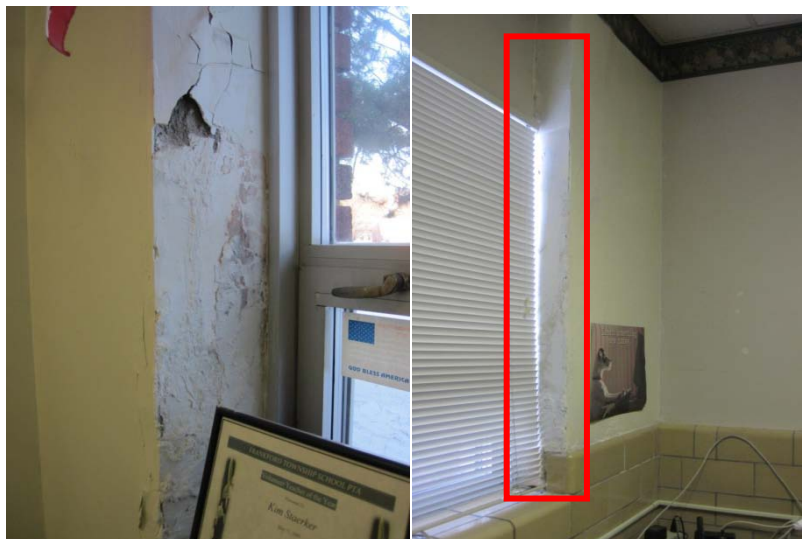
*Interior wall finish – lath and plaster wall damage*

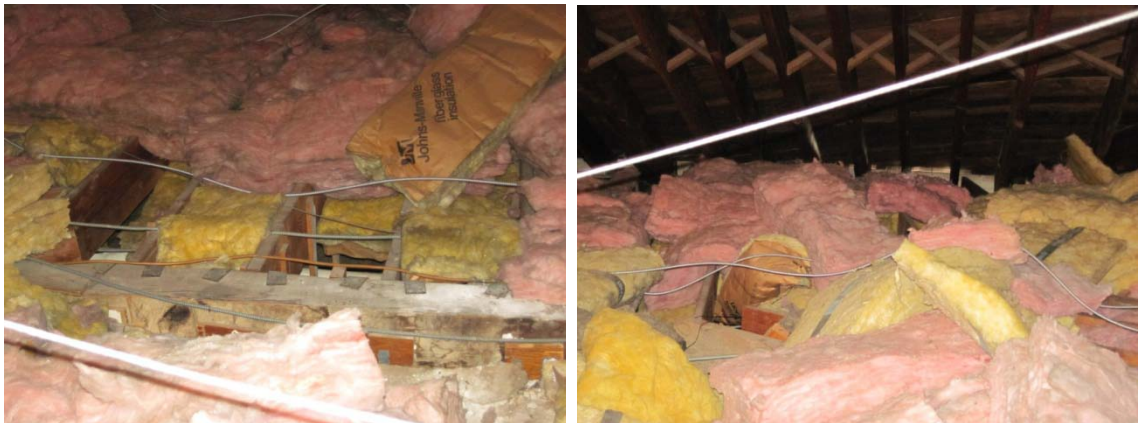
*Fiberglass insulation haphazardly displaced*

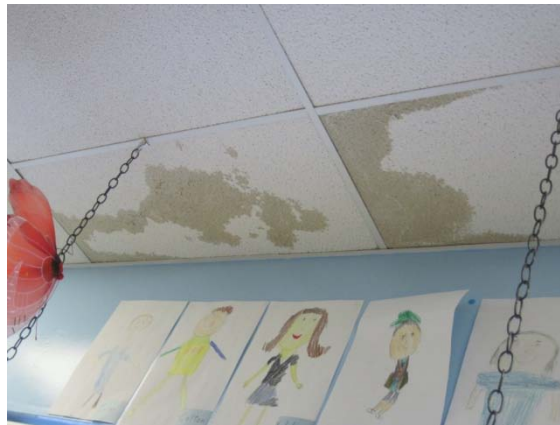
*Image showing damaged ceiling tiles in classroom*

At the time of the audit, SWA was told there are no roof leaks or roof maintenance issues. Damaged ceiling tiles should be checked and replaced in concern for indoor air quality. Regular maintenance should be performed to prevent potential damage to the integrity of the roofing system. When it is time for roof replacement (considering the 1972 roof section), SWA recommends an Energy Star certified roof membrane and rigid insulation (3") assembly.

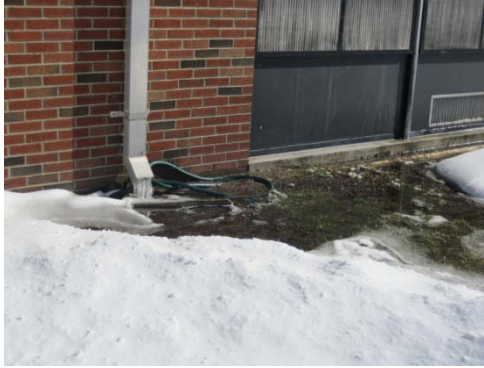
*Water pooling at base of building due to extreme weather condition*

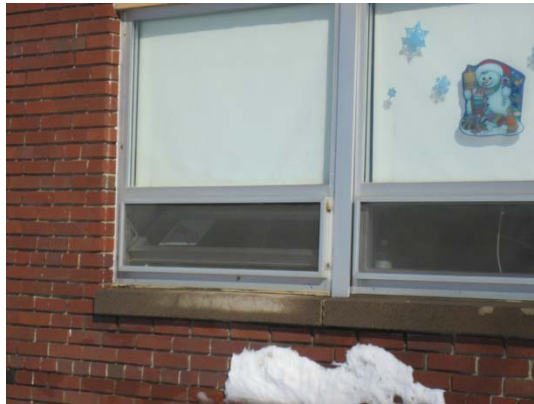
The windows of the school building are single pane, aluminum framed windows and appear to be in fair condition. The seals of the windows are ineffective and do not provide an air tight seal from exterior conditions, increasing the loss of expensive conditioned air. The windows are non-thermal break single glazed with un-insulated panels above them and are energy inefficient. SWA recommends replacement of the single pane windows as part of capital improvement and suggests replacing the existing windows with double-glazed thermal break low-E aluminum framed units. Regular maintenance should be performed, re-caulking around the perimeter of windows (exterior and interior) to ensure a tight seal.

*Open window on day of audit, approximately 28°F*

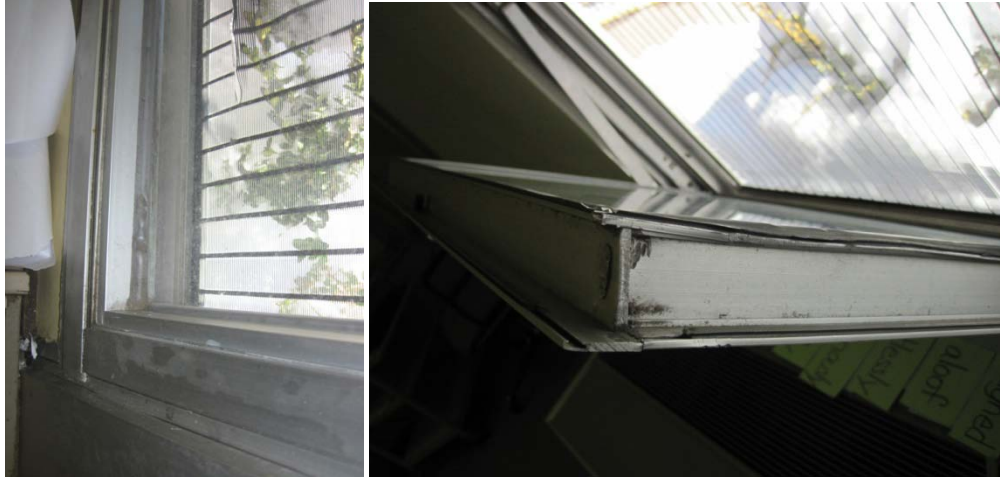
*Single pane aluminum framed windows*

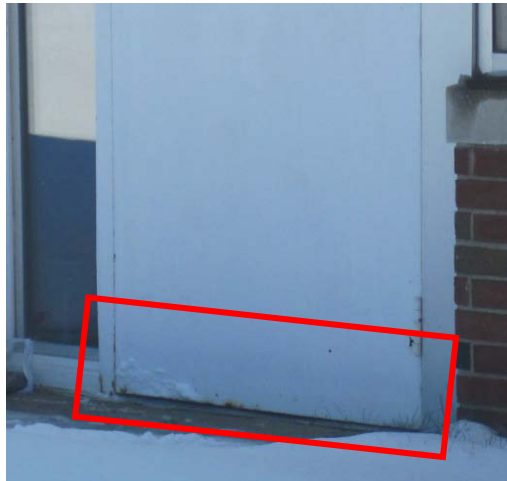
At the time of the audit SWA was told all main exterior doors were replaced in 2000. The FRP exterior doors were inspected and observed to be in very good condition. The exterior wood doors found in various classrooms are in need of replacement. Bubbling of paint (seen in the image below) may lead to rot or warping of the door.

*Older exterior wood door (serving as exit from classroom)*

SWA recommends checking the weather-stripping of each door on a regular basis and replacing any broken seals. Tight seals around doors will help ensure the building to be is kept continuously insulated. When exterior doors or garage doors warrant replacement SWA recommends upgrading existing doors with doors containing a higher R-value with effective seals.

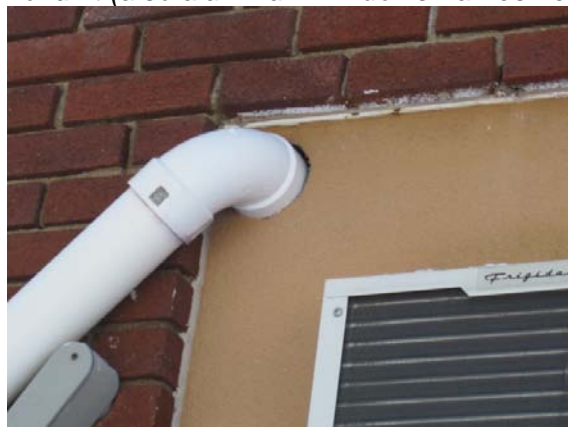
*PVC pipe entering building should be sealed with foam or caulk*

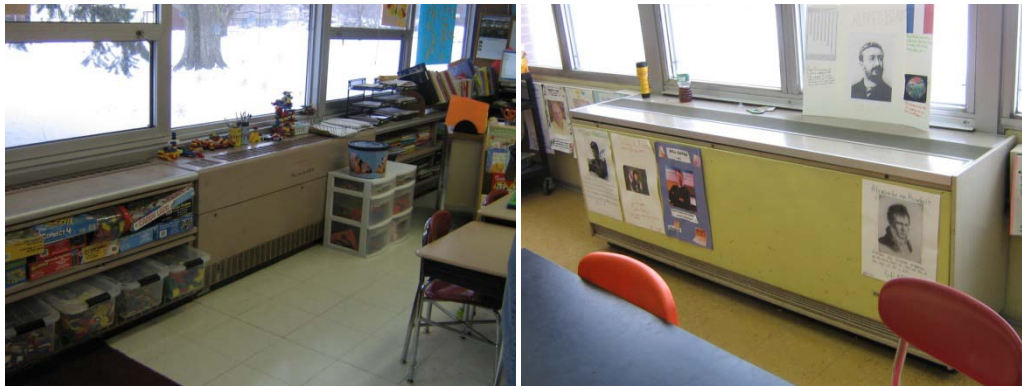
The classrooms in the remaining wings contain wall mounted unit ventilators. It appears that all of the original unit ventilators from the 1958, 1968 and 1974 construction of these wings are still present in the building. This equipment is in fair to poor condition. In total, the school contains approximately sixty (60) Nesbitt unit ventilators of varying ages.

*Unit Ventilators in B Wing (Left) and C Wing (Right)*

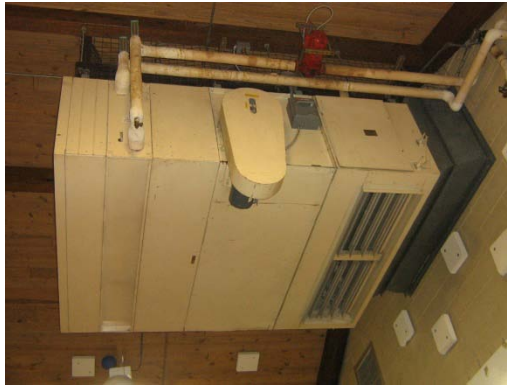
The Large Gymnasium, which also serves as the Cafeteria and Multipurpose Room, is heated by two (2) heating and ventilating (H&V) units, with fresh air provided via rooftop vents. There is one vertical unit located in a small room adjacent to the kitchen. The second unit is horizontal type and is mounted above the Stage. The Small Gym is heated by a large H&V unit suspended from the roof with fresh air provided through a wall louver.

*H&V Unit Suspended From Roof in Small Gym*

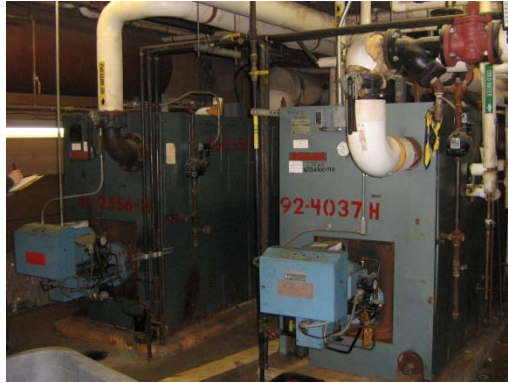
The boilers have a capacity of 2,247 MBH and 2,403 MBH respectively. The boilers are cast iron sectional type. One boiler was installed in 1986 and the other boiler was installed in 1992. According to their age, the boilers have about 6 years and 11 years respectively remaining on their expected service life of 30 years, as published in the 2007 ASHRAE HVAC Applications Handbook. The burners were installed in 1986 and 1992 respectively, and are fed from a 10,000 gallon underground oil storage tank that is adjacent to the B Wing. The first burner is beyond its expected service life and the second burner is approaching its expected service life of 21 years, as published in the 2007 ASHRAE HVAC Applications Handbook.

*A/B wing boilers*

Energy savings could be achieved by replacing these boilers with higher efficiency packaged oil-fired boilers with burner modulation, but this upgrade cannot be justified by energy savings alone.

It is assumed that the circulating pumps were installed in 1986 and 1992 when each boiler was replaced. SWA recommends that the pump motors are replaced with premium efficiency motors.

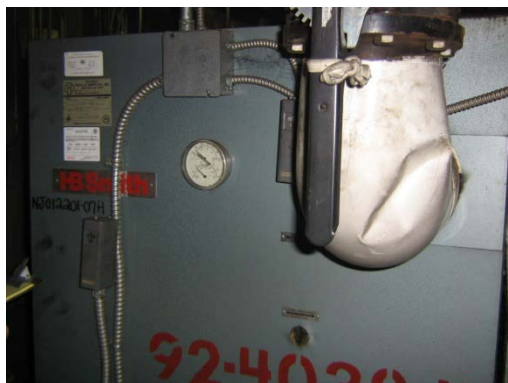
*C/D wing boiler*

Energy savings could be achieved by replacing this boiler with a higher efficiency packaged oil-fired boiler with burner modulation, but this upgrade cannot be justified by energy savings alone.

It is assumed that the circulating pumps were installed in 1992 when the boiler was replaced. SWA recommends that the pump motors are replaced with premium efficiency motors.

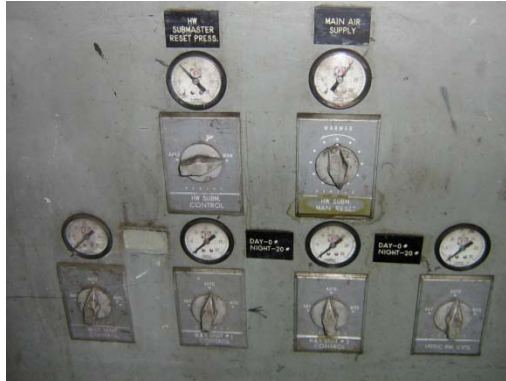
*Pneumatic Control System Panel in C/D Wing Boiler Room*

The building contains two (2) pneumatic controls systems to control the equipment in each pair of wings. The air compressors were noted to run often and in several instances, the thermostats were observed to make a hissing noise indicative of leaking compressed air.

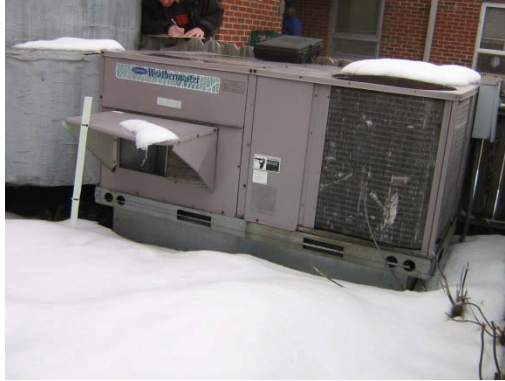
*Packaged HVAC Unit on Grade Serving TV Studio*

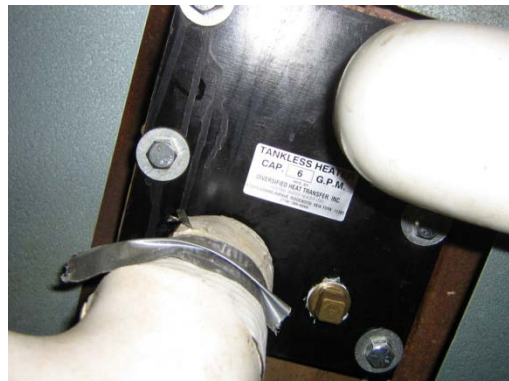
*Typical Tankless Boiler Immersion Domestic Water Heater in A/B Boiler*

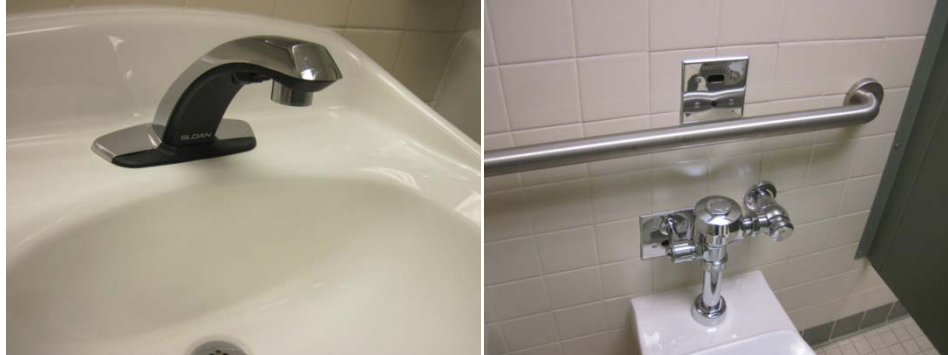
*Updated bathrooms with sensors for toilets and sinks (with 0.5gpm aerators)*

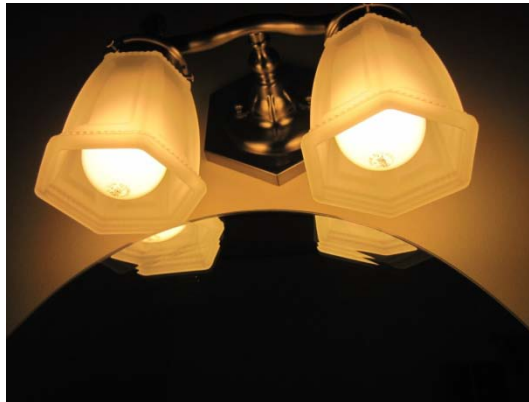
*Incandescent bulbs in faculty lounge bathroom*

*Interior Lighting* - The Frankford Township School building currently consists of mostly older inefficient T12 bulbs with magnetic ballasts. SWA recommends upgrading to high performance T8 fluorescent fixtures with electronic ballasts. There are also fixtures found to contain incandescent bulbs (as seen in the image below). SWA recommends upgrading these fixtures with compact fluorescent bulbs. Based on measurements of lighting levels for each space, there are not any vastly over-illuminated areas. SWA recommends installing occupancy sensors in classrooms, closets, offices and areas where payback on savings is justified. Typically, occupancy sensors have an adjustable time delay that shuts down the lights automatically if no motion or sound is detected within a set time period. See attached lighting schedule in Appendix A for a complete inventory of lighting throughout the building and estimated power consumption.

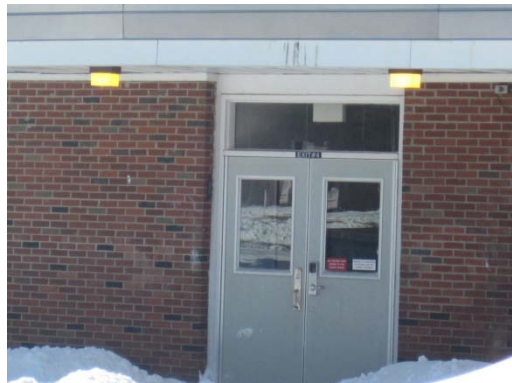
*Exterior lights left on during daylight hours*

*Exterior Lighting* - The exterior lighting surveyed during the building audit was found to be a mix of CFLs and Metal Halide fixtures. Some of the exterior lighting is controlled by photocell sensors. SWA is recommending photocell sensors for all exterior lighting or timers.

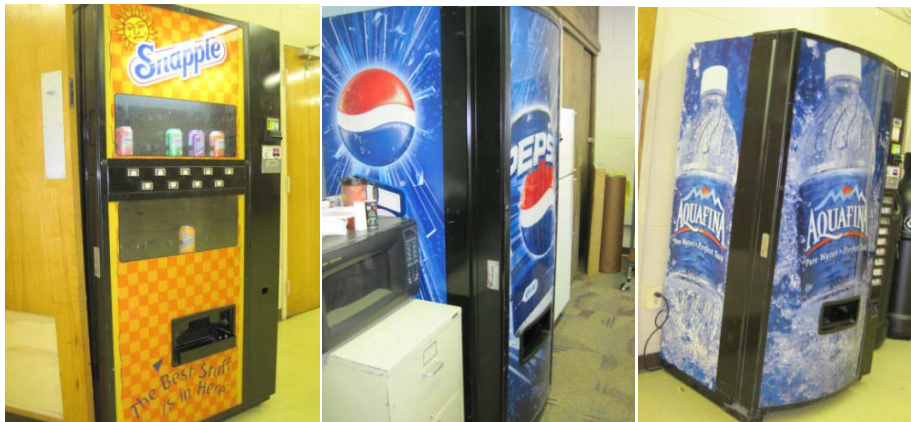
*Two vending machines in Cafeteria, one vending machine in faculty lounge*

Appliances, such as refrigerators, that are over 10 years of age should be replaced with newer efficient models with the Energy Star label. For example, Energy Star refrigerators use as little as 315 kWh / yr. When compared to the average electrical consumption of older equipment, Energy Star equipment results in a large savings. Building management should select Energy Star label appliances and equipment when replacing: refrigerators, printers, computers, copy machines, etc. More information can be found in the “Products” section of the Energy Star website at: <http://www.energystar.gov>. SWA recommends consulting with the vendor that supplies all vending machines, requesting Energy Star models when the contract is due for renewal. Also, energy vending miser devices are now available for conserving energy usage by Drinks and Snacks vending machines. When equipped with the vending miser devices, vending machines use less energy and are comparable in daily energy performance to new ENERGY STAR qualified machines.

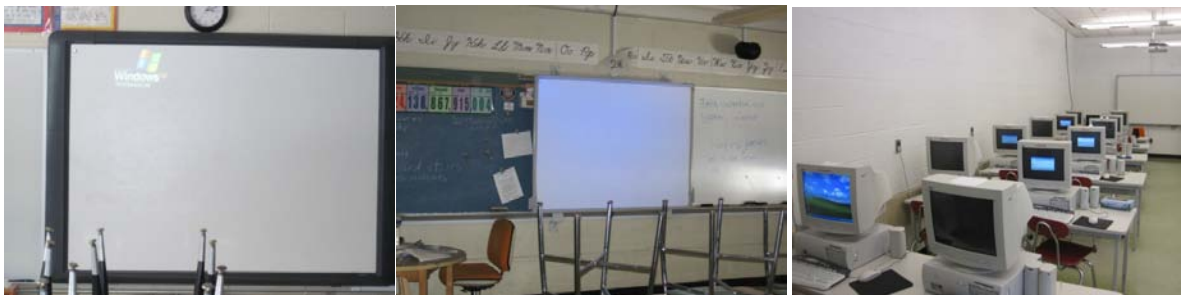
*Smartboards & Computers left on in vacant classrooms*

Computers left on in the building consume a lot of energy. A typical desk top computer uses 65 to 250 watts and uses the same amount of energy when the screen saver is left on. Televisions in meeting areas use approximately 3-5 watts of electricity when turned off. SWA recommends all computers and all appliances (i.e. coffee makers, televisions, etc) be plugged in to power strips and turned off each evening just as the lights are turned off.

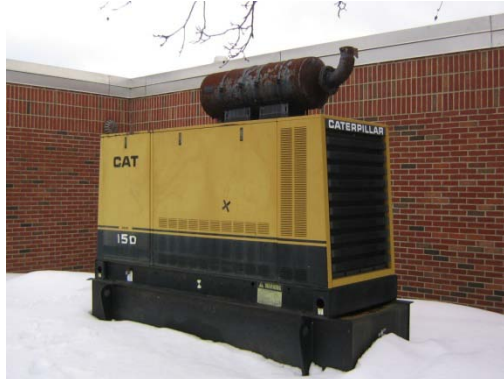
There is one (1) 150KW diesel emergency generator on site. The generator serves all A Wing loads, all Gym and Kitchen loads, the walk-in cooler and freezers, the boiler rooms and the emergency lighting loads in the B, C and D Wings. This generator was installed 2007 and is in good condition.

*Emergency Generator*
