**Local Government Energy Program
Energy Audit Final Report**

***Borough of Freehold
Municipal Building/Fire Headquarters
51/49 West Main Street
Freehold, NJ 07728***

Project Number: LGEA55

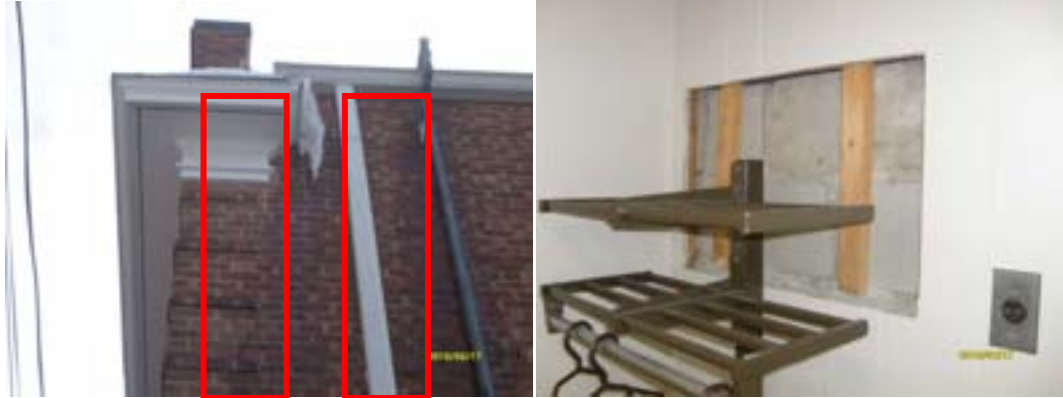
Water damage from uncontrolled roof water run-off due to missing gutters and downspouts (L).
Exposed CMU block with no insulation installed (R).

- Muni. – Replace or repair missing gutters and downspouts
 - Both – Perform routine maintenance inspections of roof surfaces
 - Both – Perform routine maintenance inspections of exterior shell of building

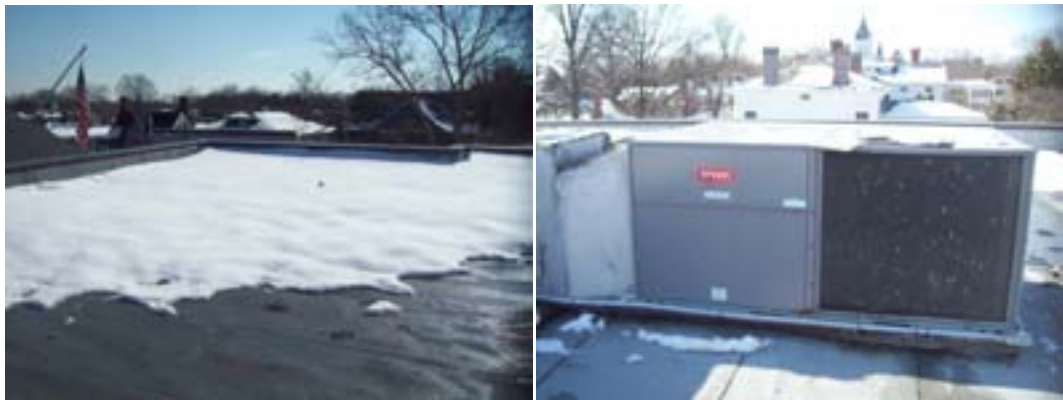
The building's roof is predominantly a flat, parapet type roof over steel decking, with a built-up asphalt finish. It is not known when the last roof replacement occurred. Two and a half inches of assumed roof insulation were observed.

Typical roof installation

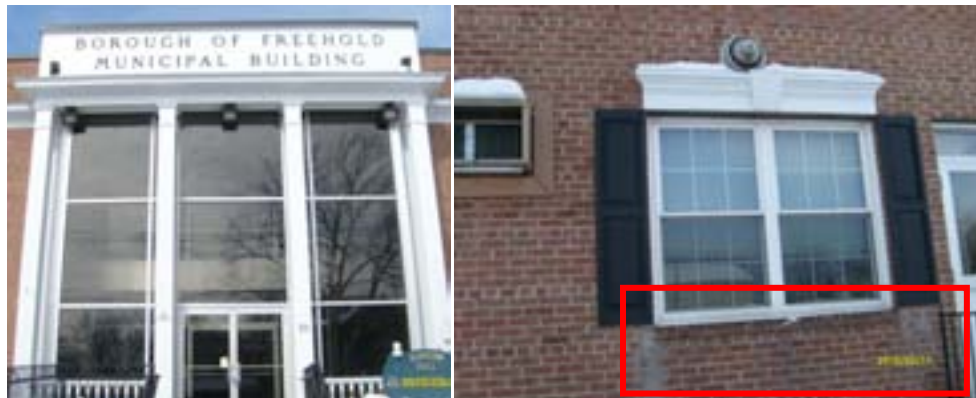
Front of Municipal building, glass entrance area (L). Missing window sill and drip-edge detail (R).

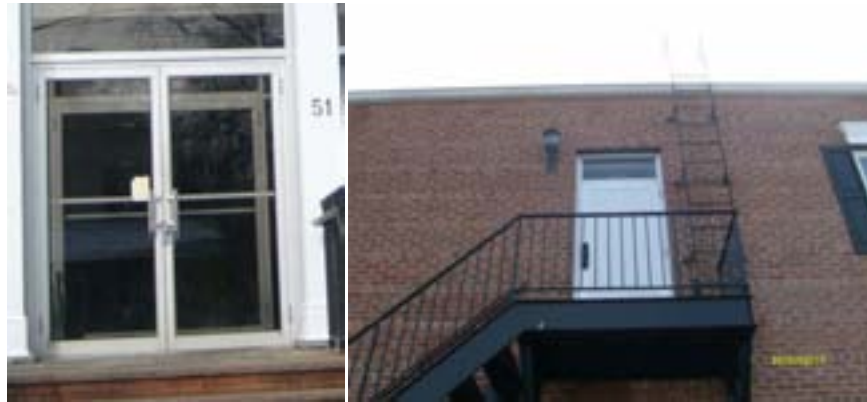
Typical door installations

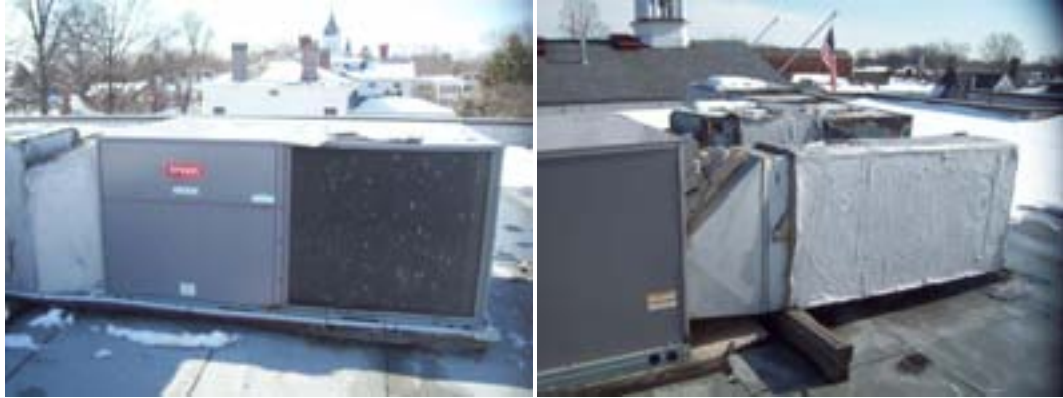
The packaged unit is used to condition the Council room only and it contains a condenser as well as a natural gas-fired furnace which conditions warm air that is directly distributed through ducting to the council room through diffusers. When in cooling mode the packaged unit uses the built in condenser and R-22 refrigerant to condition the air and distribute it through the same duct as the heating.

Bryant packaged rooftop unit

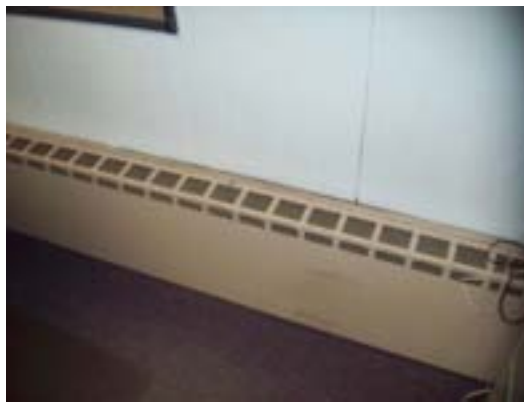
The eight window air conditioners are located in various offices throughout the building as are the electric baseboards which are controlled by nonprogrammable thermostats.

Typical electrical baseboard unit

- Capital Improvements
 - Muni. – Replace electric baseboard heaters with hot water baseboard system
 - Fire – Replace two electric baseboard heaters in basement of Fire Headquarters

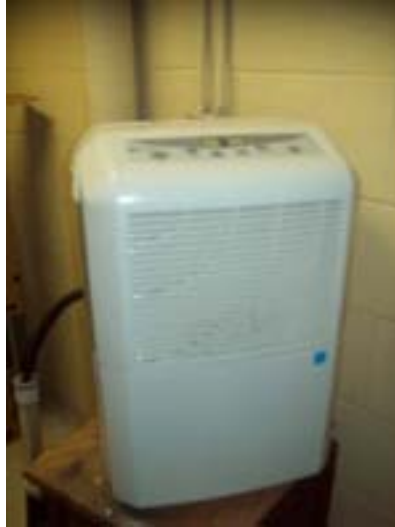
There is also a Maytag plug-in ENERGY STAR® rated humidifier installed in the basement vault.

Maytag humidifier

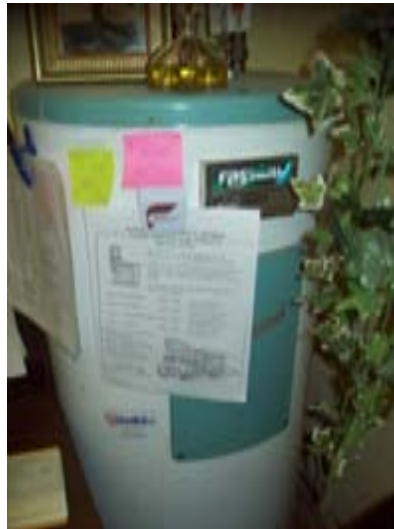
The domestic hot water (DHW) heater for the Municipal building is located in the mechanical room of the basement. DHW is provided by an electric AO Smith water heater with Model #PEN-30 with 30 gallons of storage capacity. This heater has exceeded its estimated useful lifetime and should be replaced.

Municipal Building DHW heater

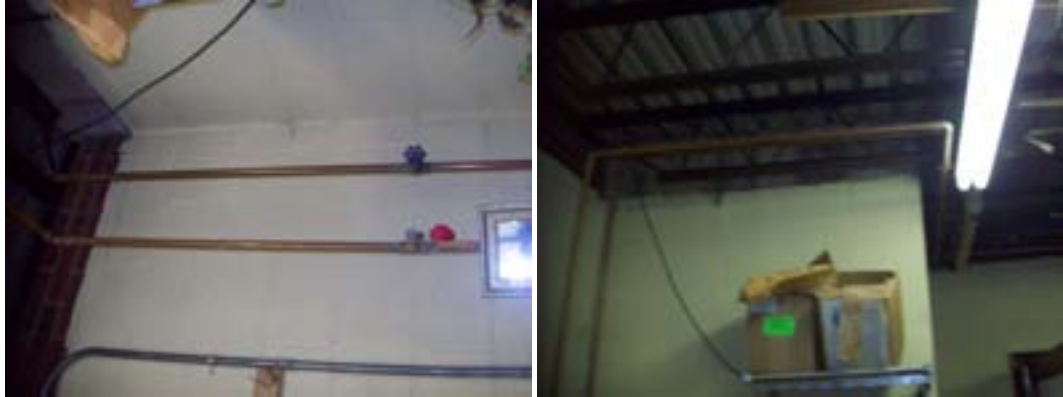
In the Municipal building, conditioned air from the packaged rooftop unit is distributed through insulated ductwork with diffusers. The electric baseboard heating and window air conditioning units have no associated ductwork. Domestic Hot Water is delivered through the building using mostly un-insulated copper piping.

Example of un-insulated copper piping in the Municipal building

- Muni. – Replace existing roof and increase insulation levels
- Operations and Maintenance
 - Both – Install pipe insulation on copper pipes used for Domestic Hot Water supply

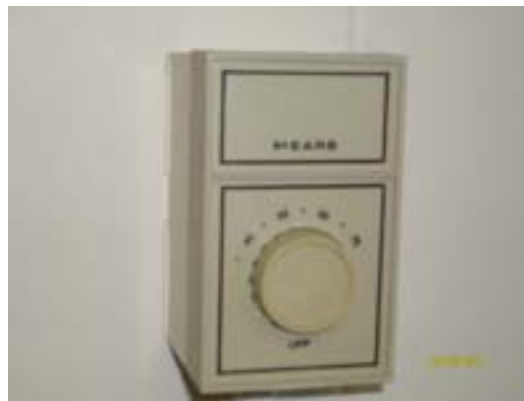
The Municipal building does not have a central building management system. The electric baseboard heaters are controlled by non-programmable thermostats. The packaged rooftop unit is also controlled by a wall-mounted non-programmable dial thermostat.

Typical thermostat for electric baseboard units

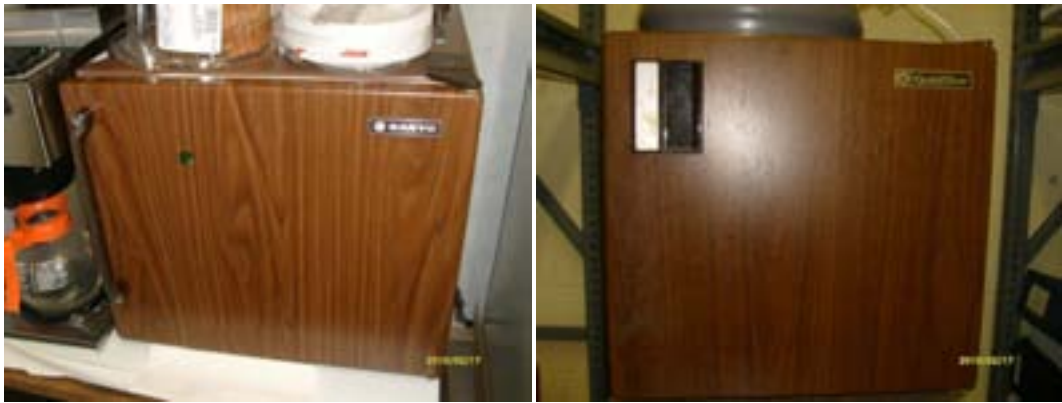
At the Municipal building four compact refrigerators were installed. The Haier and Avanti units are new and energy efficient models that should remain. The Goldstar and Sanyo units are older and inefficient models that should be replaced with ENERGY STAR® units.

Existing Sanyo and GoldStar refrigerators to be replaced

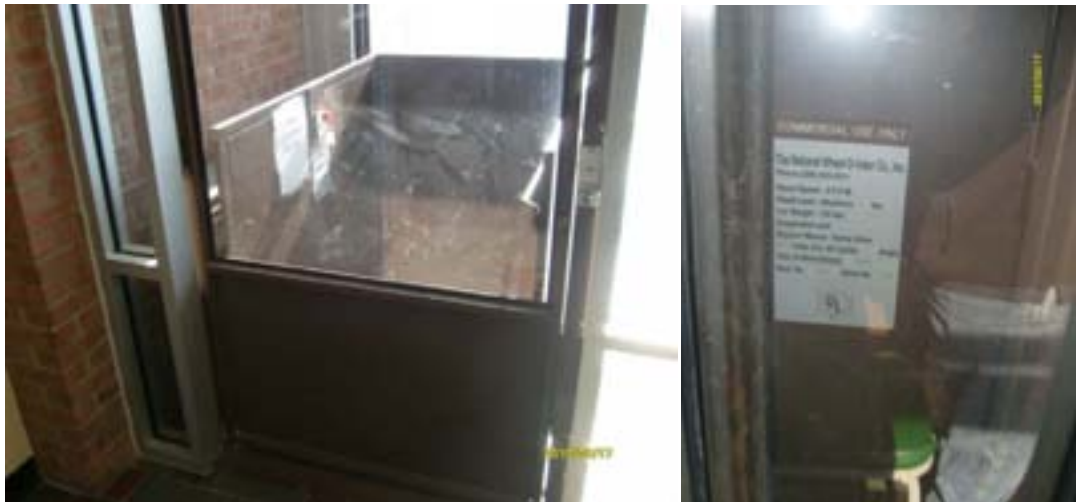
The Municipal building has a handicap accessibility lift that is rated for travel at 9 fpm with a loaded capacity of 750 lbs and was installed in 1996. This unit was observed to be in age-appropriate condition with no major signs of deterioration.

Accessibility lift and nameplate

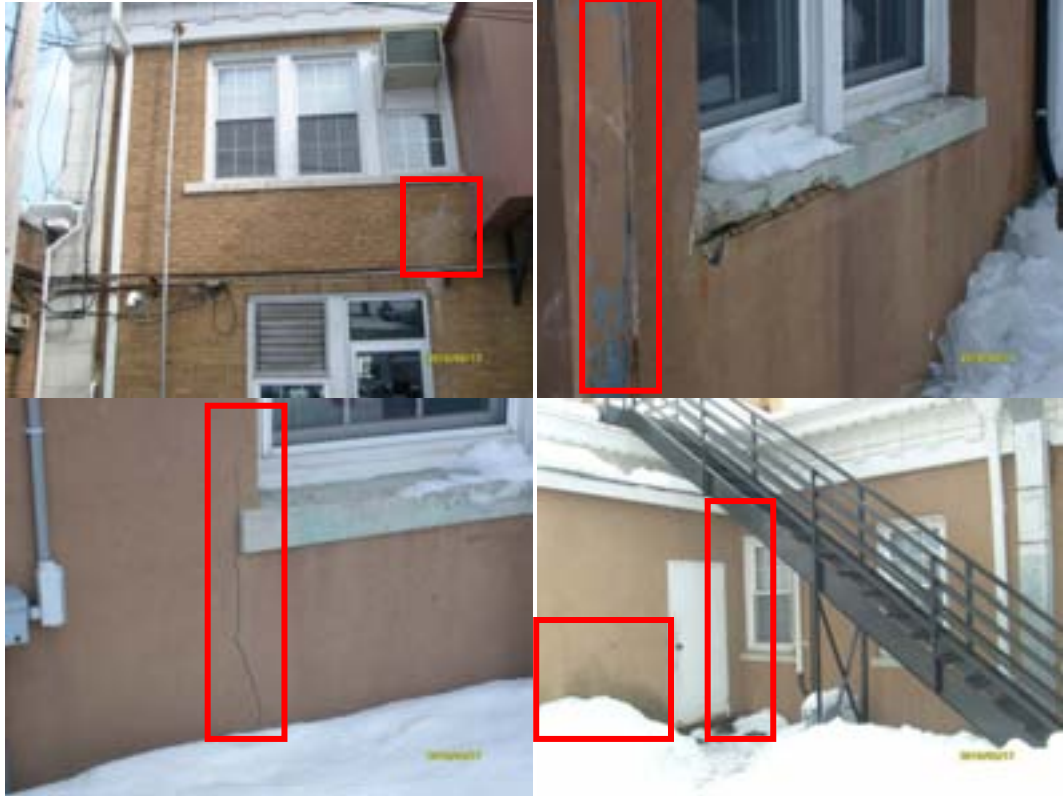
Efflorescence on brick and masonry walls indicate moisture presence within the wall cavity, cracked/aged caulk and damaged exterior wall finishes

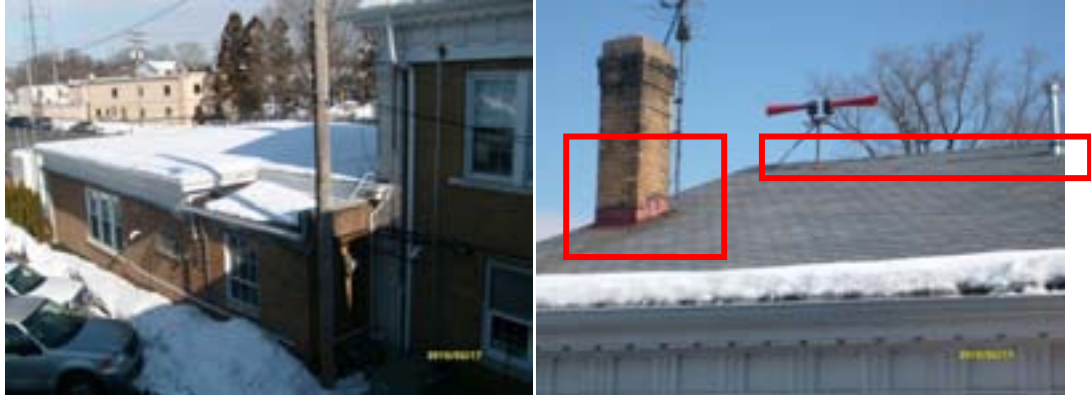
View of lower roof (L). Missing / ineffective flashing and damaged roof shingles on upper roof (R).

- Fire – Create schedule for heating of Fire Headquarters second floor
 - Fire – Replace or repair damaged window frames and window sills
 - Fire – Replace damaged shingles on upper roof of Fire Headquarters

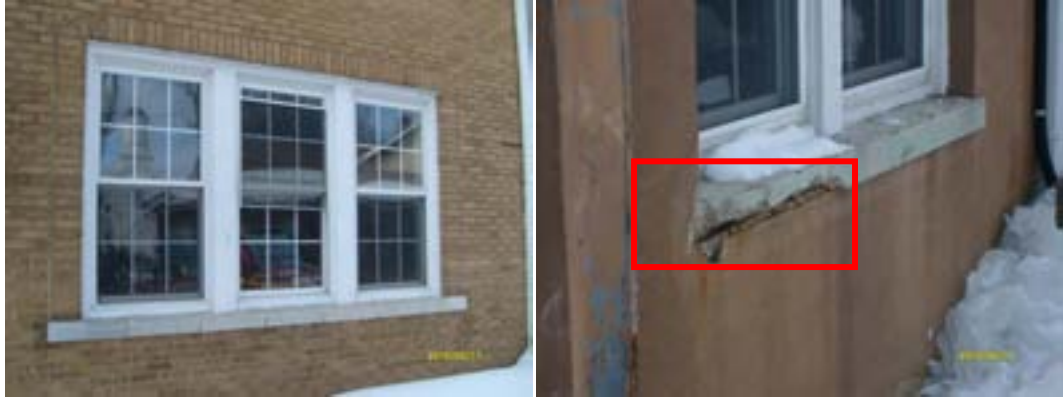
Typical double-hung window (L). Damaged/aged window frame and damaged window sill (R).

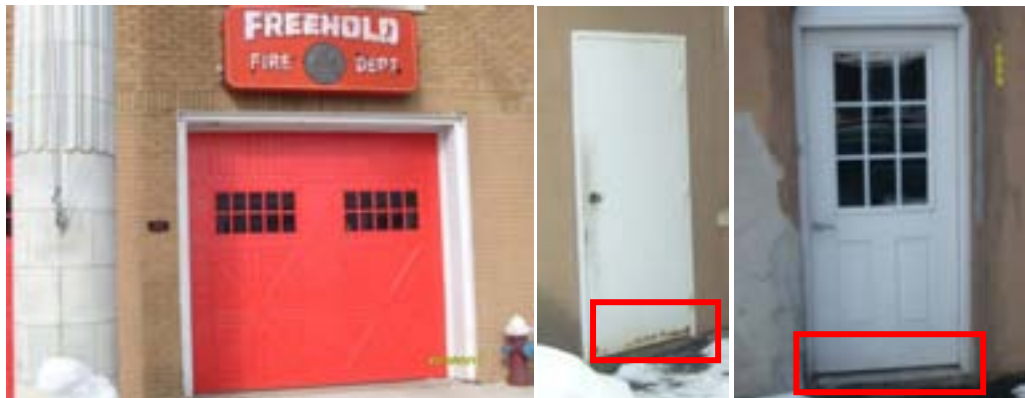
Missing/worn weather-stripping, damaged/warped/aged door frame and exterior mold/water damage signs on areas around doors

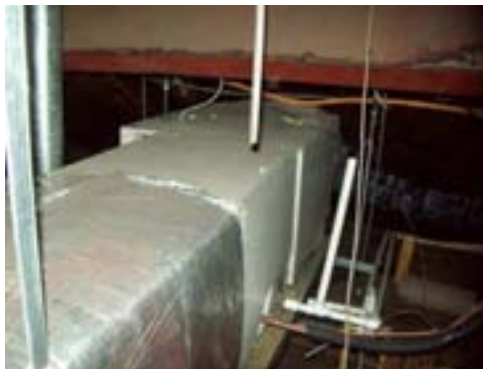
The two air handler units are located in the ceiling plenum of the second floor and are used to condition the second floor and first floor meeting areas. They contain gas-fired furnaces with cooling coils, connected to condensers located on the roof of first floor.

Air handler unit in ceiling plenum

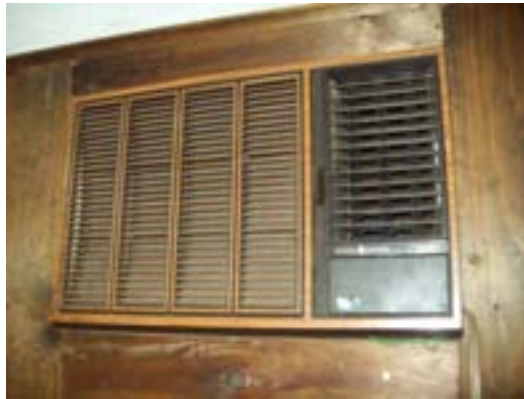
The lounge in the basement is cooled by a GE through the window air conditioner. There are also two other through the window air conditioning units installed in the second floor, however, they are no longer used due to the installation of the split system cooling units.

Basement air conditioner

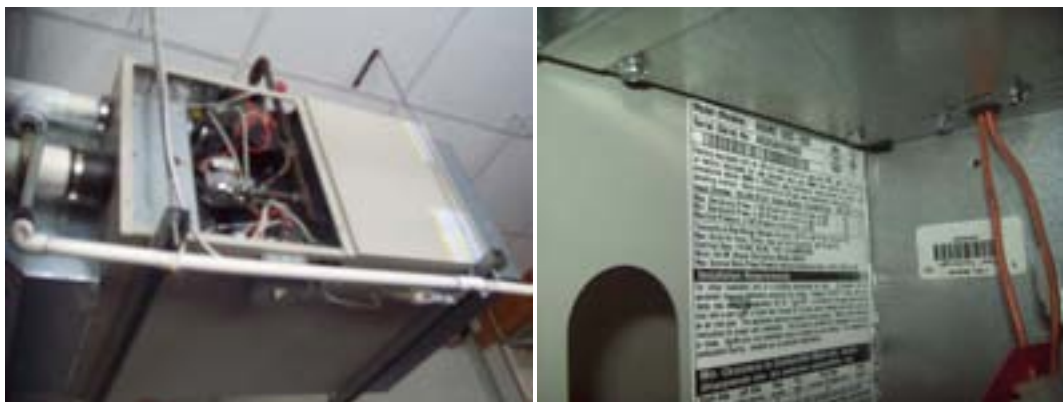
Picture of first floor furnace and nameplate

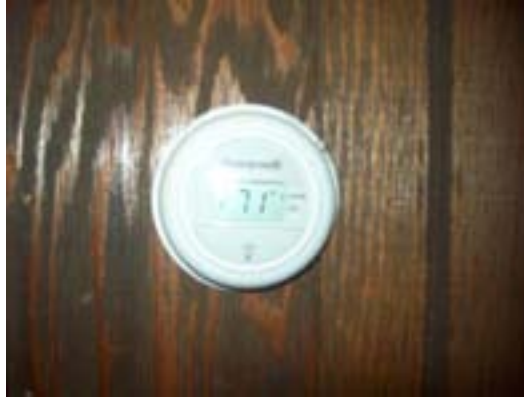
The Fire Headquarters building contains a Carrier split system that is controlled by a programmable thermostat in the first floor meeting room. The Nordyne split systems are controlled by programmable thermostats on the second floor set to 71°F and 68°F. The two electric baseboard units in the basement are controlled by a nonprogrammable thermostat set to 80°F. The garage unit heaters are controlled by programmable thermostats set to 60°F and the Nordyne/Gibson furnace is controlled by a Honeywell non-programmable thermostat.

Honeywell thermostat

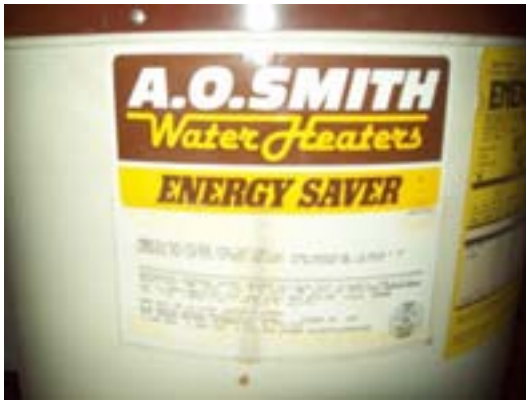
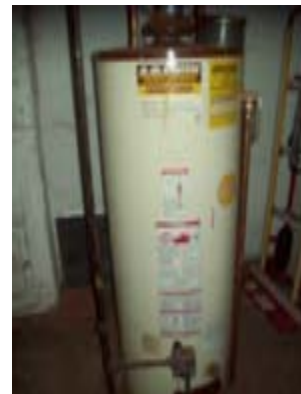
The domestic hot water (DHW) heater for the Fire Headquarters is located in the basement mechanical room. DHW is provided by an AO Smith, Model #PGX 40 216 atmospheric water heater, with a 40 gallon storage capacity. This heater has exceeded its estimated useful operating life.

Fire Headquarters DHW heater

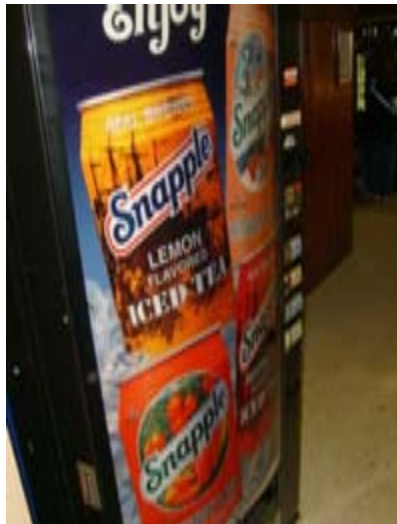
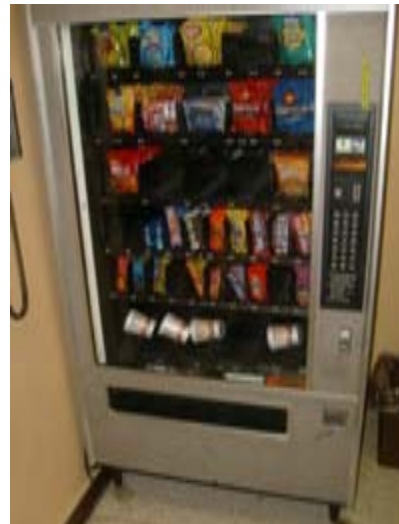
At the Fire Headquarters there are two ice machines installed, two commercial style refrigerators that are new efficient models that should remain, and an older inefficient model snack vending machine and older inefficient model refrigerated vending machine that should be retrofitted with SnackMiser™ and VendingMiser™ devices respectively.

Existing vending machines to be replaced
