**Local Government Energy Program
Energy Audit Report-FINAL**

***The Township of Millburn
Bauer Community Center
100 Main St
Millburn, NJ 07041***

Project Number: LGEA58

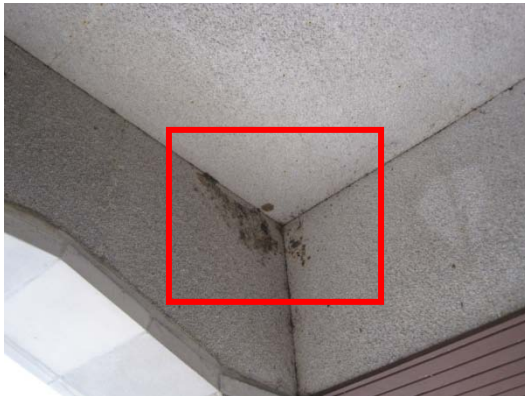
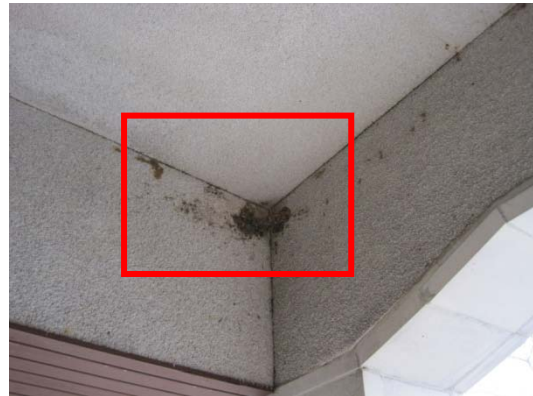
Exterior and interior wall surfaces were inspected during the field audit. They were found to be in overall good, age-appropriate condition with only a few signs of energy-compromising issues. Signs of insect infestation were found located mostly at the front of the building.

Insect nesting in exterior wall cracks and cavities

- Exterminate for insect nesting in exterior wall cracks and cavities. SWA found areas mentioned in the exterior wall section of this report, where insects have nested on the exterior wall/roof assembly. Maintenance personnel should provide regular care for these areas in order to prevent future damage to exterior wall integrity.
- Provide water-efficient fixtures and controls - Adding controlled on/off timers on all lavatory faucets is a cost-effective way to reduce domestic hot water demand and save water. Building staff can also easily replace 2.2gpm faucet aerators with 0.5gpm faucet aerators and/or low-flow

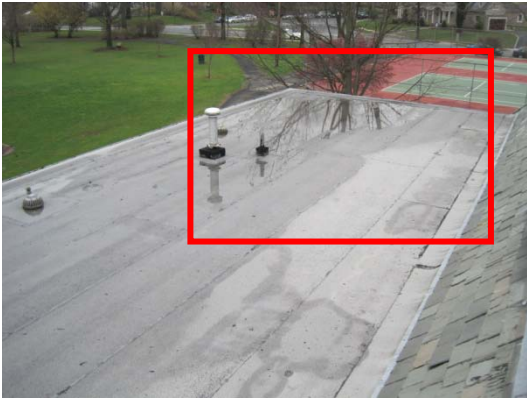
leakage and other energy-compromising issues detected on all roof areas. Water is not directed properly to drains and tends to pool in certain areas. There are no gutters in the rear of the building, so that rain runoff in the rear flows off roofs and pools around doors which in serious rains then floods building. The gutters in the front of the building are damaged and there are a number of loose shingles. According to reports from building management this damage is created by snow.

Ponding of water on flat roofs

- Slope roof surface to drain effectively at time of reroofing.
- Slope perimeter grade away from building to maximize site drainage.
- Replace un-insulated wood and metal doors with insulated and weather-stripped RFP door types

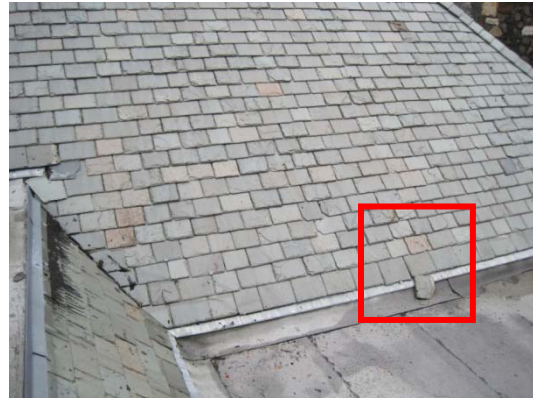
Loose slate shingles

- SWA recommends investigating the roof for leaks, deteriorating roof finishes and damaged or compromised roof and valley flashing. Inspect and maintain all roof surfaces on a regular basis. Replace loose shingles.

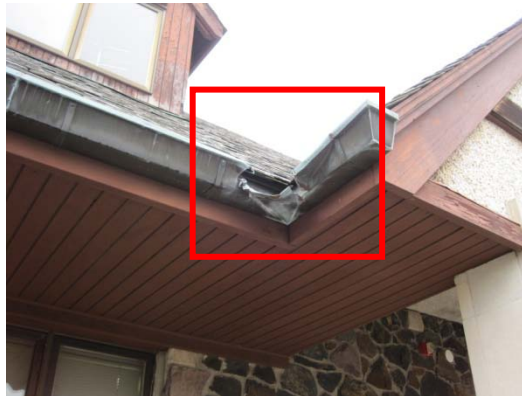
Damaged gutters in the front of the building

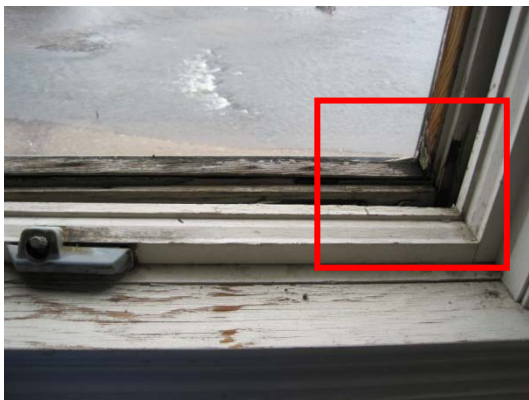
Attic window with missing pane of glass and interior water damage causing window not to operate properly

- Replace and maintain weather-stripping around all exterior doors and roof hatches.
 - Replace or repair damaged window units.
 - Add and maintain caulk around window frames and sills.

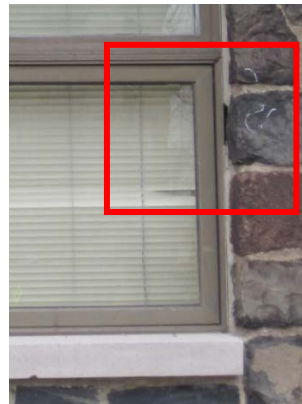
Windows, shading devices, sills, related flashing and caulking were inspected as far as accessibility allowed for signs of moisture, air-leakage and other energy compromising issues. Overall, the windows were found to be in poor condition with signs of uncontrolled moisture, air-leakage and/ or other energy-compromising issues. Some windows were found to have missing panes of glass, interior moisture damage and warping of frames causing some windows not to function properly. Caulking around some windows was found to warn and cracked.

Cracked caulk around frame on the exterior

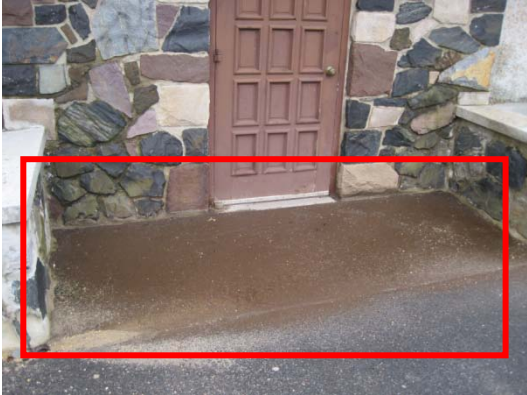
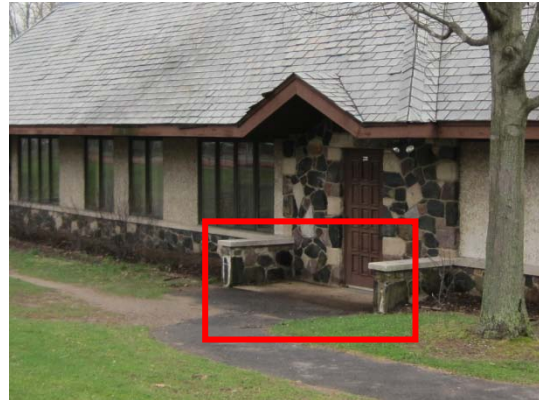
sloped towards the building and there are no roof gutters in the rear of the building. Therefore rain water tends to pool at the base of the rear of the building, especially around the rear doors and on the left side of the building. The water floods into the building through these doors (see more details in doors section). There is no evidence that the water is infiltrating the building through the base, however the grade should be sloped away from the building to direct rain runoff away as much as possible.

wood doors are warped from moisture issues and do not function properly. The grade of the ground in the rear of the building is sloped towards the building and rain water pools around the rear doors and the doors on the left side of the building. The thresholds of these doors are not elevated above grade so that water tends to flood into the building despite the door saddle.

Signs of water pooling around doors and flooding into building

Image showing area of water pooling near exterior door

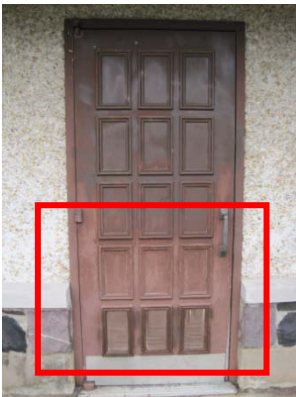
Warped and aged door and frame

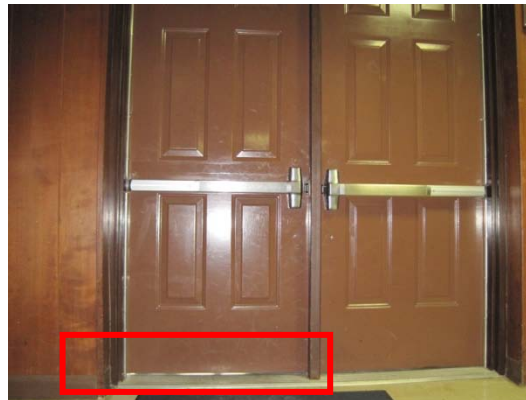
The building contains both wood type and metal type exterior doors. All exterior doors, thresholds, related flashing, caulking and weather-stripping were inspected for signs of moisture, air-leakage and other energy-compromising issues. Overall, the doors were found to be in poor condition with numerous signs of uncontrolled moisture, air-leakage and/ or other energy-compromising issues. Weather stripping around doors is worn. Some of the

Missing and worn weather-stripping around doors

- Provide weather-stripping/air-sealing - SWA observed that exterior door weather-stripping was beginning to deteriorate in places. Doors and vestibules should be observed annually for deficient weather-stripping and replaced as needed. The perimeter of all window frames should also be regularly inspected, and any missing or deteriorated caulking should be re-caulked to provide an unbroken seal around the window frames. Any other accessible gaps or penetrations in the thermal envelope penetrations should also be sealed with caulk or spray foam.

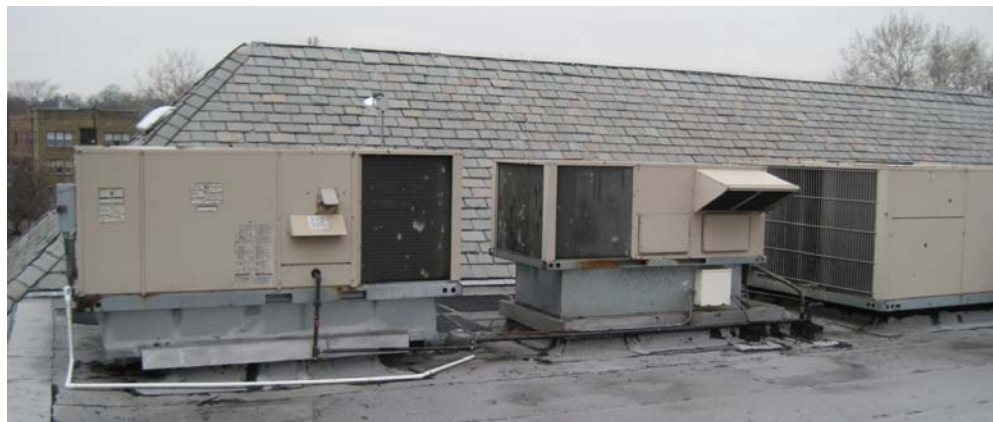
The rooftop units contain a natural gas burner for heating and a direct expansion (DX) system for cooling, made up of an evaporator, condenser and refrigerant loop. The units were manufactured by York and installed circa 1999. The units still have 27% remaining life and appear to be in good condition.

Gas fired DX cooled rooftop packaged units

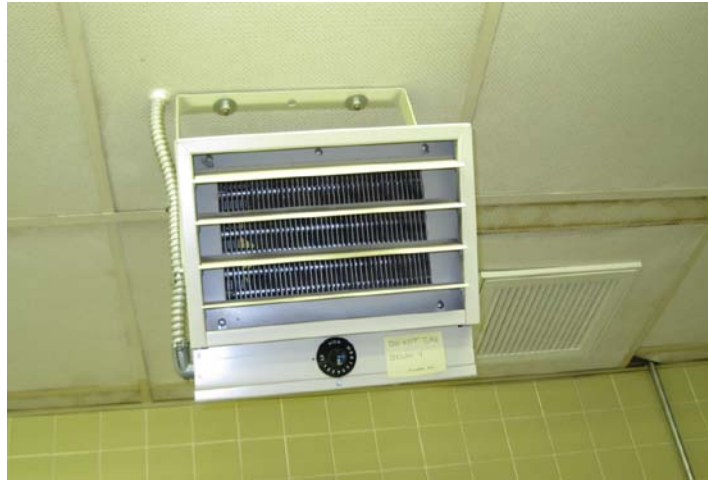
The kitchen also contains two ceiling mounted 3kW electric heaters for maintaining a minimum temperature during winter. The heaters are manually adjusted by the building operators when the outside air temperature is expected to fall below 40 deg F. SWA considered replacing these heaters with gas fired furnace or hot water heating. The payback was found to be in excess of 15 years. SWA proposes to install a gas fired furnace in the storage room to serve the kitchen as part of capital improvement.

Kitchen electric heater – manual knob control

- Replace Kitchen electric heaters with a gas fired furnace – the kitchen contains two ceiling mounted 3kW electric heaters for maintaining a minimum temperature during winter. The heaters are manually cranked up by the building operators when the outside air temperature is expected to fall below 40 deg F. SWA recommends replacing these heaters with a gas fired furnace located in the storage room to serve the kitchen as part of capital improvement. Estimated cost of replacement is \$10,000

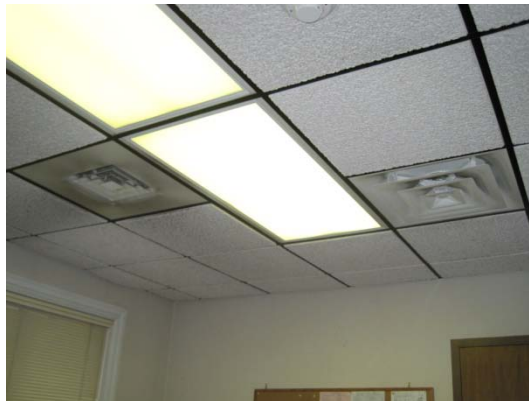
Interior Lighting - The Millburn Bauer Community Center building currently consists of mostly older inefficient T12 bulbs with magnetic ballasts. SWA recommends upgrading to high performance T8 fluorescent fixtures with electronic ballasts. T8 fixtures reduce wattage with the same lumen output. There were also fixtures found to contain screw-in incandescent and halogen (PAR) type bulbs (as seen in the image below). SWA recommends replacing the incandescent and halogen bulbs with screw-in compact fluorescent bulbs (CFLs). Please note; building management has already replaced some incandescent and PAR bulbs with CFLs in individual locations.

Example of typical fixture with inefficient 4'T12 bulbs and magnetic ballast

On the days of the site visits, SWA completed a lighting inventory of the Bauer Community Center building (see Appendix B). The existing lighting consists of mostly T12 fluorescent fixtures with magnetic ballasts. SWA recommends installing occupancy sensors in bathrooms, closets, offices and areas where payback on savings is justified. Typically, occupancy sensors have an adjustable time delay that shuts down the lights automatically if no motion is detected within a set time period. Advance micro-phonic lighting sensors include sound detection as a means to control lighting operation. SWA recommends replacing incandescent and halogen lamps with CFL lamps. The labor in all these installations was evaluated using prevailing electrical contractor wages. The Township of Millburn may decide to perform this work with in-house resources from its Maintenance Department on a scheduled, longer timeline than otherwise performed by a contractor, to obtain savings.

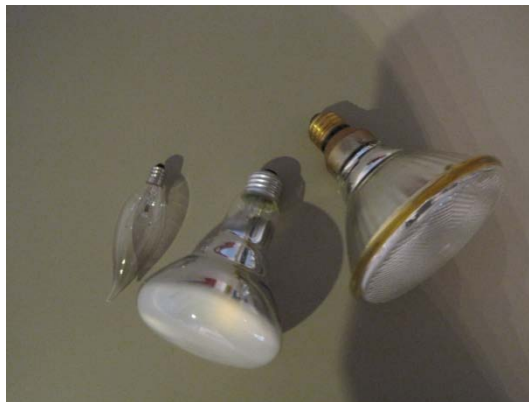
Examples of incandescent and halogen PAR type bulbs used in various rooms

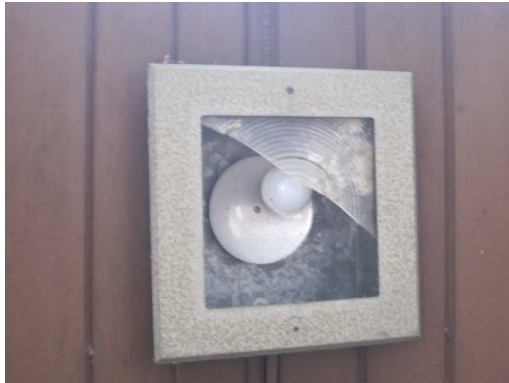
Exterior Lighting - The exterior lighting surveyed during the building audit was found to be a mix of screw-in incandescent and halogen (PAR) bulb type fixtures. Some fixtures were found to be in disrepair. SWA recommends replacing these bulbs with screw-in compact fluorescent bulbs (CFLs). The exterior lighting is controlled by an automatic timer. SWA does not recommend any changes to the controls at this time.

Exterior light fixture with inefficient incandescent bulb and damaged lens
