**Local Government Energy Program
Energy Audit Report**

***Township of Mount Holly
Municipal building
Mount Holly, NJ 08060***

Project Number: LGEA54

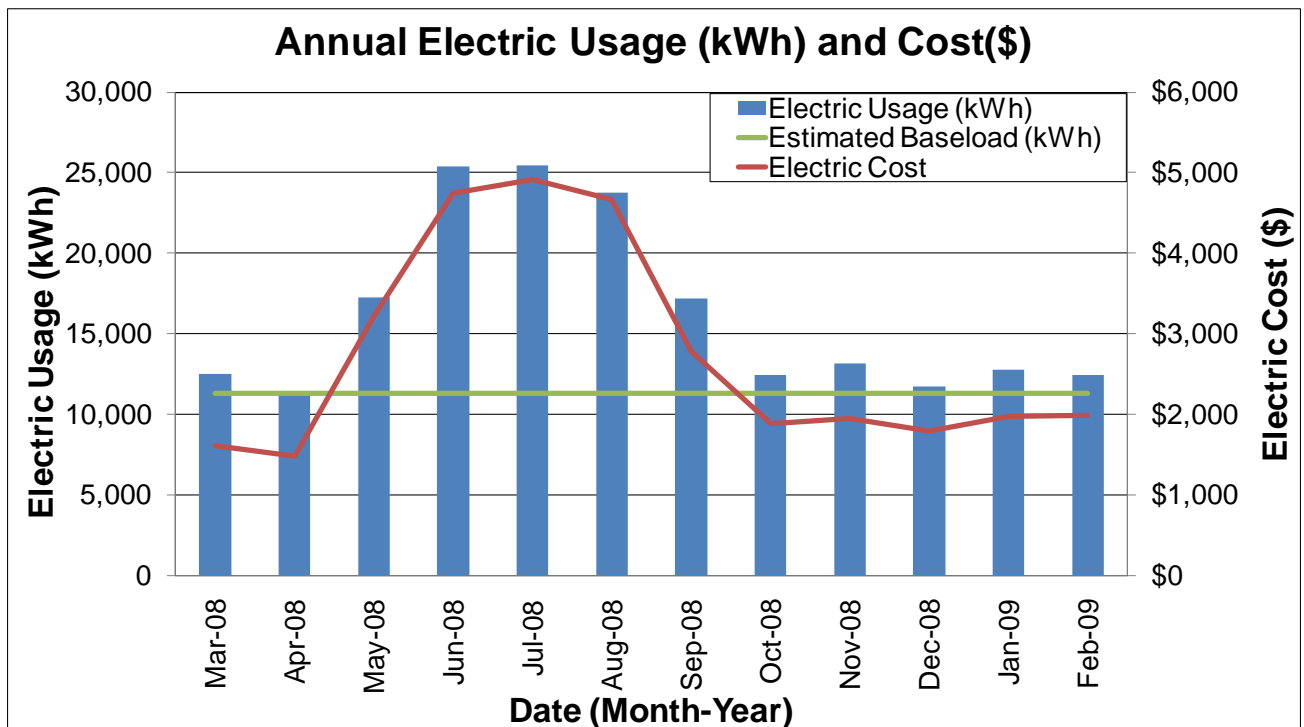
The following chart shows electricity use for the Municipal building based on utility bills for the 12 month period of March 2008 to February 2009.

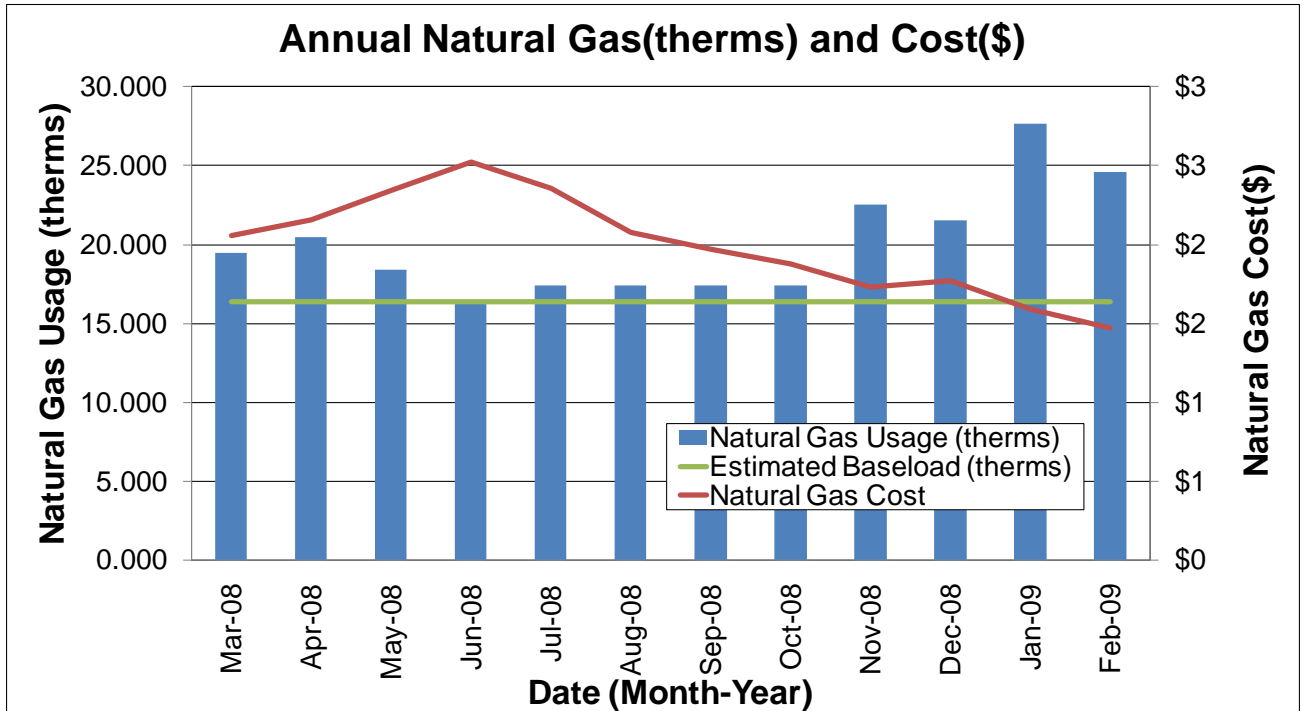
The following chart shows the natural gas energy used for the Municipal building based on receipts for the 12 month period of March 2008 to February 2009.

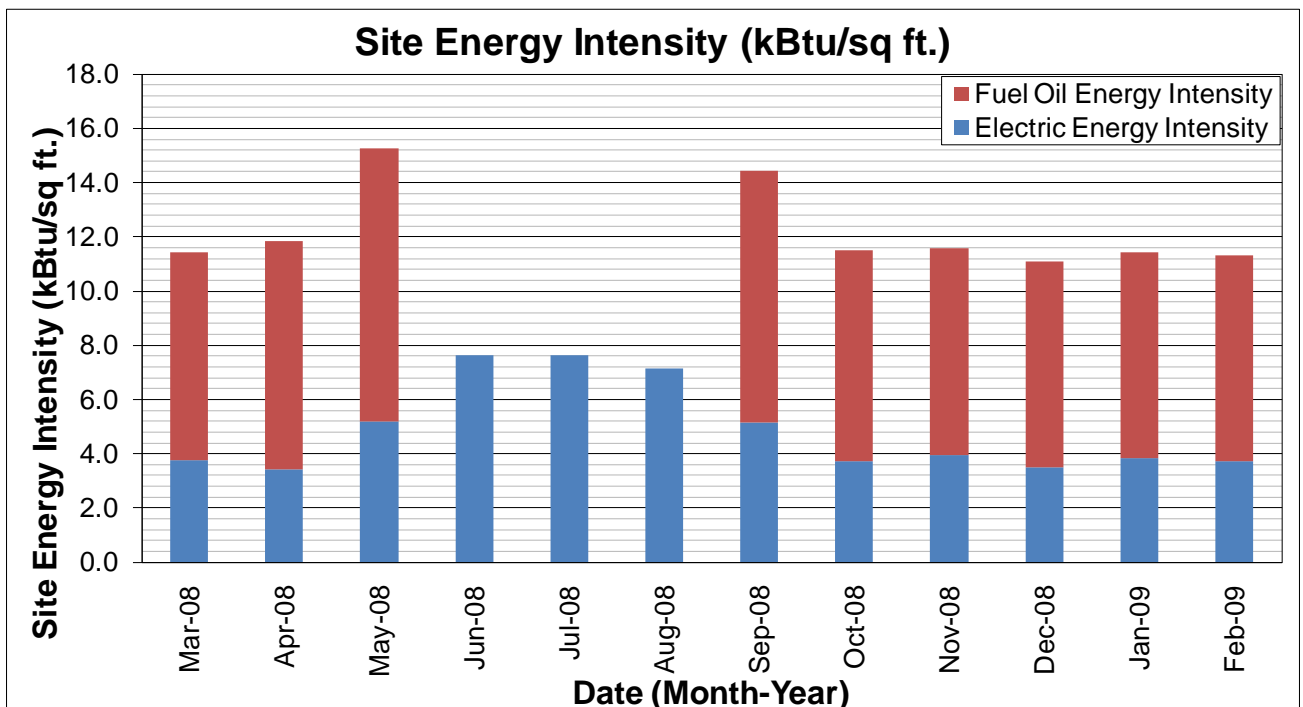
The following chart shows combined natural gas, fuel oil #2, and electric consumption in Btu/sq ft for the Municipal building based on utility bills for the 12 month period of March 2008 to February 2009.

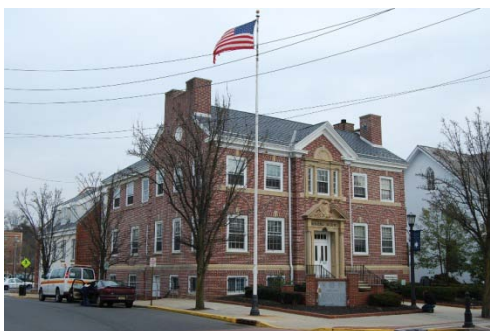
Front and Left Side Façade

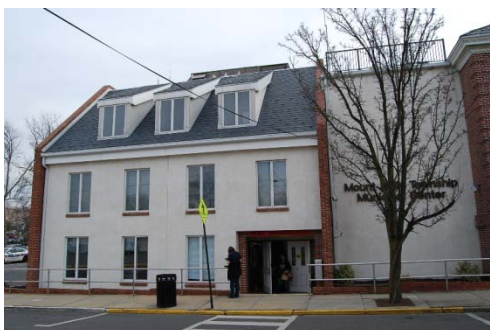
Partial Left Side Façade (typ.)

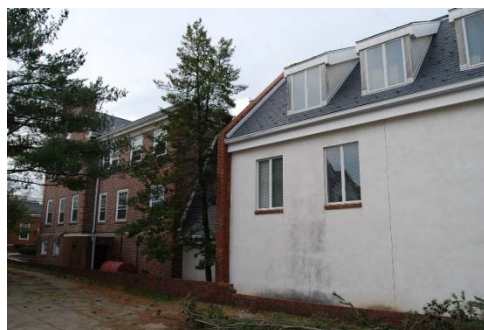
Partial Right Side Façade (typ.)

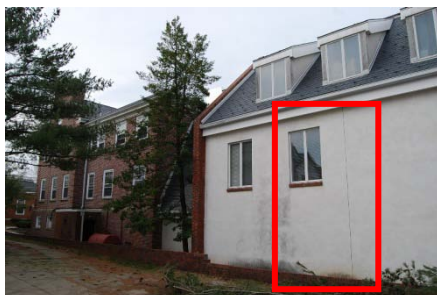
Mold/water damage on interior gypsum wallboard and exterior stucco finish due to uncontrolled water infiltration through the roof area.

- Chimney flashing should be evaluated and fixed or replaced. Once the source for the water damage on the right side façade has been determined and eliminated all affected wall and ceiling elements need to be restored or replaced if necessary.

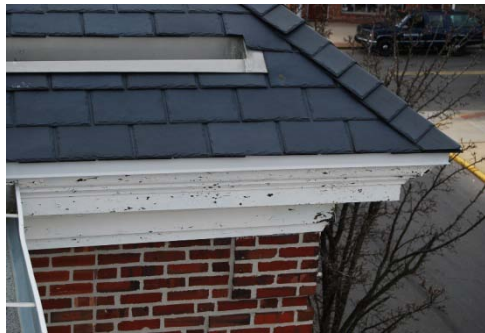
Deteriorating crown/fascia molding.

- Refinish or replace deteriorated exterior woodwork, moldings and trim to minimize and prevent water and moisture infiltration into wall or roof assemblies.

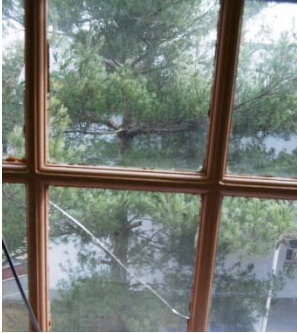
Single-glazed window with ineffective frame

- Replace single pane windows - SWA evaluated, as part of a capital improvement plan, replacing 67 single-pane windows with newer models with thermal breaks, dual glazing and a low-e rating. These windows appear to be original to the building. In context of other energy measures proposed in this report and in an effort to maximize the cost-benefit factor for improvements, SWA recommends that these windows be replaced with the next major capital improvement/renovation project. Windows considered for replacement should have the following outline specifications besides conforming to local code and regulations. The clear, low-e, argon filled dual glazing should be 2 independent panes. Air infiltration shall not exceed 0.10 cfm/sf of unit. The conductive thermal transmittance (U-Value) shall not be

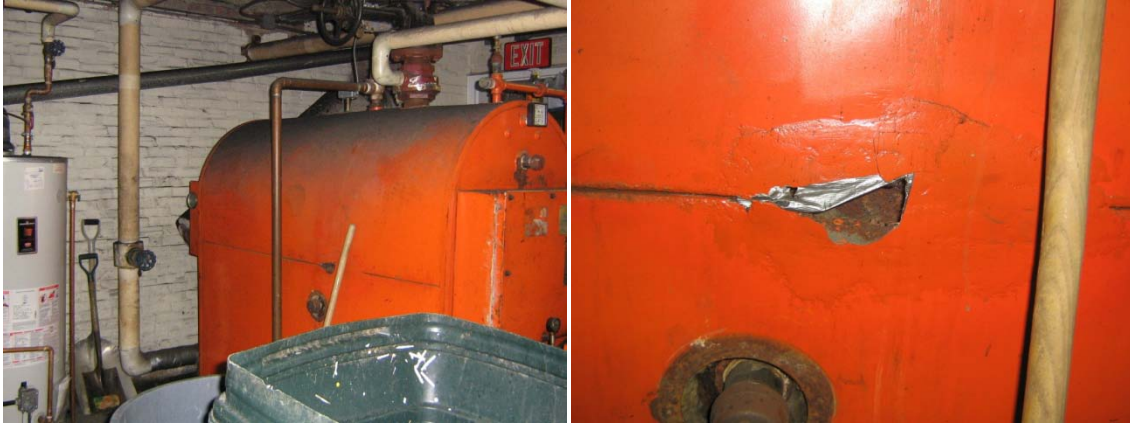
The source of heat in the building is an oil-fired fire-in-tube hot water boiler system located in the Basement level mechanical room. The boiler is rated for 1,080 MBH and is fed from an exterior underground oil storage tank adjacent to the mechanical room. The boiler system was installed circa 1976 and is in poor condition. There is a hole in the outer casing of the boiler that is degrading over time. According to its age, the boiler is operating beyond its expected service life of 30 years, as published in the 2007 ASHRAE HVAC Applications Handbook. SWA recommends that this boiler be replaced. Since the boiler room contains a small gas service and meter, it is recommended that the boiler be replaced with a gas-fired high efficiency condensing boiler and that PSE&G is contacted regarding the adequacy of the existing service to handle the new boiler or if a service upgrade is required.

Oil -Fired Boiler and Photo of Hole in Outer Jacket

The current hot water boiler is 34 years old and is in poor condition. Also, the unit is relatively inefficient as compared to more modern equipment. SWA recommends providing two (2) packaged cast iron sectional boilers with modulating burners in the boiler room (similar to Weil-McLain Model WGO), sized in accordance with the building heating load. This will provide energy savings by providing a thermal efficiency of approximately 85% versus the estimated 65-70% of the currently operating boiler. These boilers would incorporate a two-pass flue gas design, would be CSD-1 code-compliant with low water cutoff and manual high level aquastat.

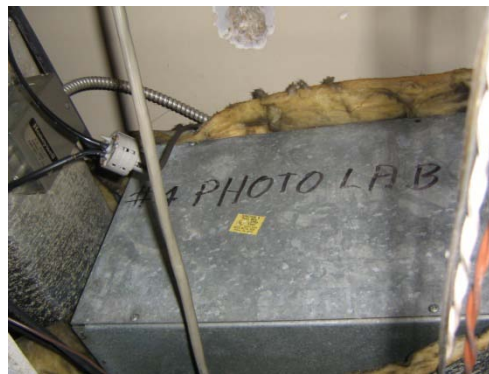
Duct Mounted Electric Reheat Coil

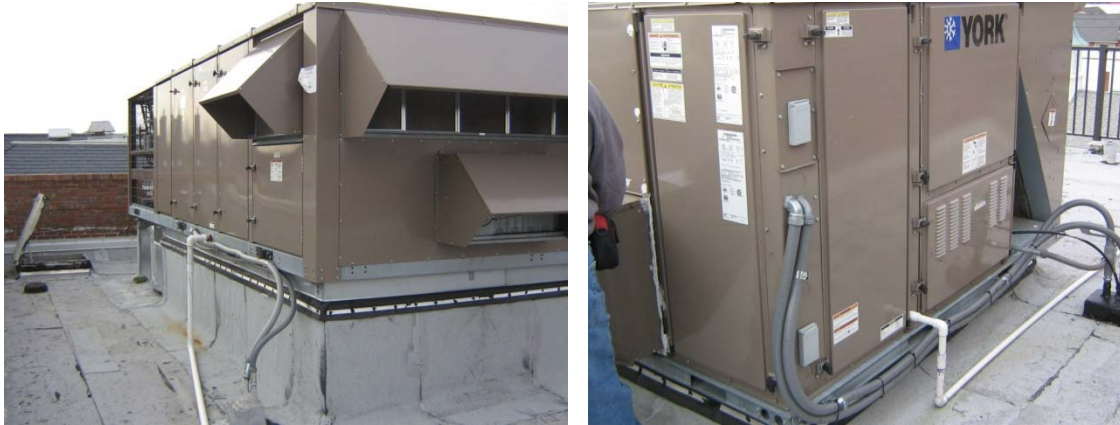
Cooling for the building is provided by the two (2) packaged DX cooling rooftop units located on the roof of the Police Department addition. The rooftop units feed the VAV boxes throughout the building which then distribute the air to the various spaces and zones which they serve. There is a 25-ton rooftop unit that serves the first & second floors, and a 12.5-ton rooftop unit serving the basement level. This equipment was installed in 2008 and is in excellent condition.

Rooftop units

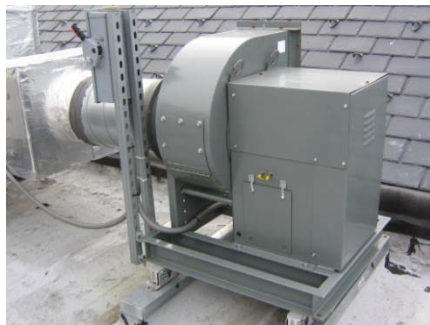
There is one (1) exhaust fan on the roof serving the toilet rooms and other miscellaneous areas in the building. This fan was installed in 2008 and is in excellent condition.

Rooftop exhaust fan

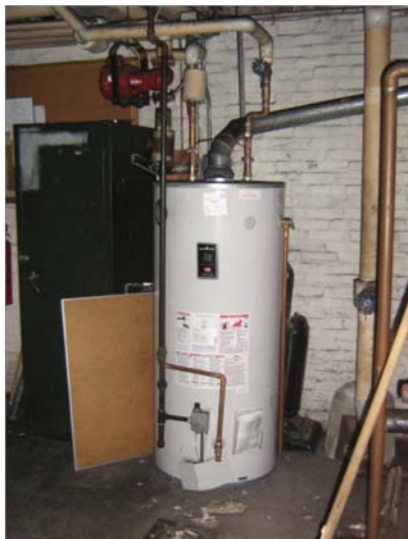
There is a single, gas-fired tank-type domestic water heater located in the mechanical room on the basement level of the building. This heater serves the lavatories in toilet rooms on all levels as well as three (3) janitor's sinks. The hot water piping is also connected to sinks in the jail cells, which are reportedly not in use at this time. The heater has a 75-gallon capacity and is equipped with a recirculation pump. This heater was installed in 2007 and is in very good condition.

Gas-fired water heater

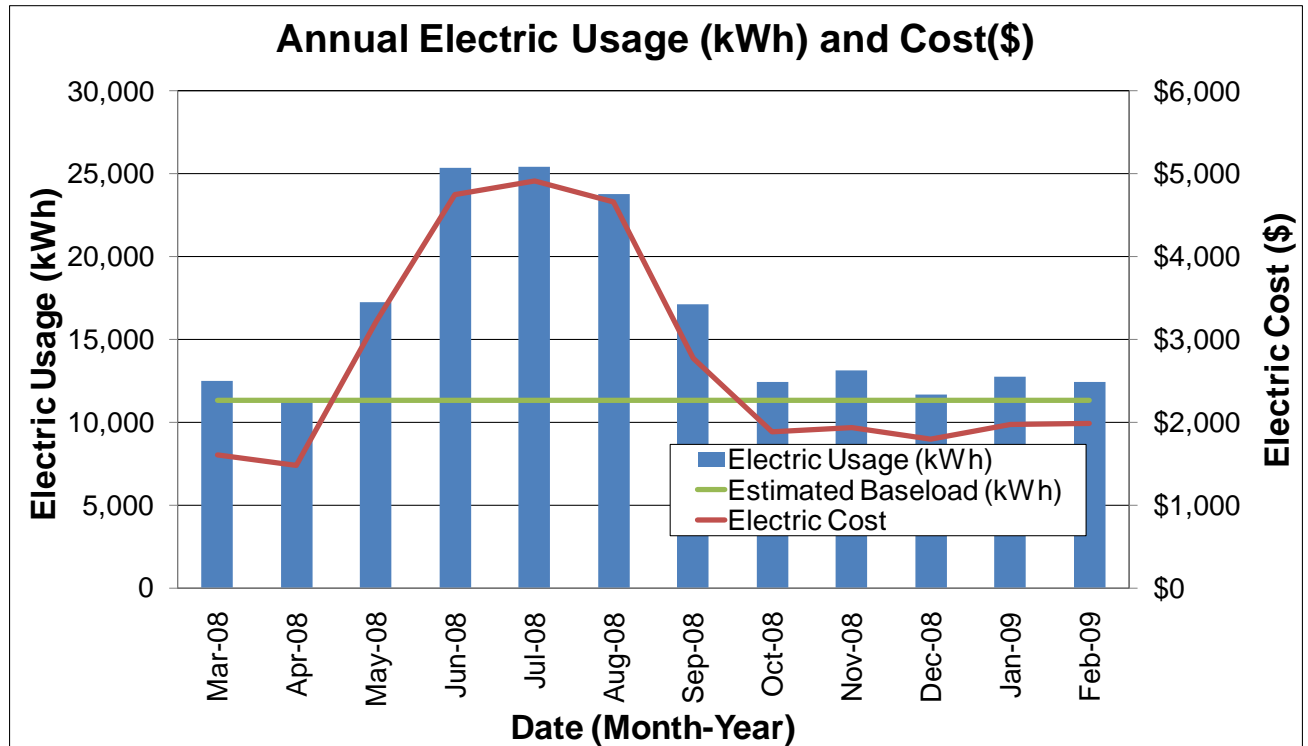
The following charts show annual electric and natural gas load profiles for the Municipal Building:

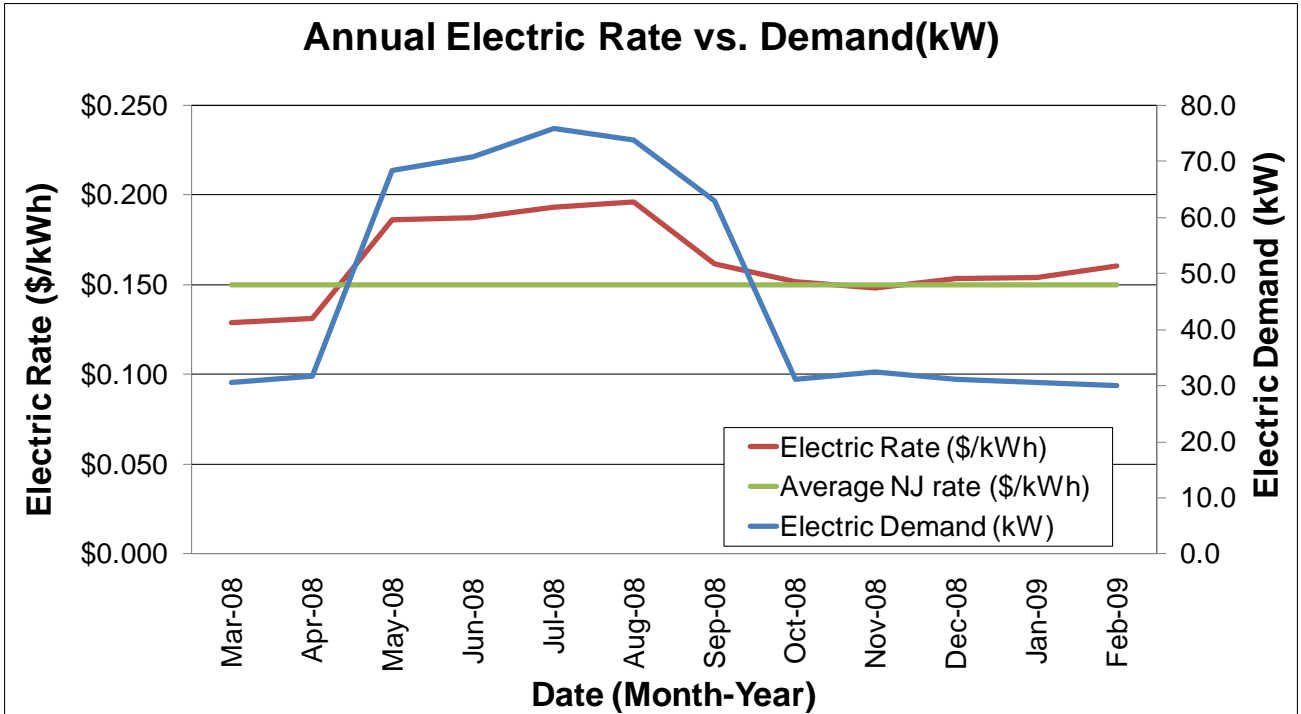
Some minor unusual electric fluctuations shown may be due to adjustments between estimated and actual meter readings. Also, note on the following chart how the electrical Demand peaks (except for a few unusual fluctuation anomalies) follow the electrical consumption peaks.

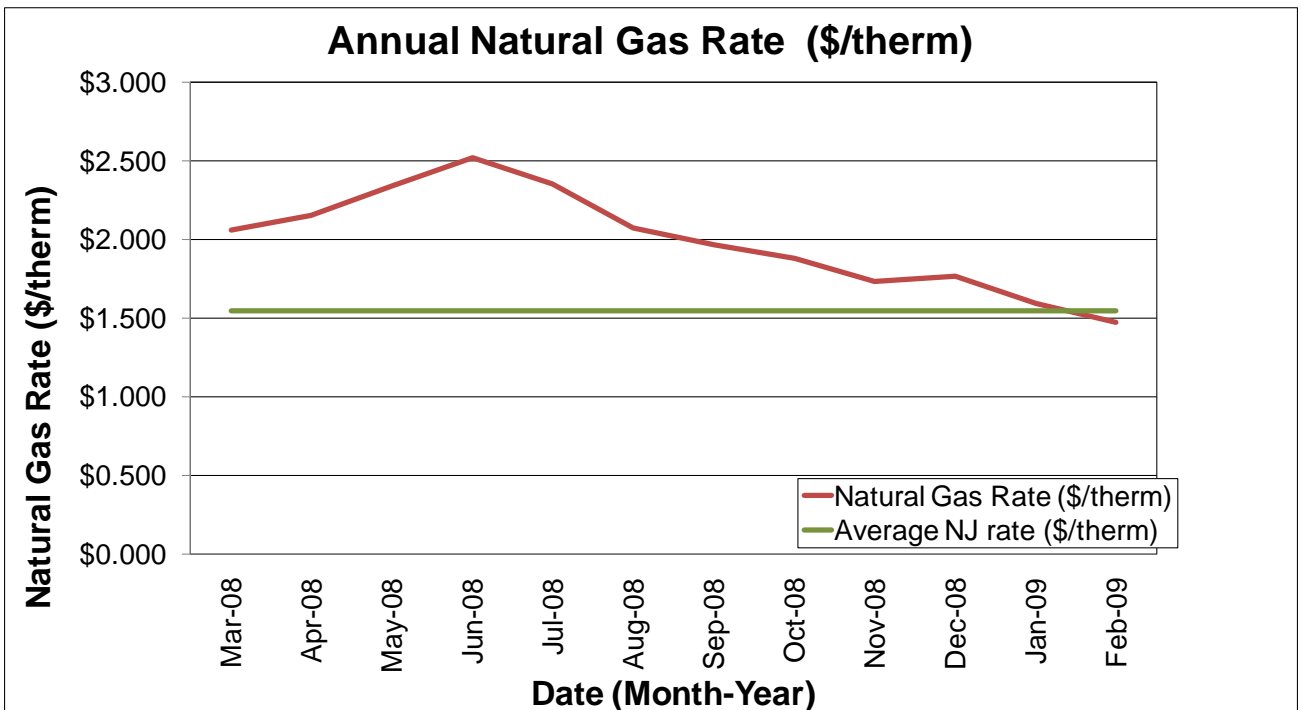
The following chart shows the estimated use of natural gas annual load for the building, peaking in the coldest months of the year and another chart showing heating oil fuel consumption following the “heating degree days” curve; the annual fuel oil use has been tailored to follow the HDD curve for an estimated 3,588 therms of annual use for the Municipal building.

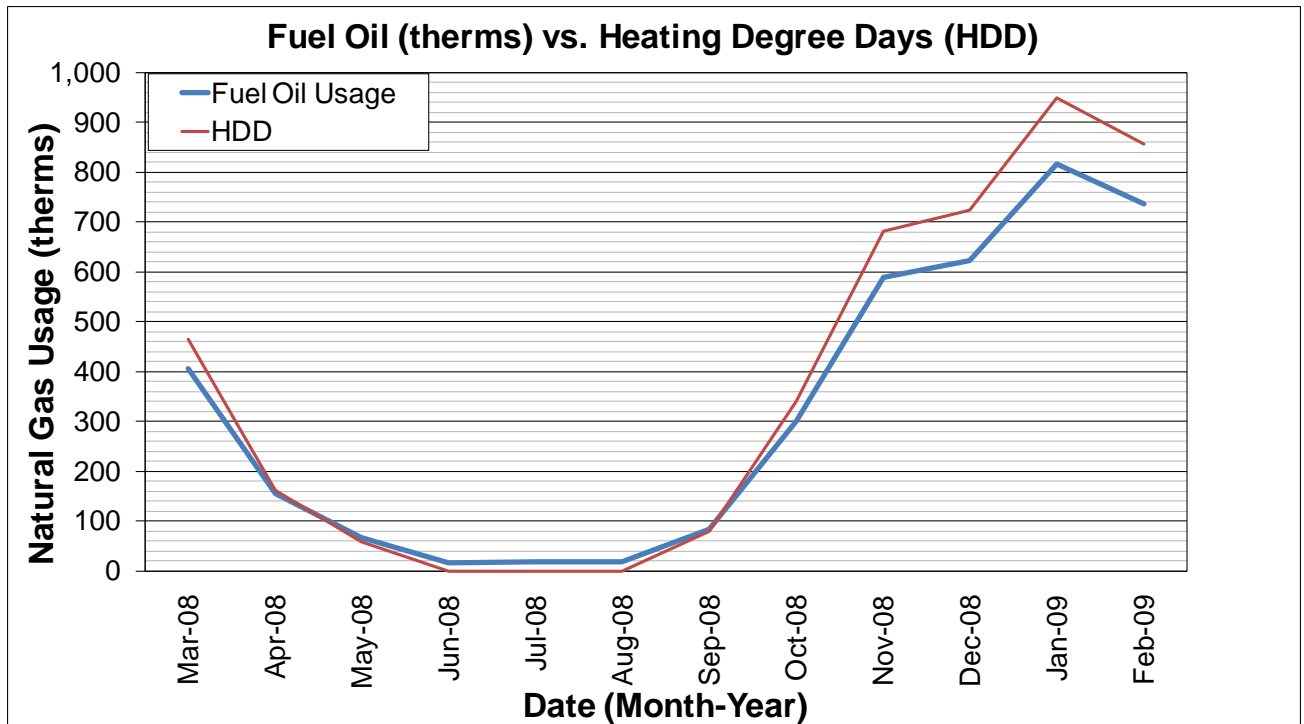
Chart reads Natural Gas and should read oil!
