**Local Government Energy Program  
Energy Audit Final Report**

***Palmyra Borough Hall  
Palmyra, NJ 08065***

***Project Number: LGEA49***

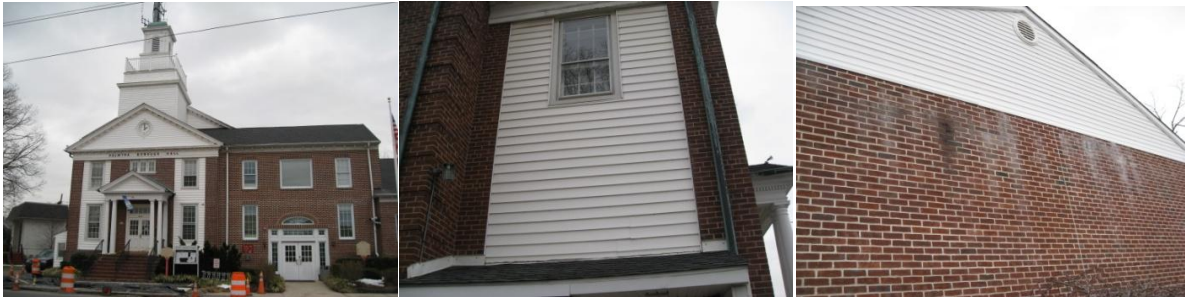
The two-story (including a partial basement), 16,100 square feet Borough Hall building was originally constructed circa 1940 with additions/alterations performed since then, the latest occurring in 1994. The older part of the building with the clock tower served as a church prior to being relocated to the present site. The building's partial basement is on level with the back lot. The basement houses the Police Department records room, evidence room, interrogation room, training room, locker rooms, a kitchenette, two cells, a detective's office, an ID room, two Sergeants' offices, a Chief's office, a Lieutenant's office, a Secretary's room, a lobby, an elevator room, a boiler room, a pump room, closets, storage spaces and two Nextel rooms. The first floor houses the Construction and Zoning Department and offices, the Fire Inspector's office, the Tax Assessor's office, the Maintenance office, the Tax office, the Payroll office, the CFO/Administration office, the Clerk's office, the Mayor's office, the Council's office, the Court's office, storage areas, a kitchen and bathrooms. The second floor houses the Court room, a waiting area, the Judge's and Council chambers, storage rooms, bathroom and ladder to the clock tower.

Front Façade and Partial Side Views

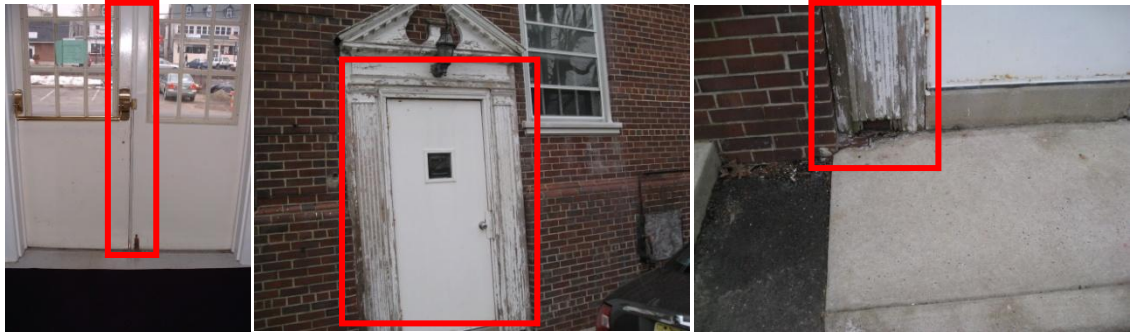
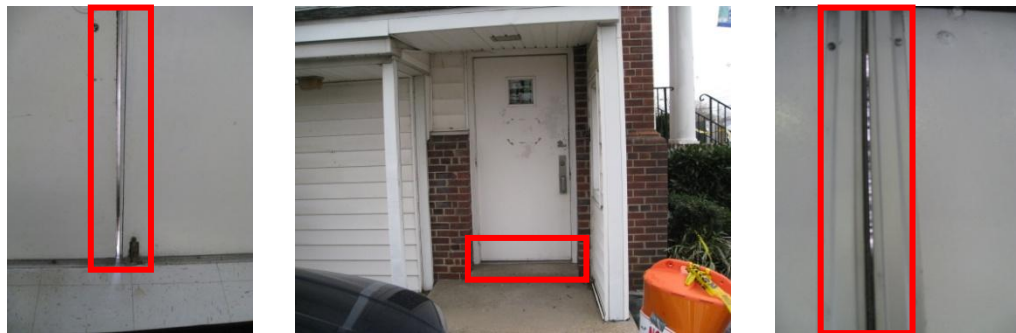
1. There are a number of wood type exterior doors in the older section of the building. They are located on the basement floor and are original/have never been replaced. The frames are starting to rot and SWA recommends replacement.
2. Other doors in the 1994 addition are Fenestra and Folger Adam 12 gauge hollow metal type exterior doors (some with vision panels). They are located throughout the building and are original/have not been replaced.

Doors with missing/worn weather stripping; other wood doors with rotting frames

1. Replace/repair and maintain broken/non-closing/damaged door units.
2. Install/replace/maintain weather stripping around all exterior doors and roof hatches.
3. Replace doors and frames with historically/architecturally accurate units. Should the doors be original, than SWA suggests only replacement of the frames and restoration of doors as necessary to minimize air-leakage.

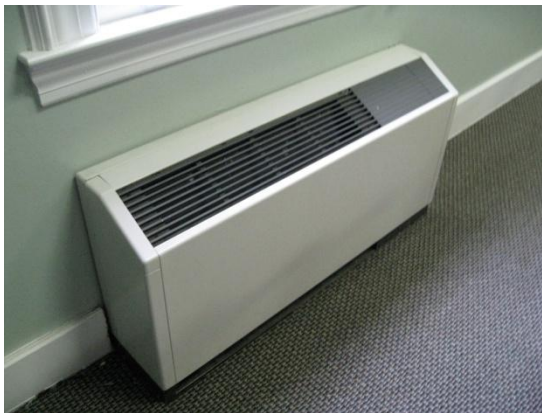
The building has a system of water source heat pumps that was installed during the 1995 renovation and addition. These units are either floor-mounted or ceiling-mounted and are located in each of the rooms as well as the corridors, vestibules and lobbies. Each water source heat pump contains a combination heating/cooling coil, compressor, fan assembly, damper, filter and controls within a metal cabinet. These units are not ducted and draw in air directly from the room, condition the air and discharge it back into the room via a small supply fan. Each unit responds to a thermostat located in the room that it serves. When the unit is in cooling mode, it uses an internal DX compressor and rejects heat to the building water loop, cooling the room air that is drawn through it by the fan. When the unit is in heating mode, the compressor rejects heat to the room air by operating in the reverse of the cooling mode, extracting heat from the building-wide water loop.

In total, the building contains approximately twenty-six (26) Climatemaster water source heat pumps. This equipment is in fair to good condition and is at the end of its service life of 15 years, as published in the 2007 ASHRAE HVAC Applications Handbook. In addition, it was reported that these units are noisy and that the system as a whole has poor temperature control. SWA recommends that these units are replaced as part of a total system replacement desired by the Borough.

Typical Water Source Heat Pump

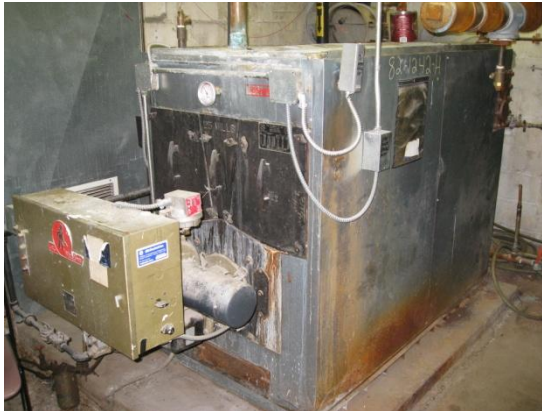
The heating hot water is produced by one (1) gas-fired, cast iron sectional hot water boiler located in the boiler room. The boiler was manufactured by HB Smith and has a rated capacity of 998 MBH. The boiler was installed in the year 1982. According to its age, the boiler has 2 years remaining on its expected service life of 30 years, as published in the 2007 ASHRAE HVAC Applications Handbook. The burner was also installed in 1982 and is beyond its expected service life of 20 years.

Hot Water Boiler

There were complaints about the ability of the heating system to provide adequate heating to the building occupants. Based on the condition of the existing equipment and control systems, SWA recommends replacement of heating equipment.

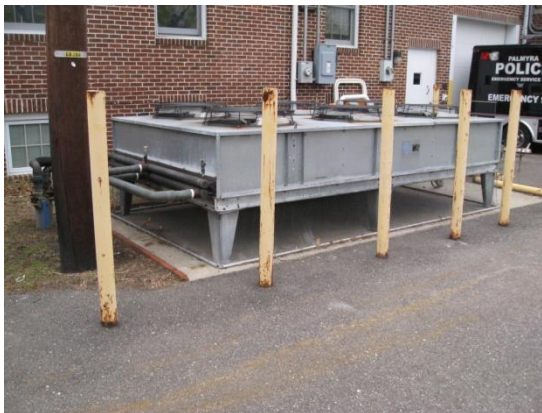
The heat is rejected from the building water loop via the fluid cooler located on grade behind the building. The fluid cooler was installed in 1997, and according to its age it is a little over half way through its expected service life of 20 years, as published in the 2007 ASHRAE HVAC Applications Handbook.

Fluid Cooler at Rear of Building

There were complaints about the ability of the cooling system to provide adequate cooling to the building occupants. Based on the age and condition of the existing equipment and control systems, SWA recommends a total system replacement.

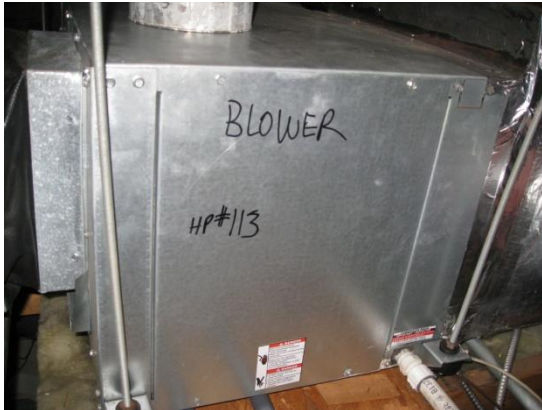
It is the intent of the floor-mounted water source heat pumps on the perimeter should introduce outdoor air via a grille and damper located on the outside wall. The horizontal, ceiling-mounted units above the interior rooms receive ventilation air from a series of small, fractional horsepower supply fans located in the attic via ductwork. Both types of units are designed to mix room air with outside air, condition the air as required, and deliver it to the occupied space. There are also fractional horsepower exhaust fans in the attic that are ducted from these spaces to aid in moving the ventilation air through the spaces. Each fan as its intake or exhaust ducted through the roof.

Typical Fan in Attic Used for Supply or Exhaust Air

Measurement or verification of the code compliance for ventilation was not part of this energy study. However, should any retro-commissioning or system upgrades be made part of some capital improvement project, the scope should include readjustment of outside air rates at the fans to provide a code-compliant level of outside air to the spaces.

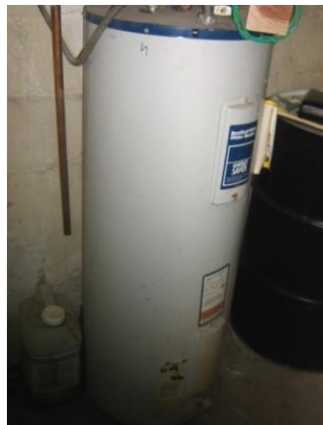
There is one domestic hot water heater located in the Boiler Room. This heater is a Bradford White tank type electric water heater that was installed in 1995. This heater serves nearby toilet rooms as well as the adjacent kitchen sink. The heater is in fair condition and is at the end of its expected service life of 15 years, according to the 2007 ASHRAE Applications Handbook.

*Domestic Water Heater*

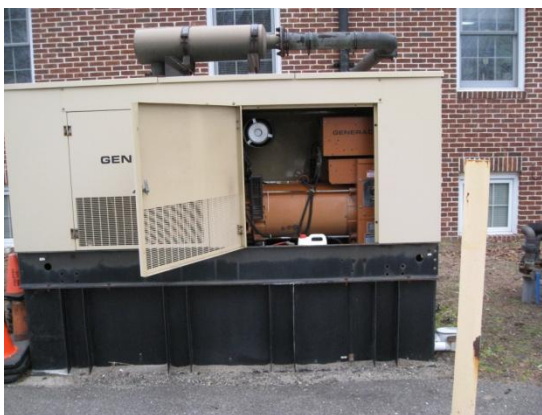
Besides an emergency 125 kW Generac generator used for emergency back-up (which has an estimated 30% left of its expected useful operating life) and a few small transformers in satisfactory condition, there are not currently any other significant energy impacting electrical systems installed at the Borough Hall. The generator serves emergency lighting, the boiler, the hot water circulating pumps, the sewage pumps, the elevator and the Police Area radios, lighting and HVAC. This generator was installed in 1995 and is in fair to good condition. The Borough has expressed interest in replacing this unit with a 200 kW natural gas driven generator and sharing its use with the adjacent Community Center that is currently under construction.

*Emergency Generator at Rear of Building*

SWA was told that the Borough Hall experiences frequent power outages, electrical phase imbalances, as well as go through relatively more than the norm of motor replacements throughout the year. SWA recommends that the Borough Hall record incoming power
