**Local Government Energy Program  
Energy Audit Final Report**

***Palmyra Firehouse***  
***Palmyra, NJ 08065***

***Project Number: LGEA49***

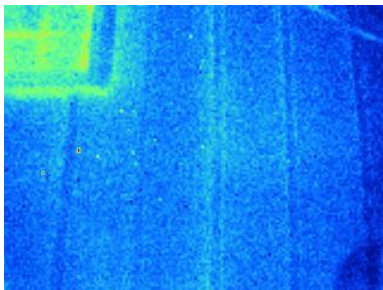
Insufficiently insulated siding - left side

1. Replace broken/ deteriorated bricks and re-point cracked mortar joints.
2. Add insulation to ineffectively or under-insulated exterior wall sections. SWA suggests applying 2" XPS rigid foam boards to the interior and cover with gypsum wallboard or other preferred interior finish with the next major renovation.
3. Safely and properly bring power to outside electric users per federal, state and local code.
4. Inspect and replace cracked/ineffective stucco.

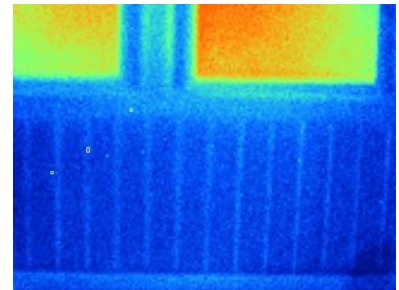
Insufficiently insulated siding - right side

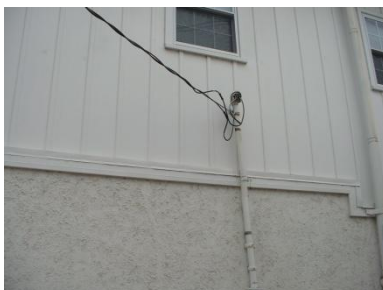
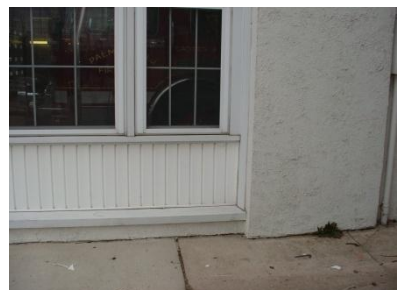
Cracked or deteriorating stucco showing signs of water/moisture

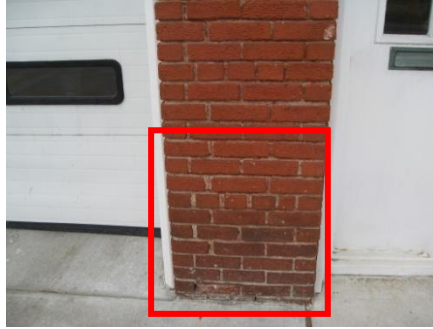
Deteriorating exterior wall finish in need of brick re-pointing

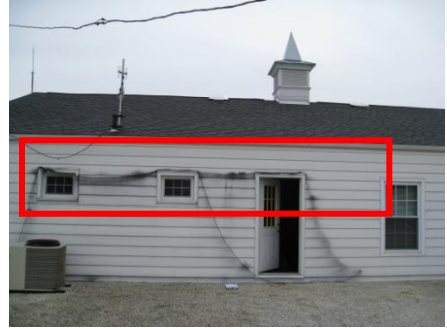
Interaction between electrical cable and exterior wall finish could lead to an unsafe situation

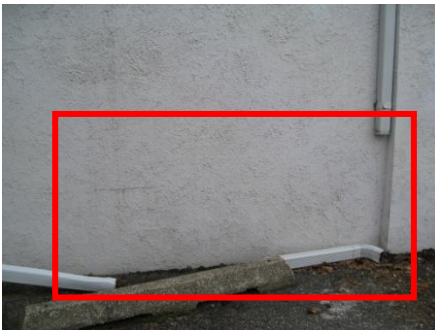
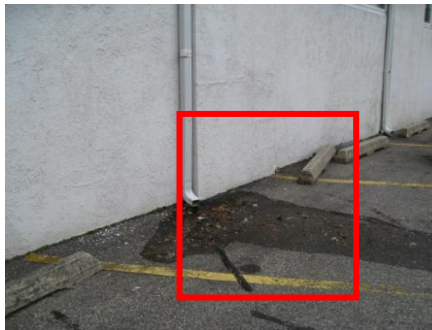
Disconnected/fallen gutters; missing splash blocks; rain water needs to flow away from the building via a splash block or equivalent

1. Unclog and maintain all roof drains/scuppers.
2. Clean gutters and downspouts. Reconnect them properly and ensure flow is over splash blocks away from the building.
3. Repair/replace roof finish due to age and condition with the next major renovation.

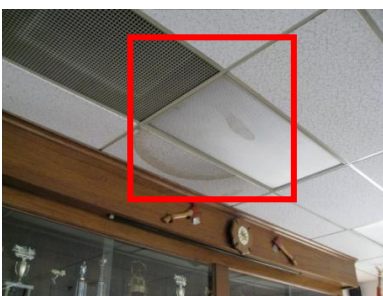
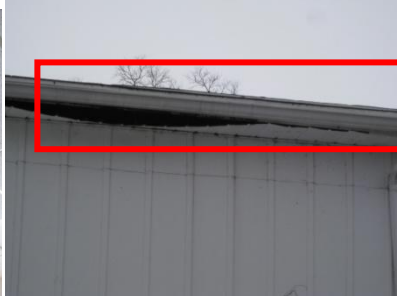
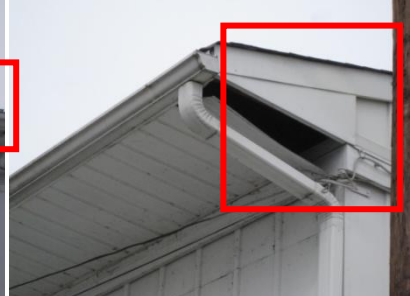
Leaking roof needs repairs/patching; soffit siding has come loose in a few areas and needs fixing

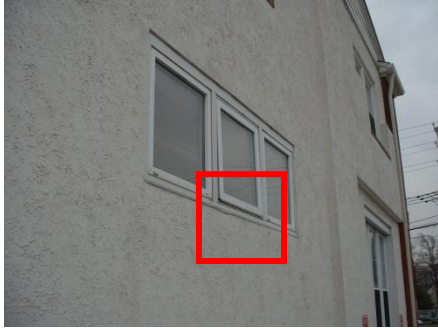
A number of awning type windows cannot be close tightly and allow loss of conditioned air

1. Install operable interior shading devices on windows.
2. Install/replace/maintain sealants at all windows for airtight performance.

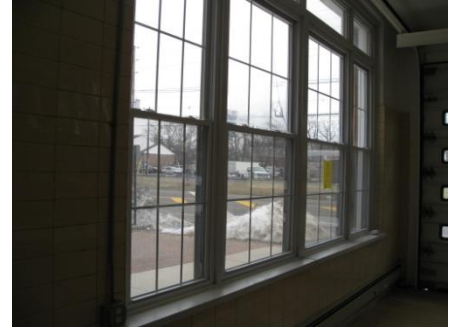
Shades are recommended to control UV light, overheating during summer and cooling during winter

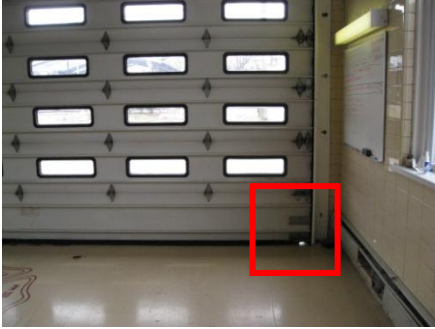
Missing/worn weather stripping

- 1. Install/replace/maintain weather stripping around all exterior doors and roof hatches.

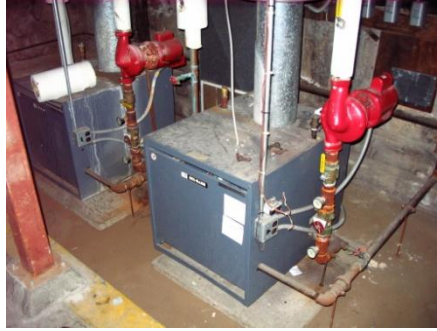
The building is heated by a series of boilers and furnaces. The office areas, meeting space, Recreation room, bar and gym area are also cooled via multiple split systems. The front portion of the building is heated by two (2) Weil-McLain gas-fired boilers that are located in the partial basement below the garage. Each identical boiler was installed in 1993 and provides 301 MBH of output. These boilers have an estimated remaining life of 40%. Each boiler is installed with its own supply pump. The heating system appears to be arranged such that there is one primary boiler and pump, and one backup pair.

Gas-fired Boilers in Basement Mechanical Room

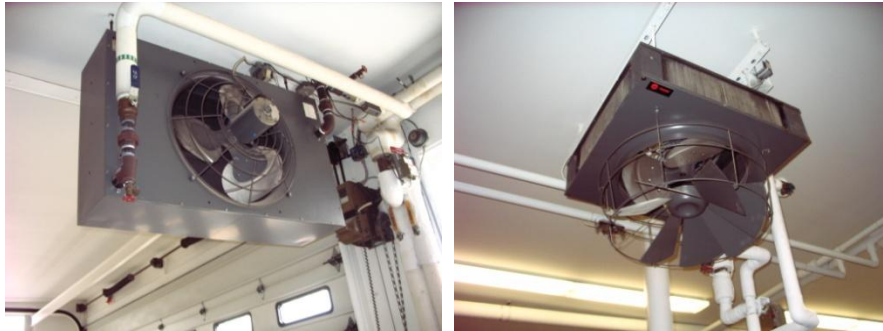
Hot water is supplied to two (2) horizontal hydronic unit heaters near the front garage doors, two (2) vertical hydronic unit heaters located at the underside of the second floor and behind the central stair, baseboard finned-tube radiation in the garage and hydronic unit heater in the Kitchen and downstairs bar. Heating is controlled by wall-mounted thermostats in each zone. It should be noted that the vertical unit heaters are not provided with OSHA fan guards. This could be a hazardous situation since there is some high storage below the units and they are accessible to the occupants of the facility.

Unit heaters in garage

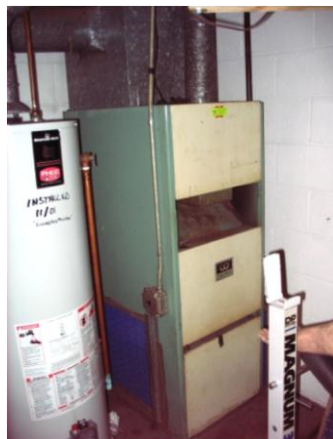
Heating for the small gym, offices and kitchen at the rear of the garage is provided by a gas-fired furnace with DX cooling coil located in the small gym. This furnace is ducted to above the ceiling, where it is ducted to registers in the spaces that it serves. This unit was installed in 1968 and is well beyond its expected useful life of 18 years, according to the 2007 ASHRAE Applications Handbook.

Domestic Water Heater and Furnace in Small Gym

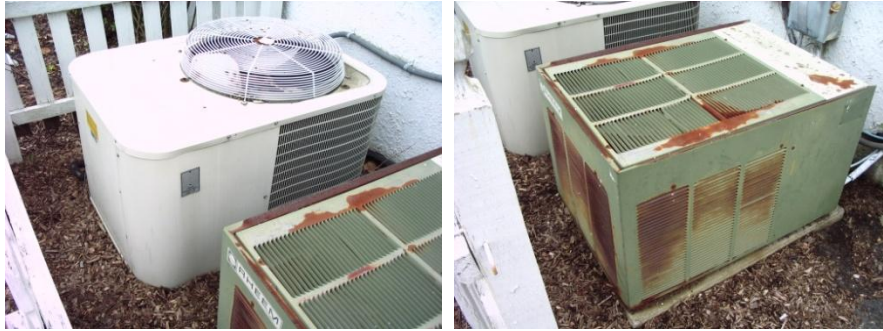
The second floor recreation room is cooled by a DX split system with air handling unit in the rear closet next to the boiler. The condensing unit for this system is located on grade behind the building. This unit was installed in 1974 and is well beyond its expected life of 15 years. The bar is cooled by a DX split system with electric furnace located in the closet beside the bar. The condensing unit for this system is located on grade behind the building. This unit was installed 1987 and is beyond its expected life span.

Split System Condensing Units on Grade for Bar and Second Floor Recreation Room

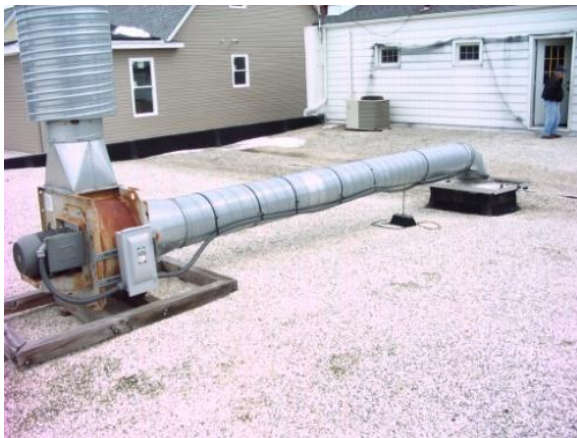
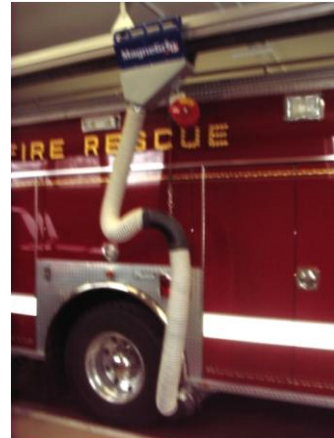
The garage area is ventilated via a vehicle exhaust fan. The vehicle exhaust fan had no indication of age on its nameplate, but it is estimated to be about 10 years old. This fan is expected to have 5-10 years of remaining life. The kitchen also has a sidewall exhaust fan with fan guard, and appears to be very old and beyond its expected lifespan.

Vehicle Exhaust Fan on Roof (left) and Vehicle Exhaust Connection to Truck

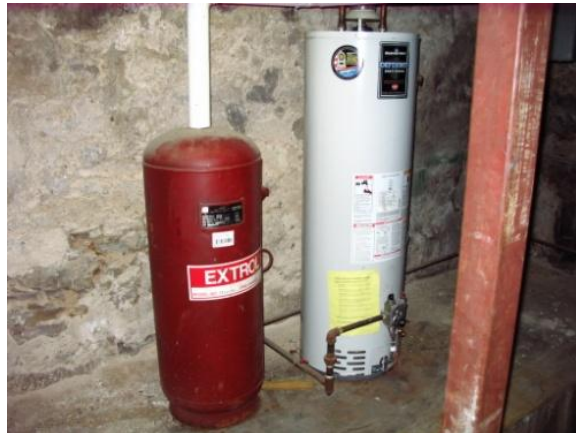
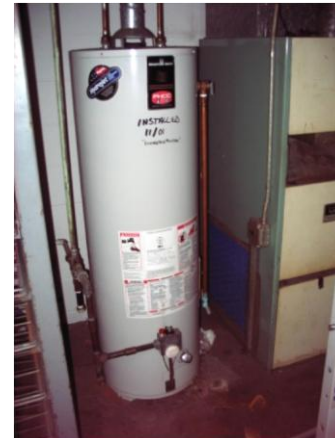
There are three (3) domestic water heaters in the building. The partial basement contains one (1) 40 gallon gas-fired heater that was installed in 1997. This heater is believed to serve the toilet rooms near the rear of the garage. This equipment is at the end of its expected lifespan. The gym contains one (1) 40 gallon gas-fired heater that was installed in 2001. This heater serves the kitchen and is about halfway through its expected life. The mechanical closet adjacent to the bar contains a small 12 gallon electric tank type water heater to serve the bar sink. The age of this unit could not be determined from the nameplate, but it is assumed to be the same age as the electric furnace, which was installed in 1987. That would put this unit beyond its expected service life.

Domestic Water Heater in Basement Mechanical Room (on right in left photo) and in Gym

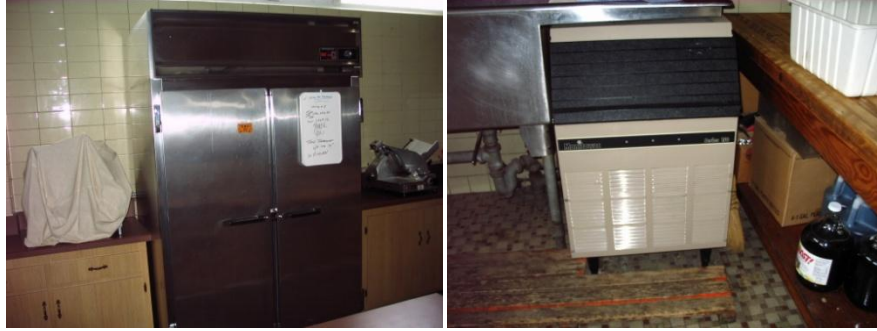
There is (1) refrigerator in the kitchen that has no indication of age on the nameplate but is estimated to be greater than 10 years old. This unit is not Energy Star rated. There is one (1) commercial stainless steel 2-door refrigerator in the kitchen. There was no visible nameplate, but based on condition and the fact that it utilizes R-134a refrigerant, it is estimated to be about 5 years old. The kitchen also contains a commercial ice machine. This unit was manufactured in 1995 and is in fair condition. The bar contains a commercial refrigerator in the mechanical closet. There was no visible nameplate, but based on the fact that the unit uses R-12 refrigerant, it is estimated to be from the 1990s or before. This unit should be replaced with a more energy efficient model that utilizes environmentally friendly refrigerant.

Commercial Refrigerator (left) and Ice Machine in Kitchen
