**Local Government Energy Program
Energy Audit Report**

***Township of Sparta
Eagles Nest Well House
Holland Circle
Sparta, NJ 07871***

Project Number: LGEA21

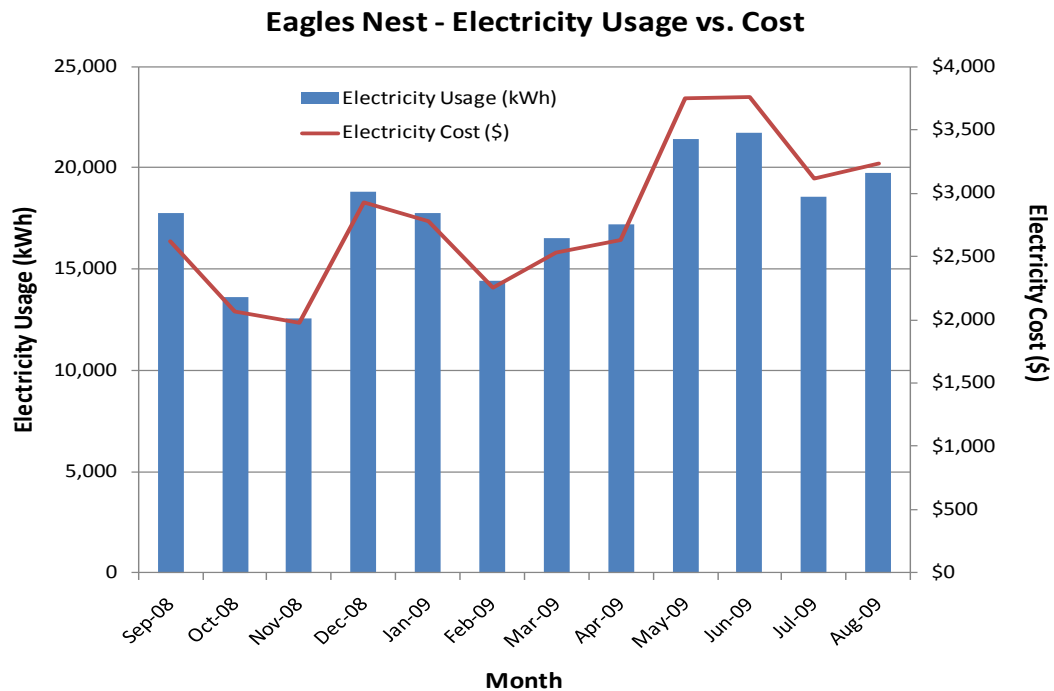
The following chart shows electricity use versus cost for the Eagles Nest Well House building based on utility bills for the 12 month period of September 2008 to September 2009.

The electricity cost follows a trend line similar to that of the electricity usage as expected.

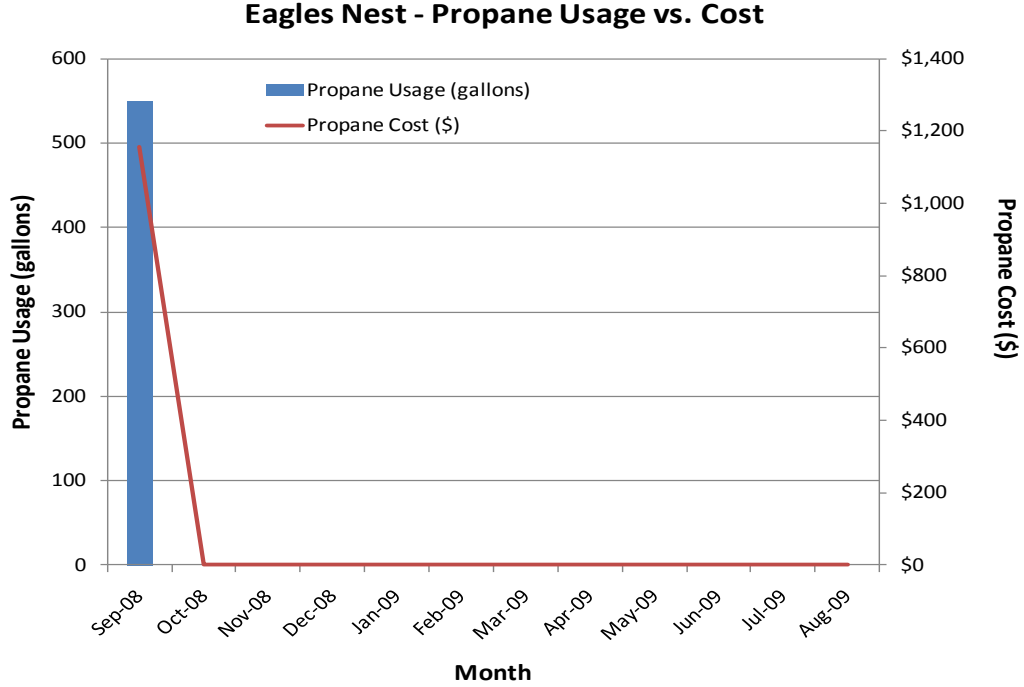
The following chart shows propane use versus cost for the Eagles Nest Well House building based on utility bills for the 12 month period of September 2008 to September 2009.

The above graph shows propane usage based on delivery. Since the Eagles Nest Well House only receives one delivery per year, the graph will not accurately portray energy usage. Unlike Natural Gas, Propane is delivered via truck when needed. The Eagles Nest Well House contains one 2000 gallon propane tank that is partially filled based on necessity. Currently, the propane tank is filled to around 550 gallons once per year.

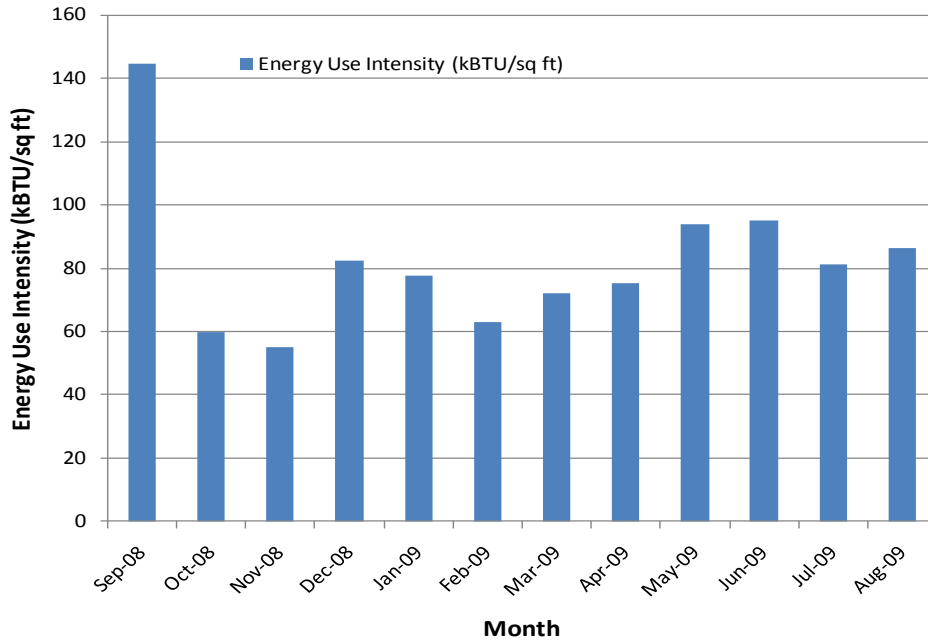
Eagles Nest - Energy Use Intensity

The following chart shows combined propane and electric consumption in kBtu/sq ft for the Eagles Nest Well House building based on utility bills for the 12 month period of September 2008 to September 2009.

Energy Use Intensity fluctuates with the heating and cooling season as expected. September shows an unusually large peak due to the fact that propane is delivered on an irregular basis and all propane use is therefore attributed to that single annual delivery.

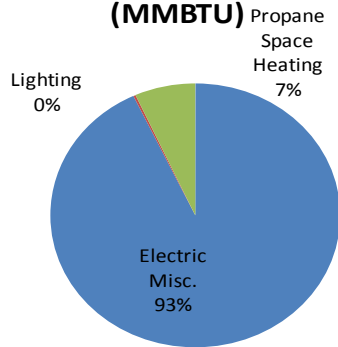
Annual Energy Consumption (MMBTU)

The following table and chart pies show energy use for the Eagles Nest Well House building based on utility bills for the 12 month period of September 2008 to September 2009. Note electrical cost at \$46.9/MMBtu of energy is more than 2 times the cost of propane at \$22.2/MMBtu. Also, miscellaneous electric use accounts for a large percentage of the building electric use due to the high usage of electricity used by the pump motors.

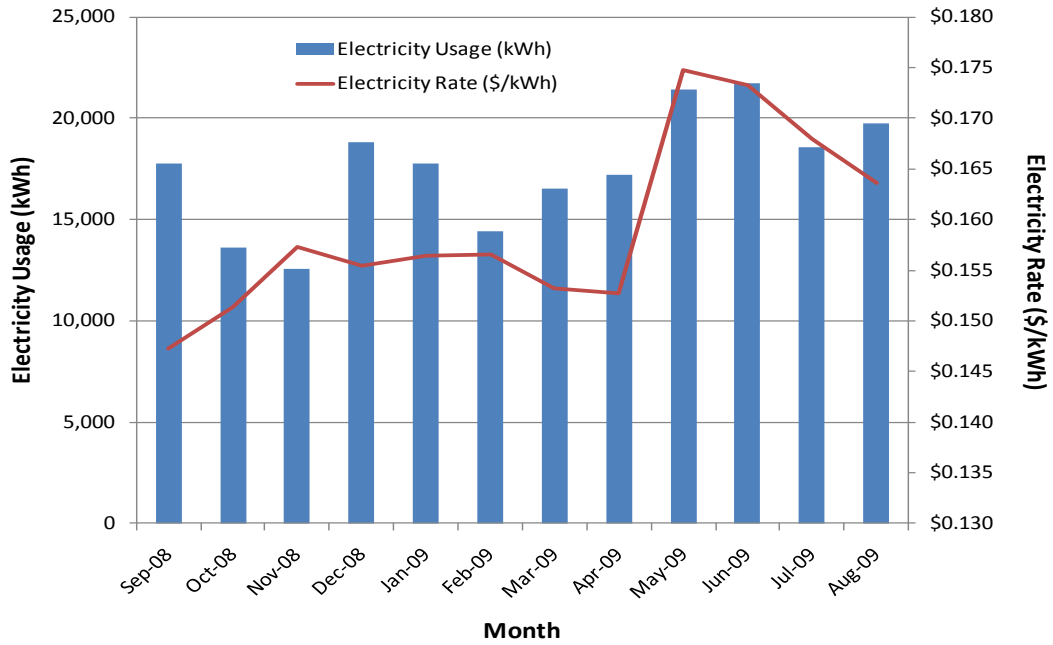
Eagles Nest - Electricity Usage vs. Rate

The electricity rate fluctuates inversely proportional to usage, as expected. Typically, the more units of electricity that are used by the building, the cheaper electricity becomes per unit. Some rate fluctuations may be due to estimated utility readings as opposed to actual readings.

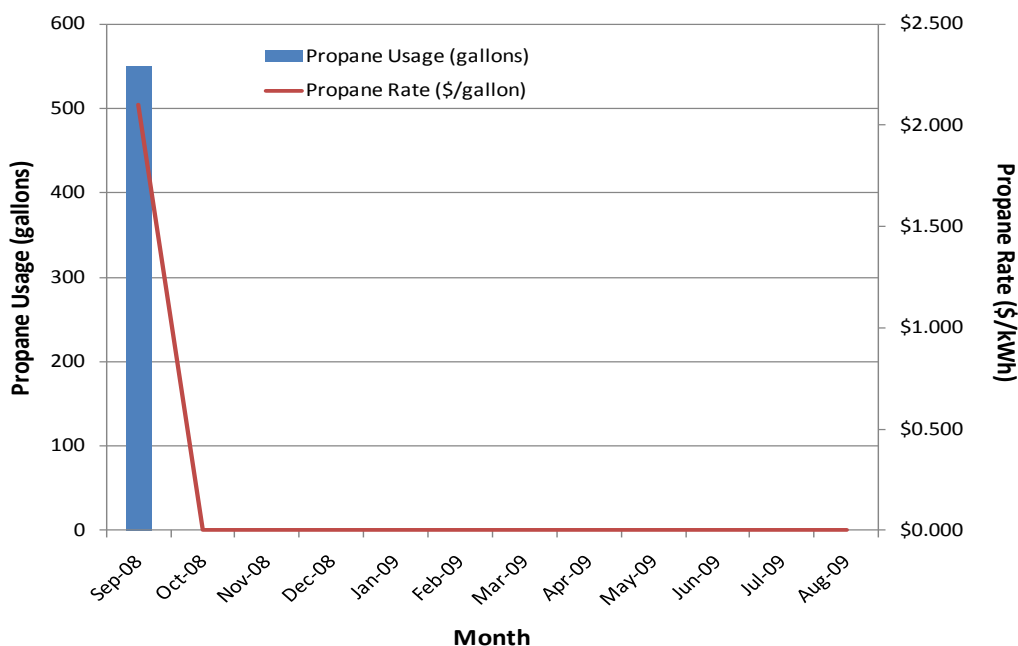
Eagles Nest - Propane Usage vs. Rate

The Eagles Nest Well House only receives one delivery of propane per year, based on previous utility bills. Since there is only one delivery per year, the propane usage graph will only show one point.

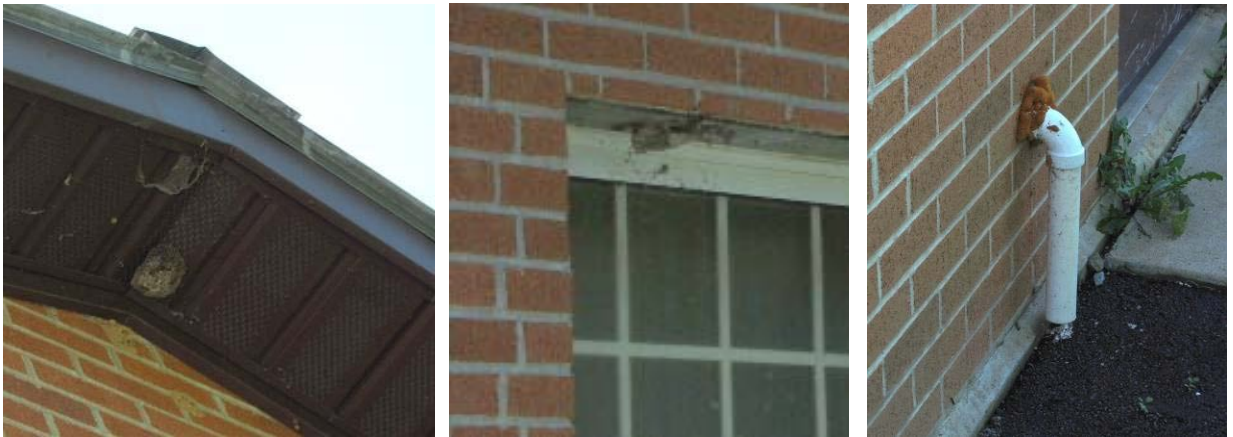
This building’s exterior envelope wall material was found to be in overall good condition. Under eaves and around some windows insect nesting was observed which should be cleaned up to prevent possible future infestation.

Wall penetrations were found to be sealed with inappropriate materials and methods. SWA recommends using manufacturer’s recommended sealants and caulks.

Insect nesting around eaves and windows in addition to inappropriate wall penetration sealer were found

- Properly seal building to prevent insect nesting – SWA recommends caulking and installing proper sealing to prevent insect nesting in small openings and penetrations of the exterior shell.

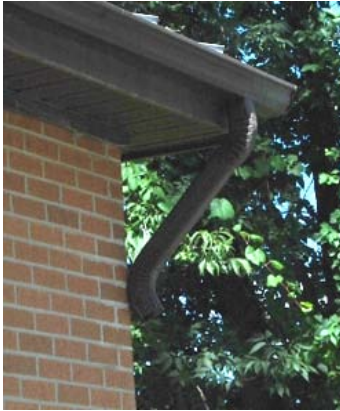
Gutters and downspouts were inspected and found to be in good condition except of one downspout was missing and needs to be installed and properly attached to the building.

Missing downspout

- Replace missing downspout – SWA recommends replacing a missing downspout that was observed to be missing during the audit. The downspout is important to keep water away from the building exterior and preventing any moisture damage.

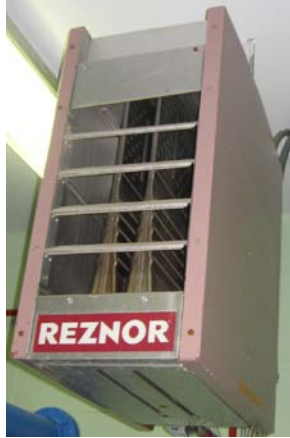
Heating is provided by two 25 MBH, 80% efficient Reznor gas-fired unit heaters, set for 60°F. The units consume propane fuel. They were found to be in good operating condition.

Reznor unit heater

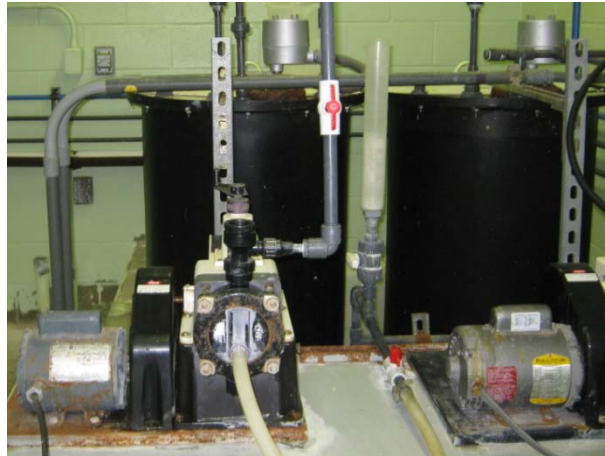
The Eagles Nest Well House processes have been relocated to the Germany Flats pump station. There are only two pumps remaining at this facility. Those two pumps have two motors which are both rated at ¼ HP and 1,725 RPM, and operate the chemical feed system. The pumps and motors have been installed in the recent past and are in good operating condition.

Two (2) chemical feed pumps
