**Local Government Energy Program
Energy Audit Report**

***Township of Sparta
Germany Flats including Storage Garage
12 Park Lake Road
Sparta, NJ 07871***

Project Number: LGEA21

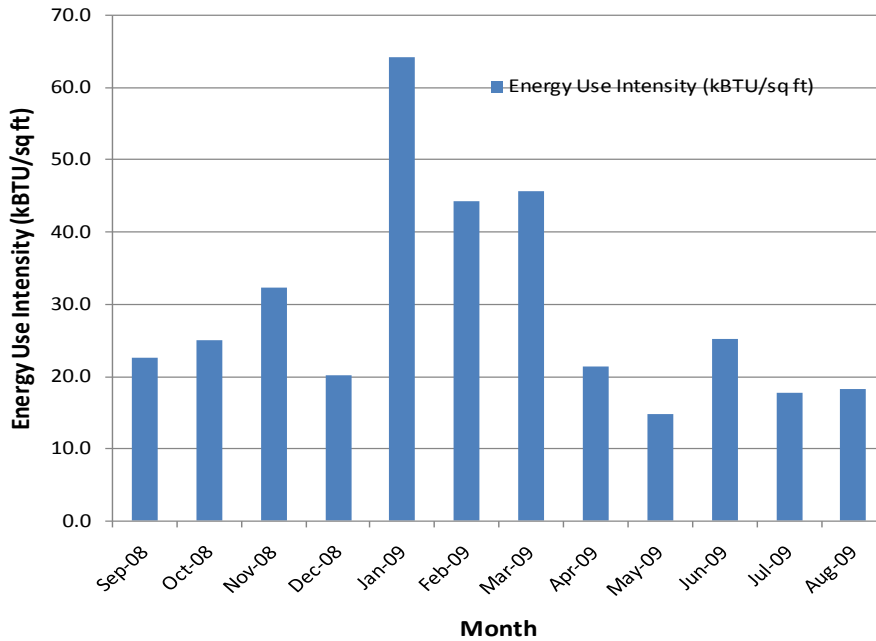
Germany Flats - Energy Use Intensity

The following chart shows combined propane and electric consumption in kBtu/sq ft for the Germany Flats building based on utility bills for the 12 month period of September 2008 to September 2009.

Energy Use Intensity fluctuates with the heating and cooling season as expected. Energy use peaks during January, when heat is being used the most.

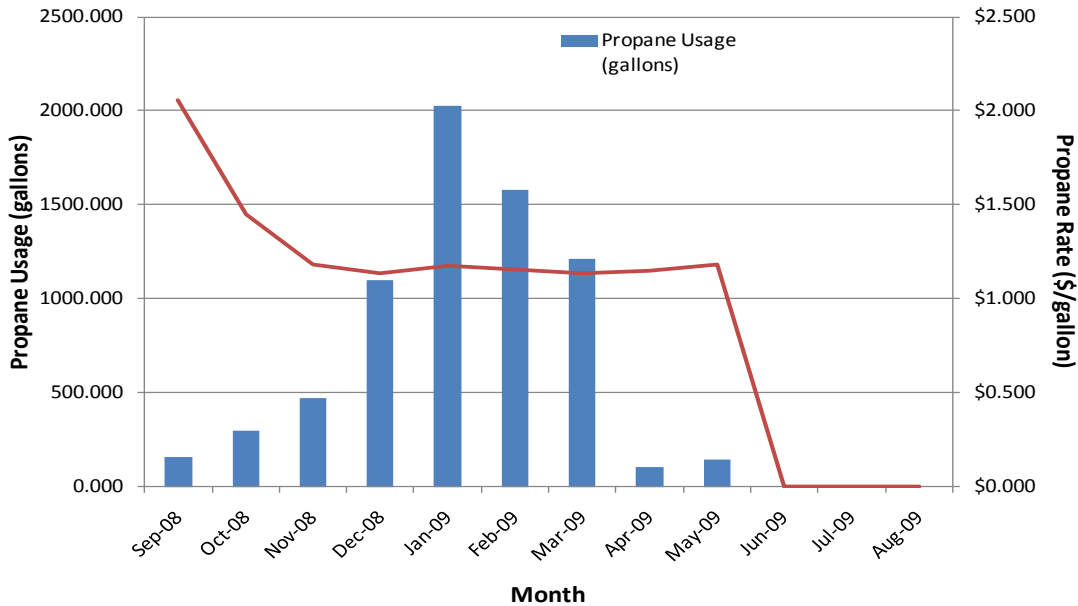
Germany Flats - Propane Usage vs. Rate

The propane rate fluctuates inversely proportional to usage, as expected. Typically, the more units of propane that are used by the building, the cheaper propane becomes per unit. In summer periods, when a minimal amount of propane is used, the propane rate (\$/gallon) increases sharply until propane use hits 0 gallons.

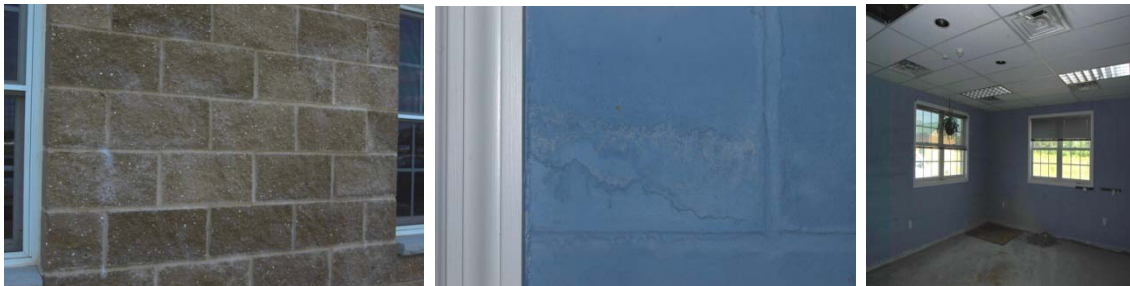
This recently constructed building’s exterior envelope walls were observed to be in poor condition with signs of previous and present water and moisture problems. Efflorescence on the exterior and interior masonry surfaces and damaged gypsum wall board is visible in some areas, indicating a hidden source of water, possibly from the gutter/ soffit area. Further investigation that exceeds SWA’s scope is necessary.

Efflorescent and other water problems visible on the interior and exterior walls

- Investigate water leaks – The recently constructed building’s exterior envelope walls were observed to have water damage and moisture problems. Efflorescence on the exterior and interior masonry surfaces and damaged gypsum wall board is visible in some areas, indicating a hidden source of water, possible from the gutter/soffit area. SWA recommends hiring an independent contractor to investigate the source of the leaks and take corrective actions as soon as possible.

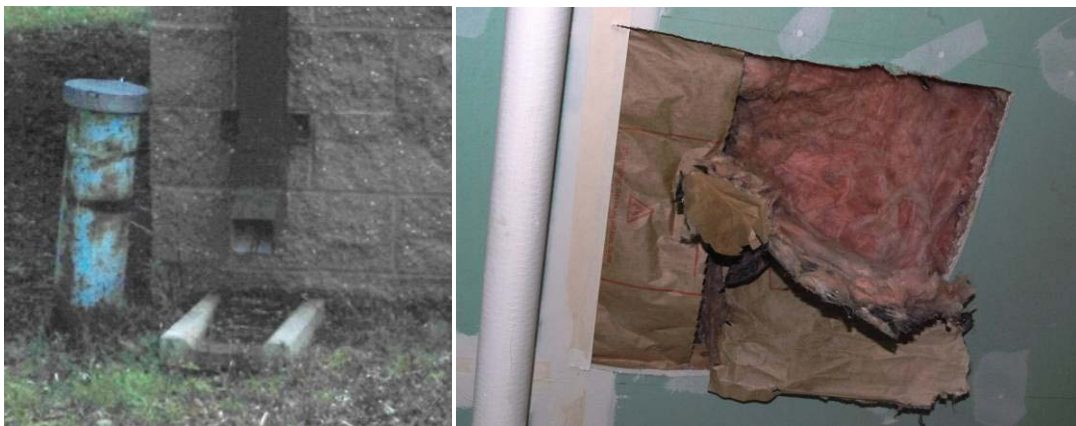
The wood framed low pitch standing seam metal roof shows no visual signs of leakage. Attic insulation levels could not be verified but in some areas fiberglass batt insulation was visible through gypsum board openings in the ceiling. SWA recommends a minimum of R-30 attic insulation and that all gypsum board ceiling penetrations be sealed and covered as required by code.

Gutters and downspouts were inspected and found to be in good condition but need to be inspected for possible leakage as mentioned under “Exterior Walls”. SWA recommends that all downspout diverters slope away from exterior walls to minimize potential water and moisture problems around the perimeter foundation.

Downspout diverter with insufficient slope Unsealed openings in ceiling

- Maintain roofs - SWA recommends regular maintenance to verify water is draining correctly.
- Install downspout diverters – SWA observed that the building was properly fitted with gutters and downspouts; however the downspouts allow the water to pool directly next to the exterior wall of the building. SWA recommends installing downspout diverters in order to divert water away from the building in order to prevent damage to the exterior walls.

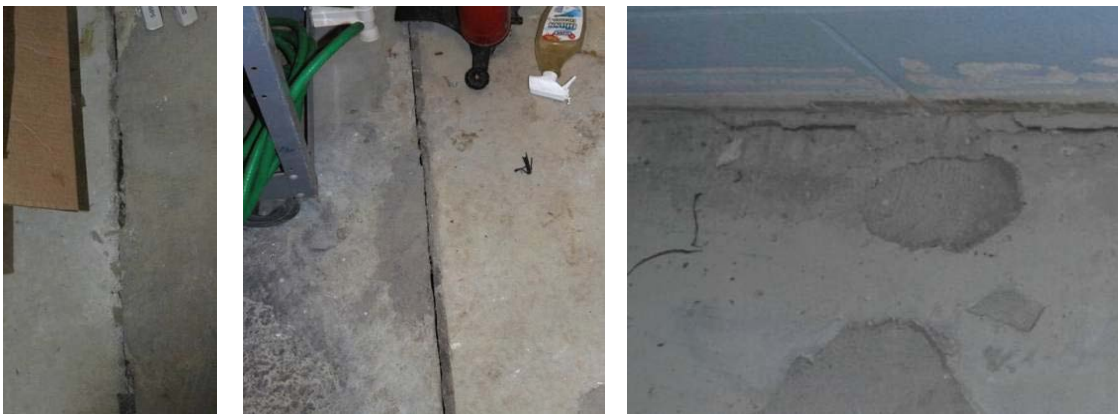
The building’s base is a 4” concrete slab-on grade with a perimeter footing. There were numerous signs of structural cracks, possibly a differential settlement issue. SWA recommends having the slab and foundation evaluated by a structural engineer.

Signs of differential settlement in slab

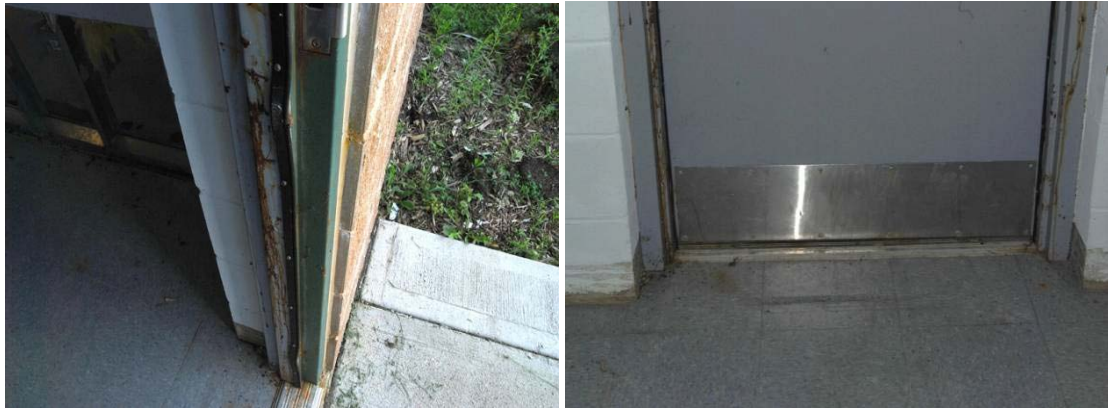
The metal exterior doors were observed to be in good condition except for some missing or worn weather-stripping, including the overhead type doors, where excessive wear was detected. SWA recommends that the exterior doors of the building be weather-stripped in order to decrease the amount of conditioned air that is lost around each door. SWA also recommends checking the weather-stripping of each door on a regular basis and replacing any broken seals immediately. Tight seals around doors will help ensure the building to be is kept continuously insulated.

Worn and missing weather stripping around doors

- Provide weather stripping / air sealing – SWA observed that all windows and doors had proper weather-stripping and air sealing due to their age. As a best practice, SWA recommends that each window and door is inspected twice per year for deficiencies. Any time that a seal has been compromised, building maintenance staff should repair and replace the seal immediately to ensure that thermal barriers are not breached.

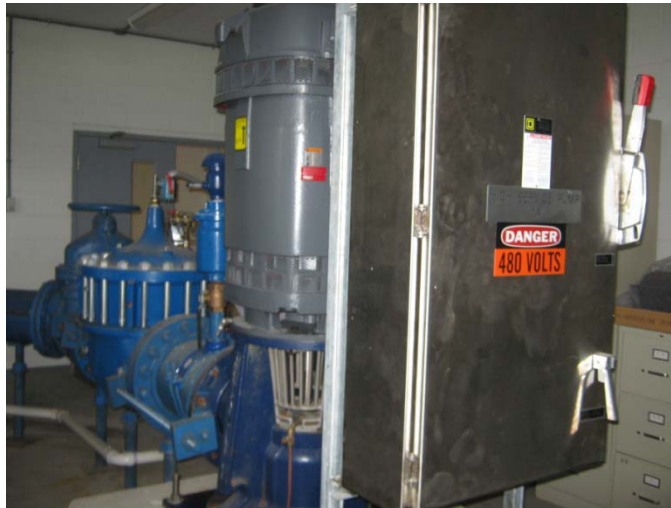
There are four premium-efficiency pumps in the pump room, all with variable-frequency drives. Pumps 1A and 1B are American Turbine pumps with 250 HP, 1,780 RPM, Emerson motors rated at 95.8% efficiency. Pumps 2A and 2B are American Turbine pumps with 125 HP, 1,795 RPM Emerson motors, rated at 95.4% efficiency. There are three chemical pumps in the chemical room, all with fractional-HP motors. All motors and pumps were installed in 2005 and were found in good operating condition.

Pumps and motors located at Germany Flats
