**Local Government Energy Program
Energy Audit Report**

***Township of Sparta
Library
16 Woodport Road
Sparta, NJ 07871***

Project Number: LGEA21

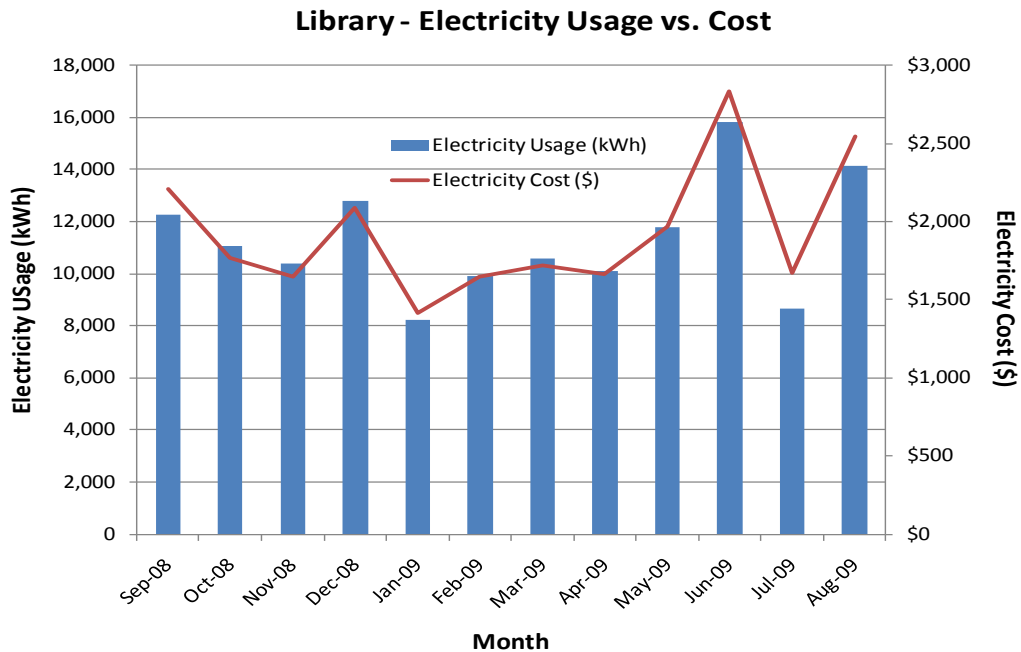
The following chart shows electricity use versus cost for the Library building based on utility bills for the 12 month period of September 2008 to September 2009.

The electricity cost follows a trend line similar to that of the electricity usage as expected.

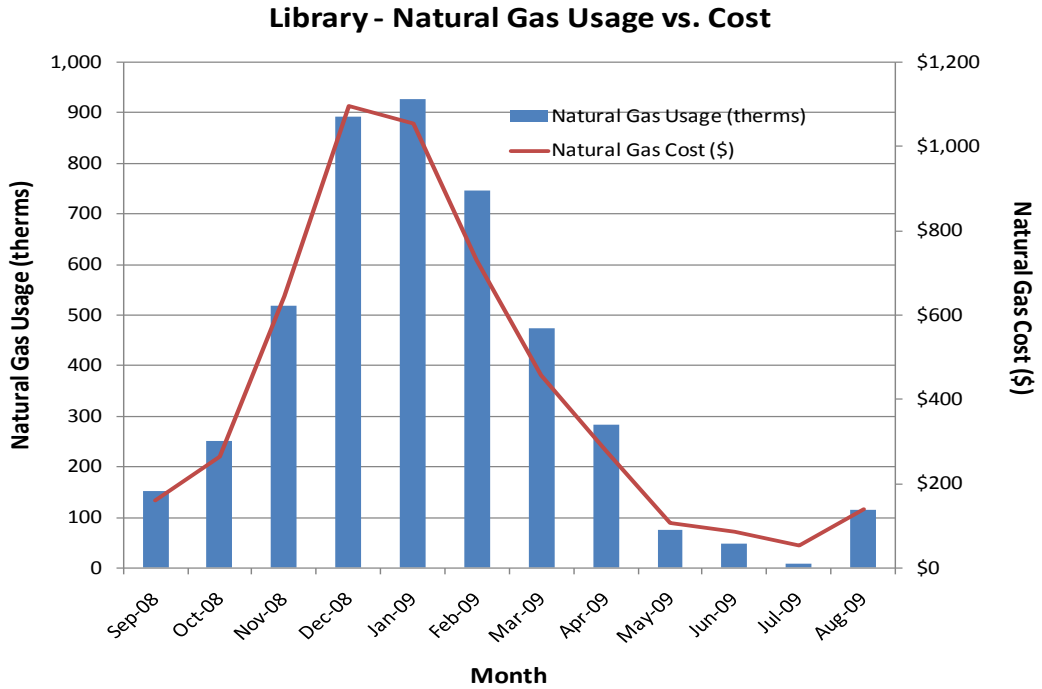
The following chart shows natural gas use versus cost for the Library building based on utility bills for the 12 month period of September 2008 to September 2009.

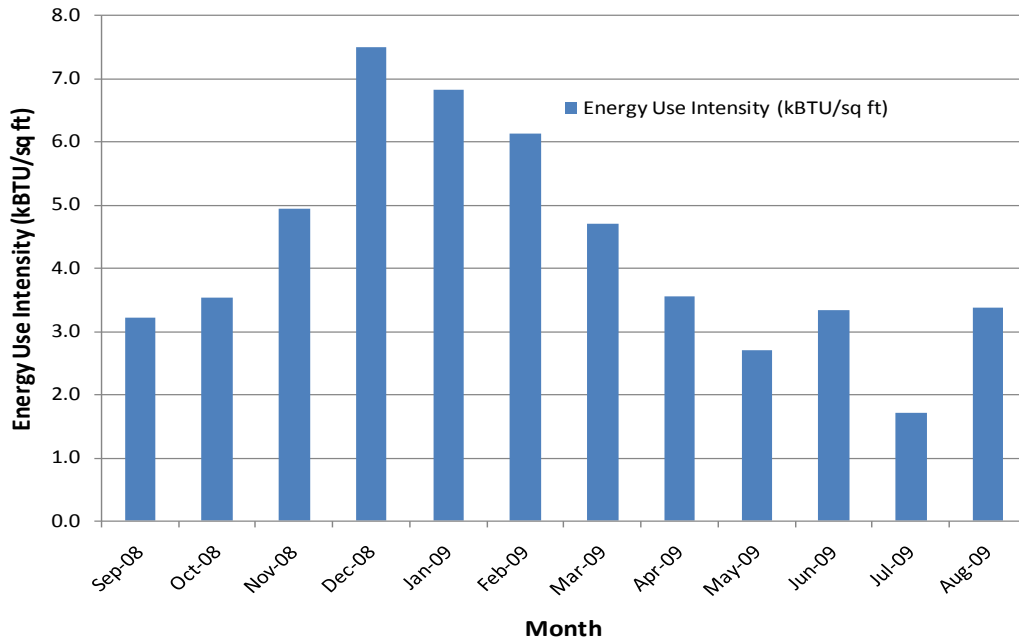
Library - Energy Use Intensity

The following chart shows combined natural gas and electric consumption in kBtu/sq ft for the Library building based on utility bills for the 12 month period of September 2008 to September 2009.

Energy Use Intensity fluctuates with the heating and cooling season as expected. Energy use peaks during January, when heat is being used the most.

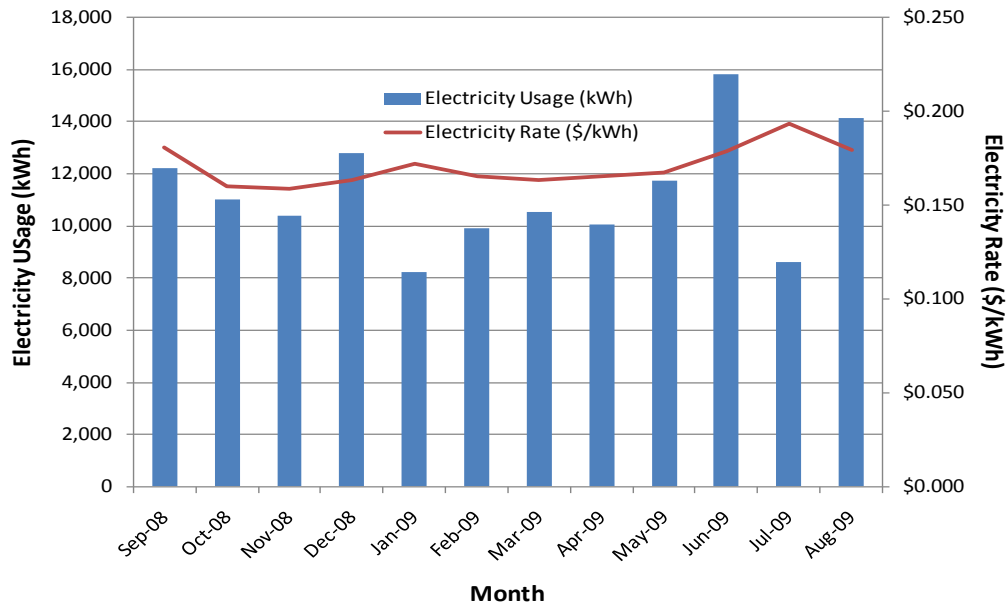
Library - Electricity Usage vs. Rate

The electricity rate fluctuates inversely proportional to usage, as expected. Typically, the more units of electricity that are used by the building, the cheaper electricity becomes per unit. Some rate fluctuations may be due to estimated utility readings as opposed to actual readings.

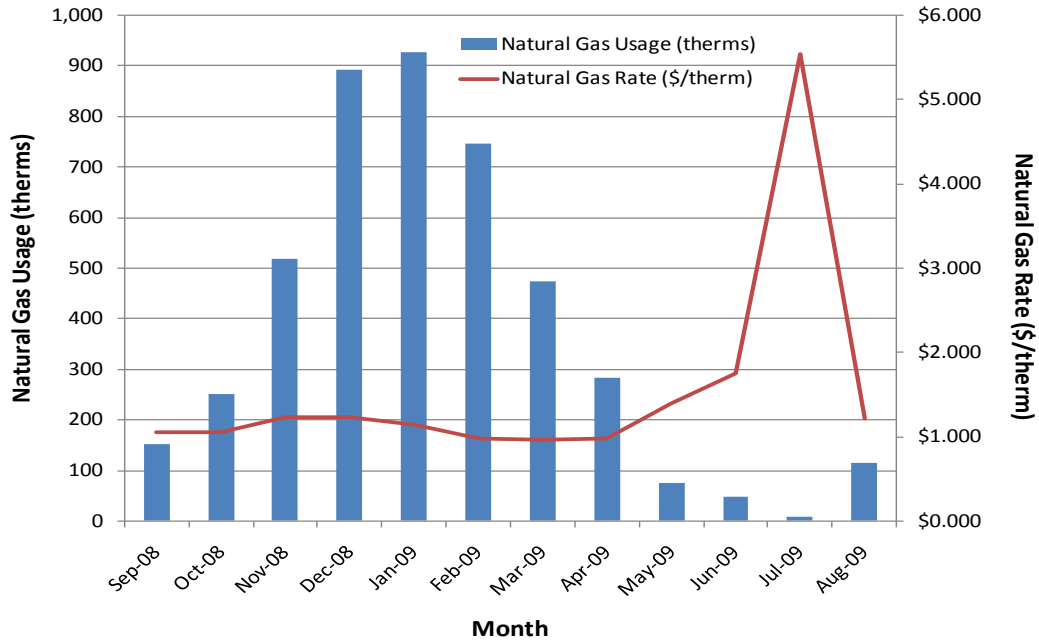
Library - Natural Gas Usage vs. Rate

The natural gas rate fluctuates inversely proportional to usage, as expected. Typically, the more units of natural gas that are used by the building, the cheaper natural gas becomes per unit. In summer periods, when a minimal amount of gas is used, the natural gas rate (\$/therm) increases sharply. Each month, the utility customer pays service and delivery charges to the utility company regardless of use. When minimal amounts of gas are used, the rate appears to sky rocket since service and delivery charges are the same amount as during high use months but represent a larger percentage of the total bill.

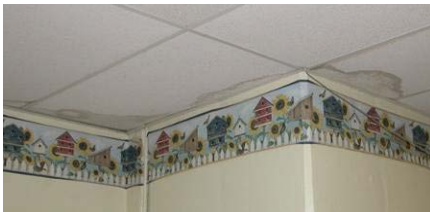
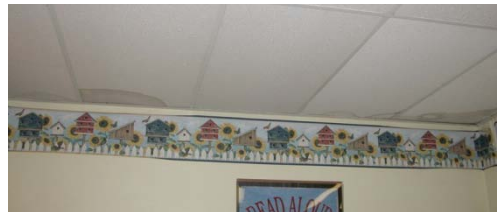
The exterior envelope consists of a brick veneer façade with cut stone accents and a wood box cornice wrapping the two sides of the Library. The basement walls are poured concrete stem walls with some signs of water damage in ceiling tiles around the perimeter, possibly from damaged down spouts.

Water damage visible on ceiling tiles in basement perimeter

- Investigate water leaks – There were several water damage spots noted on ceiling tiles. SWA was unable to identify the major source of these leaks. SWA recommends investigating these leaks when they are first noticed and perform corrective maintenance. Preventative maintenance such as air-sealing and bi-annual inspections can help prevent future leaks.

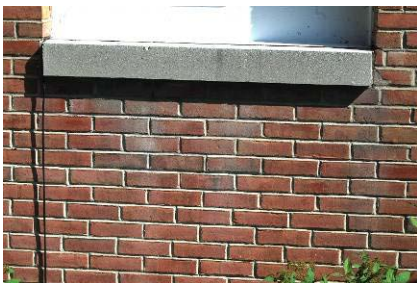
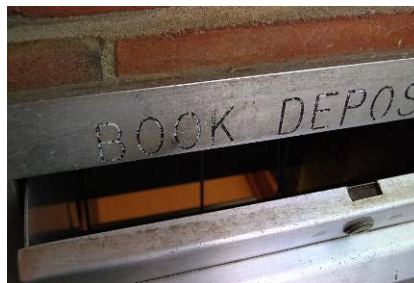
The book drop box sleeve in the exterior wall, next to the main entry doors was found not to be sealed. SWA recommends sealing both openings inside and outside with weather stripping to ensure no conditioned air to escape unhindered through this large opening.

Slightly aged sill caulk and brick veneer Unsealed book drop box sleeve

- Seal openings at book drop box sleeve in exterior wall – SWA recommends sealing both inside and outside openings with weather-stripping to ensure no conditioned air to escape through large opening around book drop box sleeve.

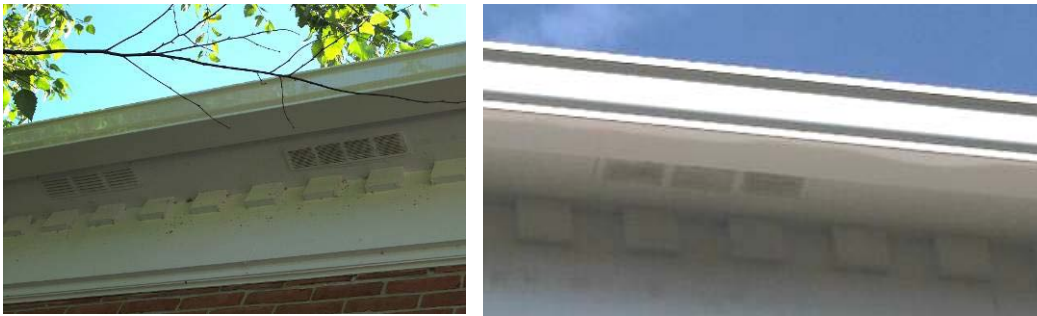
Soffit and ridge vents were identified and SWA recommends verifying that unobstructed air flow between the two is provided. The amount of soffit vents was found to be insufficient and SWA recommends adding additional vent. This helps to prolong the life of the installed synthetic slate roof and minimize potential leakage which can compromise insulation performance and structural components. It also significantly lowers the attic temperature during summer months which reduces the overall building's cooling load.

Insufficient amount of soffit vents

- Increase attic insulation levels – SWA recommends that insulation with a minimal insulation value of R-30 is added and maintained in the plenum above the ceiling.
- Upgrade windows – SWA recommends that all single-pane windows are replaced with newer double-paned windows with low-e glazing. New windows should also include frames that have a thermal break.
- Increase soffit venting – SWA observed that the amount of soffit vents was found to be insufficient. SWA recommends using additional venting in order to prolong life of the installed synthetic slate roof and minimize potential leakage. Roof ventilation should be installed according to local building codes.

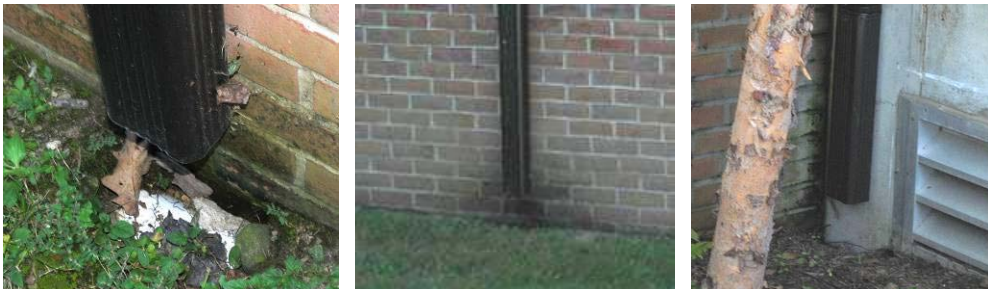
Gutters and downspouts were inspected and found to be in good condition with the exception of missing or disconnected down spout deflectors and diverters. SWA recommends that all downspout diverters slope away from exterior walls to minimize potential water and moisture problems around the perimeter foundation.

Downspout deflectors and diverter missing, causing water penetration between basement wall and insulation

- Maintain roofs - SWA recommends regular maintenance to verify water is draining correctly.
- Install downspout diverters – SWA observed that the building was properly fitted with gutters and downspouts; however the downspouts allow the water to pool directly next to the exterior wall of the building. SWA recommends installing downspout diverters in order to divert water away from the building in order to prevent damage to the exterior walls.

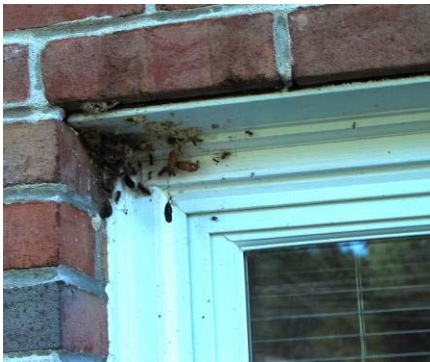
Extensive insect nesting was noticed around some windows and the eaves. SWA recommends inspecting all caulking around windows and doors for openings that could attract insects of various kinds with the potential of sub-surface damage to structure and insulation. SWA recommends exterior and interior inspections of all windows as part of the building's routine maintenance schedule to ensure air and water tight performance year round.

Excessive insect nesting

- Routine maintenance inspections of exterior walls, windows and doors – SWA observed several areas around windows and doors that were missing caulking and created openings allowing insects to build nests where there were surface transitions. SWA recommends routine maintenance inspections to prevent insect nesting and look for minor maintenance issues that have the potential of creating larger problems in the future.

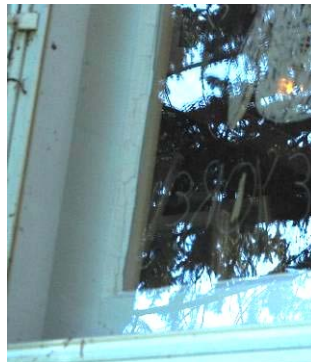
The building contains double hung and fixed windows. Most of them were found to be newer wood frame type double glazed with low-e coating and simulated dividers. The original remaining single pane wood windows are in poor condition however they would not be cost effective to replace at this time. If major renovations are undertaken in the future, SWA recommends replacing them with double glazed low-e windows.

Original single pane windows with cracked panel

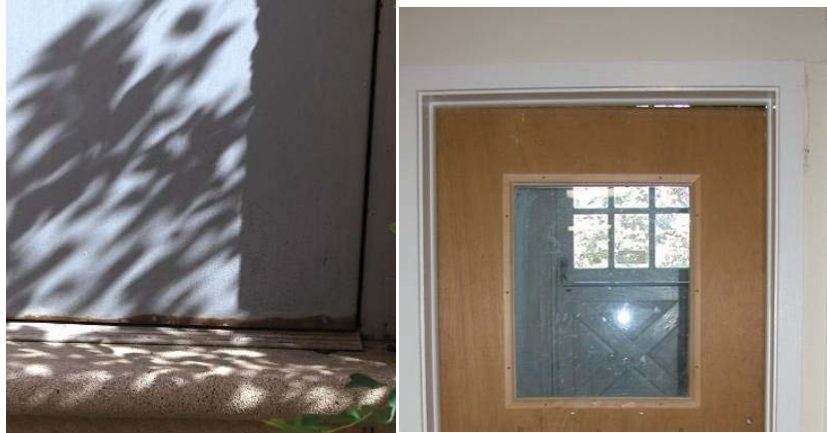
The wood main doors and metal composite side doors were observed to be in fair condition except for some missing or worn weather-stripping. SWA recommends that the exterior doors of the building be weather-stripped in order to decrease the amount of conditioned air that is lost around each door. SWA also recommends checking the weather-stripping of each door on a regular basis and replacing any broken seals. Tight seals around doors will help ensure the building to be is kept continuously insulated.

Worn and missing weather stripping around doors.

- Provide weather stripping / air sealing – SWA observed that all windows and doors had proper weather-stripping and air sealing due to their age. As a best practice, SWA recommends that each window and door is inspected twice per year for deficiencies. Any time that a seal has been compromised, building maintenance staff should repair and replace the seal immediately to ensure that thermal barriers are not breached.

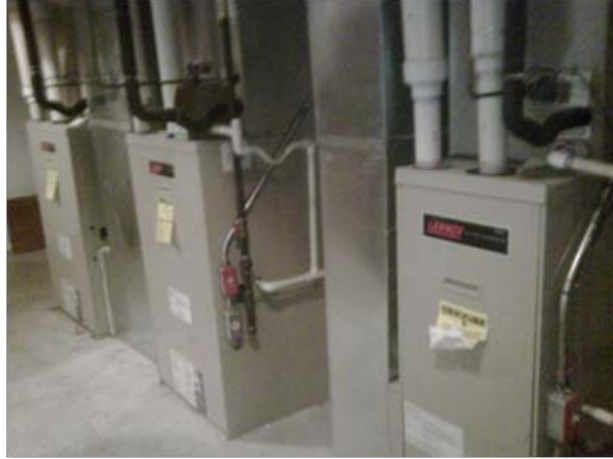
At this location there were six Lennox G26 Series natural gas furnaces. Each is equipped with a DX cooling coil fed from remote condensers (See 2.4.2 Cooling). Every area is controlled by a Night Set back programmable thermostat and it is not recommended that they be replaced.

Sample of heating furnaces

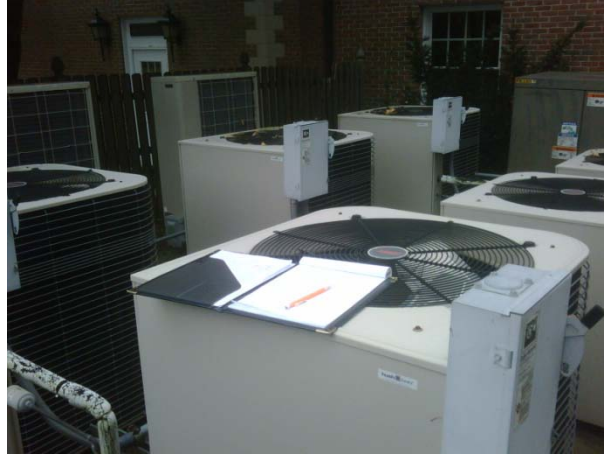
At this location there are eight residential-grade condensers located on the side of the building. The Lennox condensers feed the Lennox DX Cooling coils located above each furnace. (See 2.4.1 Heating) listed above. Supplemental cooling is provided by individual Mr. Slim wall mounted Split systems. All of the units have a SEER value of 11.4 or higher and were found to be in good condition, and it is not recommended that they be replaced.

Condensers located outside along the exterior wall of the building
