**Local Government Energy Program
Energy audit report**

***Cresskill Borough Hall
Borough of Cresskill
Bergen County, NJ 07626***

Project Number: LGEA06

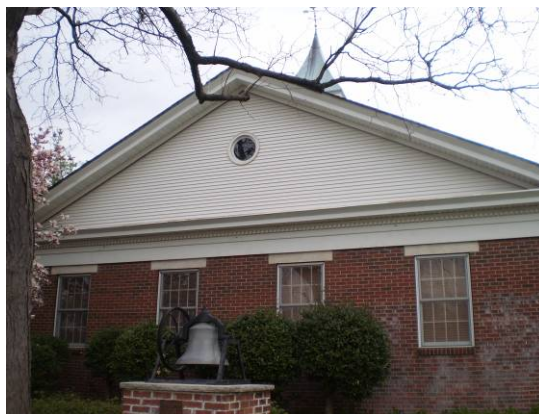
The exterior walls of the Borough Hall building consist of a 4" face brick with 2"x4" wood framing spaced 16" on center on the interior side. There is 6" of R-11 fiberglass batt insulation situated in between each of the wooden studs. There are portions of the exterior walls where the gabled trusses form the roofline, these areas are sided with ¾" duroply siding. While insulation could be added to the exterior walls of the main building, it would not be aesthetic and it would have a significant impact on building operations. SWA has determined that it is not cost effective to do so at this time. If any portion of the building is renovated or improved as part of a capital improvement plan, SWA recommends increased insulation is added to any walls during construction.

Face brick on lower portion; siding on trussed section

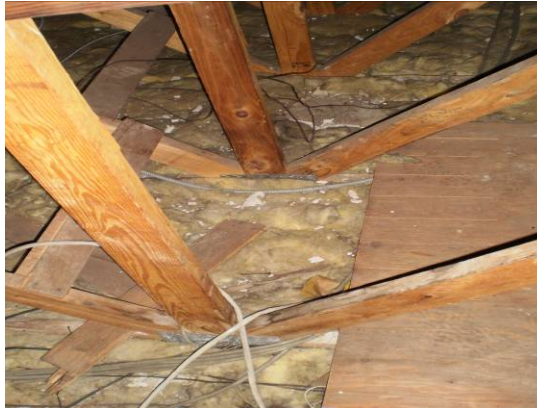
Wooden trusses with 6" batt insulation

SWA observed 6" worth of R-19 batt insulation located in the attic area of the building. SWA has determined that it is not cost-effective to add insulation at this time. If the ceiling or roof is improved as part of a capital improvement plan, SWA recommends increasing the amount of insulation located in the attic in order to airseal any leaky attic space to keep more conditioned air inside of the actual conditioned spaces and allow the least amount of expensive, conditioned air to escape.

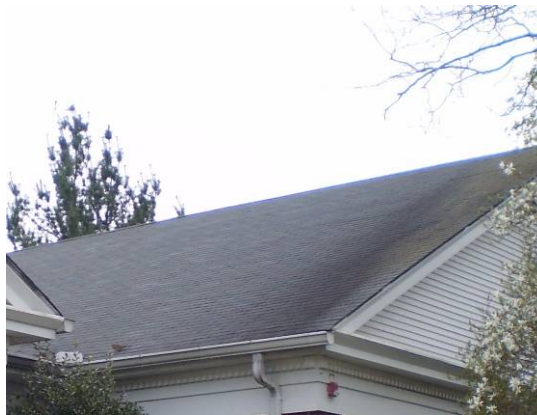
The pitched roof of the building is formed from wooden trusses and the surface is formed from dark gray asphalt shingles. The roof surface appeared to be in fair-good condition and it would not be cost effective to upgrade at this point in time. The roof utilizes vented soffit to vent the attic space.

Asphalt shingles on pitched roof

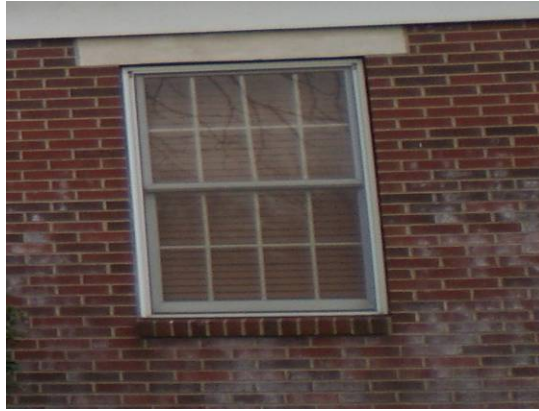
All of the windows in the building are wooden framed double-hung windows. These windows contain double-pane glass except in Police Department secure areas where security glass is used. The windows appeared to be in fair-good condition and did not allow for air or moisture penetration around the frame. There are no cost-effective measures for the windows at this point in time.

Typical double-hung window

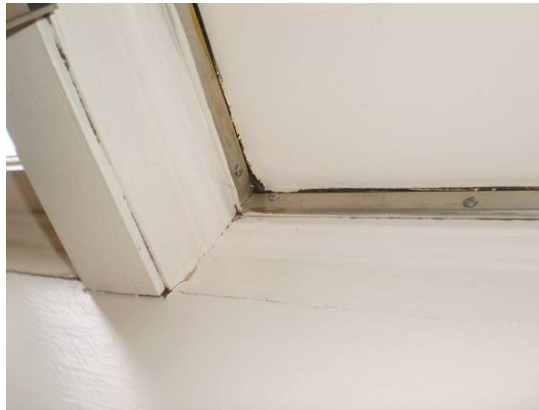
The entrance ways for the Cresskill Municipal Building consists of insulated steel doors set in a metal frame. The frames of these doors are poor insulators and allow expensive, conditioned air to leak out of the building. Many of the doors were observed to be having deteriorated weather-stripping so that they did not seal well to the frames. SWA recommends weather-stripping around all of the doors of the building in order to prevent conditioned air from leaking outside of the building. Weather-stripping should be checked at least once a year and replaced as soon as signs of deterioration show.

Edges of door in Public Assembly room no longer form tight seal

- **Weather Stripping/Air Sealing** - SWA observed that exterior door weather-stripping was beginning to deteriorate. Doors and vestibules should be observed annually for deficient weather-stripping and replaced as needed. The perimeter of all window frames should also be regularly inspected and any missing or deteriorated caulking should be re-caulked to provide an unbroken seal around the window frame. Any other accessible gaps or penetrations in the thermal envelope penetrations should also be sealed with caulk or spray foam.

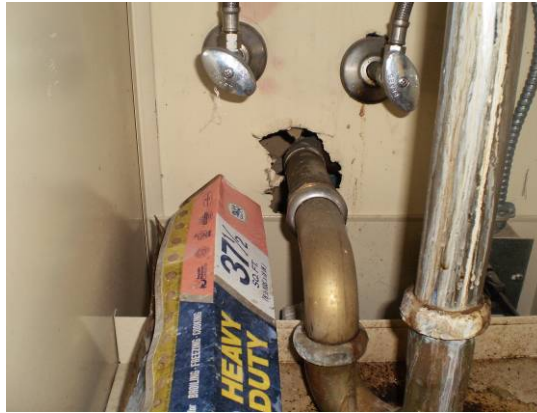
The Cresskill Municipal Building was relatively tight with the exception of the exterior doors and some small penetrations inside of the building. Windows and Entranceways such as the front and back vestibule of the main Borough Hall Building should be maintained so that a tight seal is always formed to keep conditioned air from leaking outside of the building. There are also some areas located inside the building that can allow cold air to enter from outside the building and can cause comfort issues. One specific problem area was that there were large holes around piping penetrations located under the sink in the general meeting room behind the public assembly room.

These excessive holes around the penetrations allow cold drafts to enter the room and should be sealed tighter around the penetrations.

Piping penetrations under sink in meeting room

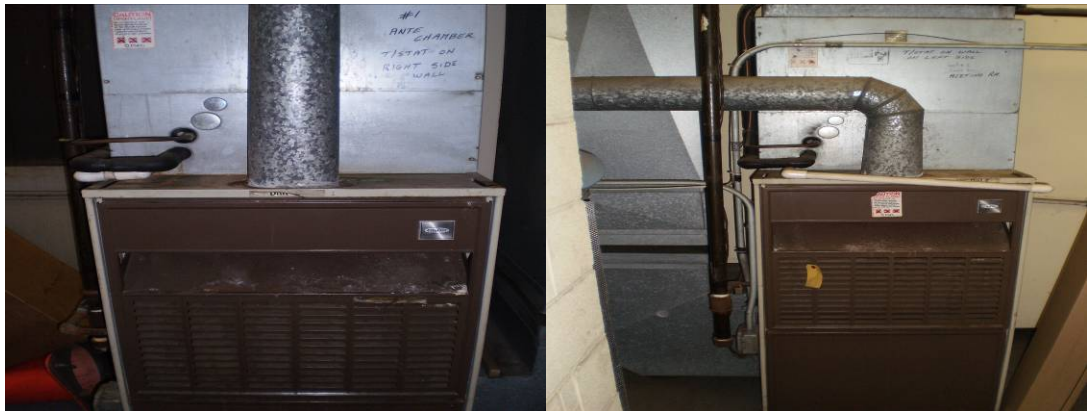
Hot Water (DHW) heater, the DHW booster pumps, and main sprinkler system. Each of these Carrier furnaces are identical to the two furnaces and have a total input of 125,000 Btu/hr. Unit 3A and Unit 3B serve the office area as well as hallways in the Borough Hall building. Unit 4 serves the Police Department. SWA performed combustion efficiency tests on Unit 3A and Unit 3B and based on test results, assume that the annual efficiency of these furnaces is <80%. The combustion efficiency test for Unit 3B revealed potentially dangerous levels of Carbon Monoxide. There was no Carbon Monoxide detected in the maintenance room, however, very high levels of CO were detected inside of the flue. This indicates that the furnace is not completely burning all of the chemicals inside of the fuel during the combustion process. The excessive levels of CO were detected inside of the flue where they are being pushed outside of the building through ductwork penetrating the roof. This situation is potentially dangerous if the ductwork becomes sealed at some point and allows that CO to enter the conditioned space. Replacing this equipment will help mitigate this problem but CO sensors should be kept up-to-date and tested regularly inside each of the maintenance rooms or anywhere else there is a combustion appliance. A combustion efficiency test could not be performed on Unit 4 since the unit could not be forced into fire-mode by the thermostat. The Police Department thermostat was already reading 85°F, which is also the upper temperature limit of the thermostat.

Furnace Units #1 and #2 (Typical furnace units)

All five of the Carrier furnaces are approaching 30 years old since they are original to the building. Heating equipment such as furnaces, generally have a useful lifetime 25 years. SWA recommends replacing incorporating the replacement of all 5 furnaces into a capital improvement plan. These furnaces should be replaced with furnaces capable of handling the same heating demand but with a much higher efficiency. These atmospheric furnaces should be upgraded to sealed-combustion furnaces. Sealed-combustion furnaces are much more efficient and will therefore reduce gas usage significantly. The furnaces can also be replaced with similar-type atmospheric furnaces that have a higher efficiency. Also, the furnaces should be regulated with a programmable thermostat to make sure that they are operated only when needed. It is important that rooms like the Public Assembly room are also regulated with a programmable thermostat as well. Even though some rooms are only used sparingly, a programmable thermostat can be setup to ensure that rooms are not unnecessarily conditioned overnight, over weekends or over other prolonged periods of time when they are not being used.

The existing five (5) hot air furnaces have been maintained properly but are now past their useful life expectancy. The furnaces typically have been reasonably well-maintained but they are inefficient relative to newer technology and they have reached the end of their useful life. The recommendation provided here cannot be cost justified by energy savings alone. However, the age and condition of the equipment warrant attention and this recommendation is intended to provide guidance to help the building management staff prioritize upgrades within the facility. SWA recommends incorporating the replacement of the furnaces into a capital improvement plan that accounts for energy efficiency but also includes safety and reducing building maintenance.

The existing equipment is approximately 79% efficient. To improve heating plant energy performance, SWA recommends replacement of the existing furnaces with new furnaces that have a higher efficiency. The atmospheric type furnaces should be replaced with new sealed-combustion type furnaces for better efficiency and improved safety. Based on difficult experiences with sealed-combustion appliances however, the Borough of Cresskill recommends that they replace the existing atmospheric furnaces with similar atmospheric furnaces with better efficiency instead of upgrading technologies at this time. If the furnaces are replaced with similar atmospheric furnaces, SWA recommends that the greatest efficiency is chosen. Newer atmospheric furnaces can reach efficiencies of 82% or greater. For each room that a combustion appliance is installed, active CO detectors should also be replaced or installed to ensure that CO will be detected if it were to leak outside of the furnace. Furnace capacity should be properly sized. As part of this upgrade, programmable thermostats should be installed where there are currently manual thermostats. Once the furnaces are installed, the system should be calibrated to operate in accordance with typical use of the building. The furnaces have a negative return on investment but will also save on maintenance costs and increase occupant safety.

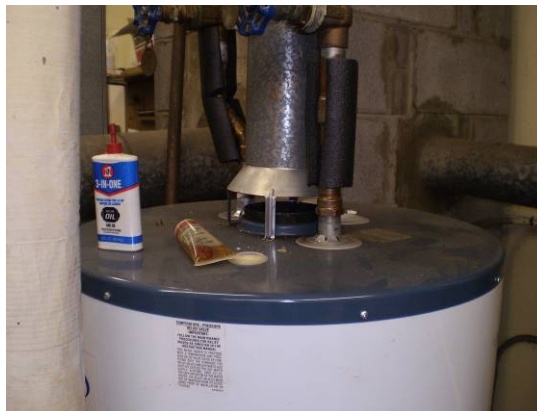
Domestic Hot Water for the building is provided by a RHEEM Guardian hot water system with a Fury gas water heater located in the main mechanical room. The hot water heater is newer and is an atmospheric type heater with an input of 50,000 Btu/hr and 60 gallons of storage. In the main mechanical room, city water comes in at 55°F and is heated by the DHW heater to 125°F. On the day of the audit, the system was using 56 psi of pressure to deliver water to different parts of the building. Water was tested at various faucets throughout the building and was measured to be between 110°-120°F. Water is pumped through the system using a 1/12th horsepower, Bell and Gossett Booster Pump.

Atmospheric DHW Heater

It is not cost-effective to replace the existing water heating equipment with higher efficiency equipment. However, higher efficiency water heating equipment will save energy and should be strongly considered upon replacement of the equipment. Energy saving appliances bearing the ENERGY STAR label should be selected to ensure efficiency performance. Incentives may be available to offset any added costs for the installed equipment.

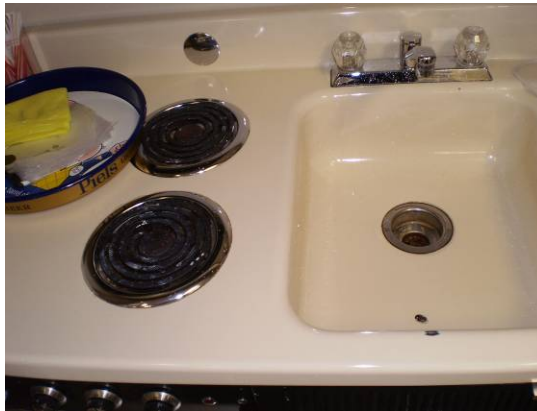
More efficient water-consuming fixtures and appliances save both energy and money through reduced energy consumption for water heating, as well decreased water and sewer bills. The kitchenette faucet located in the meeting room behind the Public Assembly room was measured to be 4.5gpm which can be reduced to 1.5gpm using low-flow aerators. SWA recommends that the aerators in all sinks are retrofitted with low-flow aerators that constrict the volume of water allowed to flow out of the faucets during the time it takes to wash hands, wash dishes, etc. Building staff can also easily install faucet aerators and/or low-flow fixtures to reduce hot water consumption. In addition, routine maintenance practices that identify and quickly address water leaks are a low-cost way to save water and energy.

Kitchenette sink with flow measuring 4.5 gpm

- **Water Efficient Fixtures & Controls** - Adding controlled on/off timers on all lavatory faucets is a cost-effect way to reduce domestic hot water demand and save water. Building staff can also easily install faucet aerators and/or low-flow fixtures to reduce water consumption. There are many retrofit options, which can be installed now or incorporated as equipment is replaced. Routine maintenance practices that identify and quickly address water leaks are a low-cost way to save water and energy. Retrofitting with more efficient water-consuming fixtures and appliances will save both energy and money through reduced energy consumption for water heating, while also decreasing water and sewer bills.

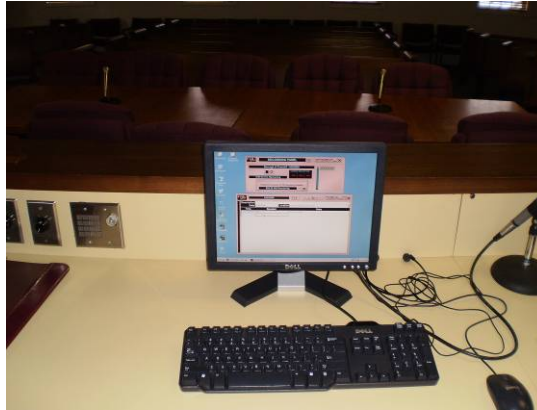
The Public Assembly room is used sparingly, mostly in the evenings, according to building staff. Building staff should ensure that everything, including the thermostat and any appliances are always shut off when this room is not in use. On the day of the audit, SWA observed that the computer centered at the podium was left on when the room had not been used for at least a day. Computers and other appliances should be shut down, or at least their screens should be when not in use for extended periods of time.

Computer left on in Public Assembly room

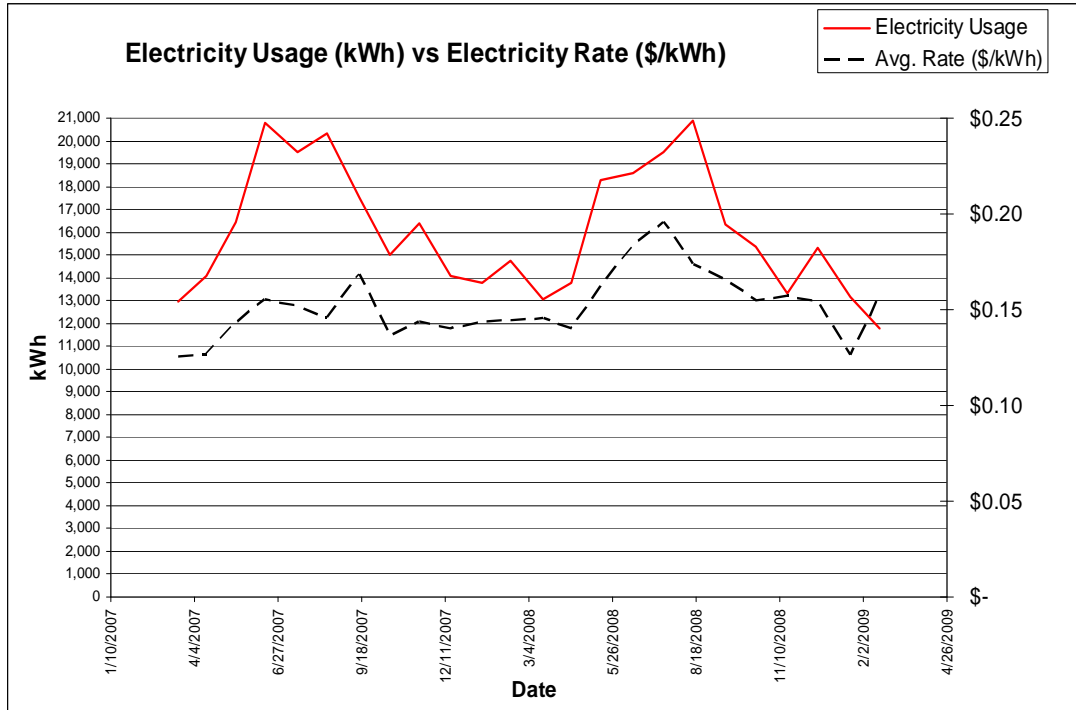
Electricity prices reflect electricity usage

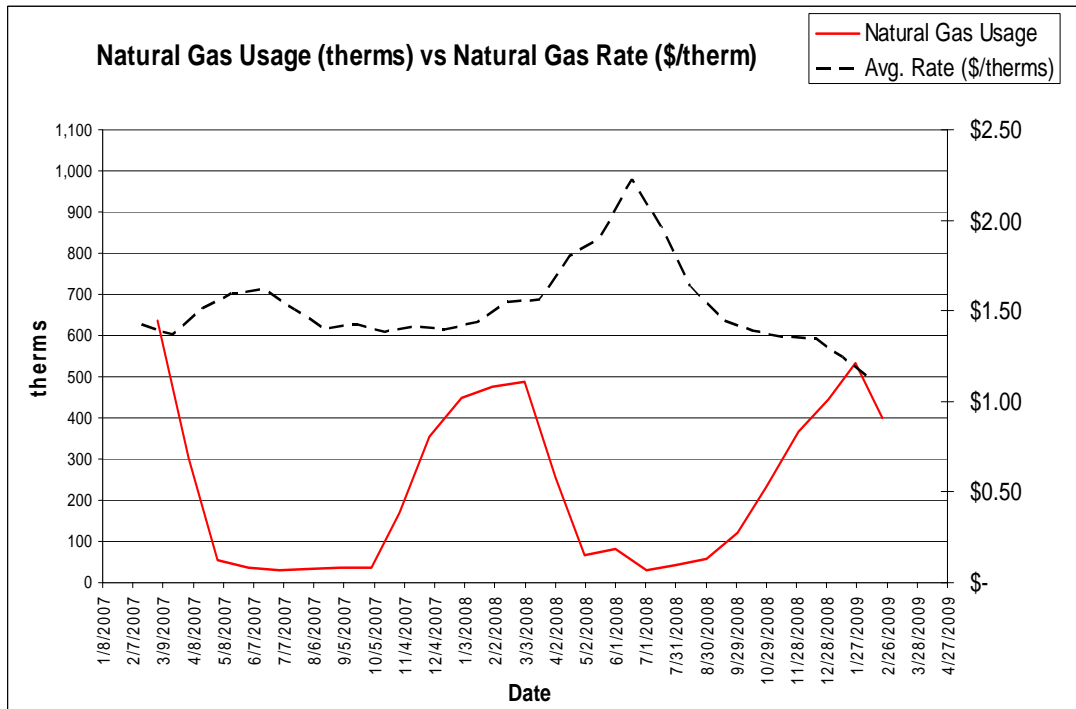
Natural gas prices fluctuate as expected with usage

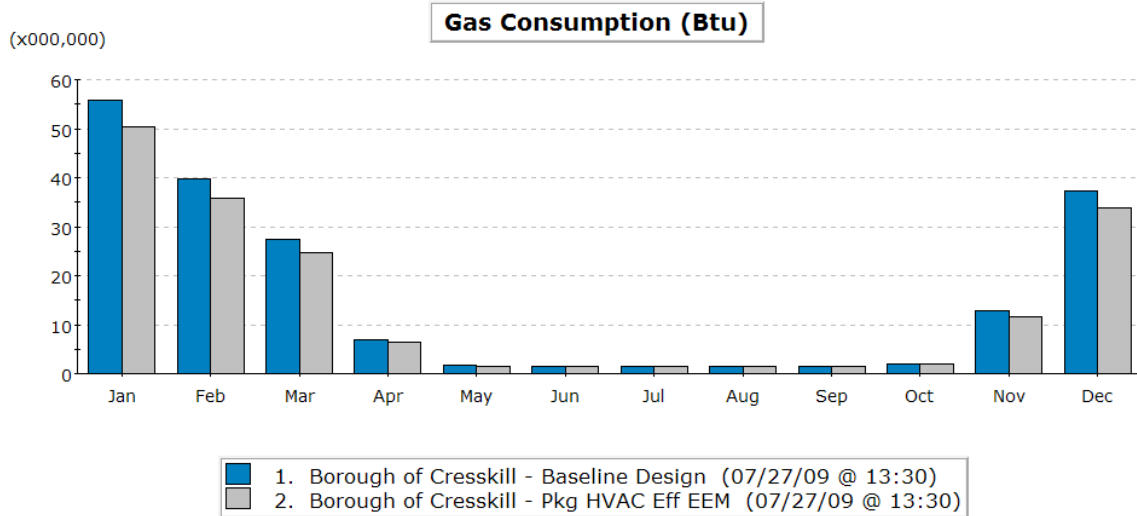
Natural Gas Savings from Furnace Replacement
