**Local Government Energy Program  
Energy audit report**

***Borough of Waldwick  
Waldwick, NJ 07463***

***Project Number: LGEA02***

The present report is for the DPW building only.

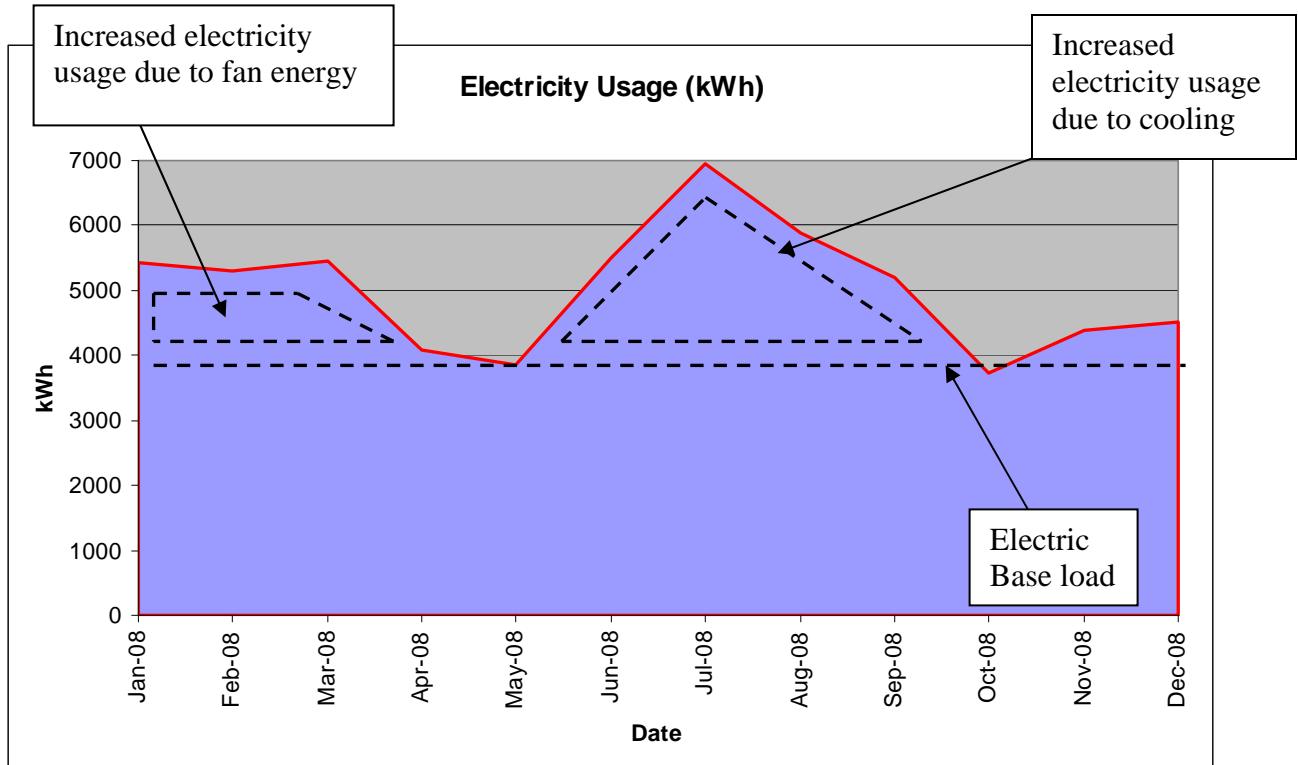
The following chart shows electricity usage for the DPW building based on utility bills for the year 2008.

In the above chart, we can see a clear electric base load by looking at the shoulder months (May, October) when we are between seasons and using minimal heating or cooling. The electricity for the DPW peaks in the summer as expected due to cooling but also in the winter due to the use of fan energy to assist in heating the building. Below is an electricity usage chart from the DPS eQUEST model that shows the same trend but also breaks down the electricity usage by end use.

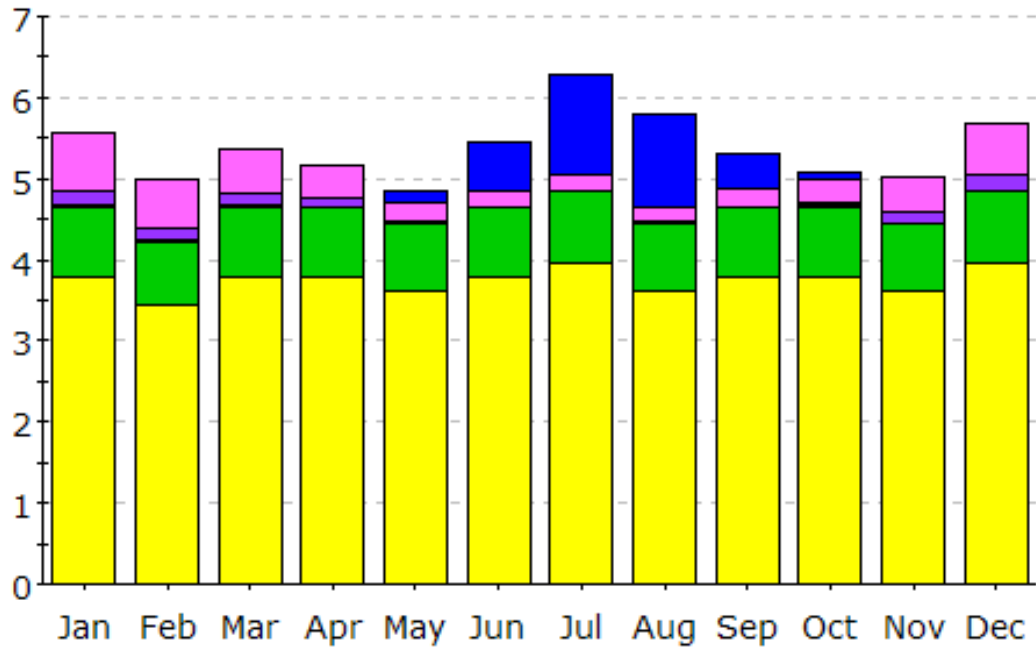
(x000) **Electric Consumption (kWh)**

- Area Lighting
- Misc. Equipment
- Pumps & Aux.
- Ventilation Fans
- Exterior Usage
- Space Heating
- Water Heating
- Ht Pump Supp.
- Refrigeration
- Heat Rejection
- Space Cooling

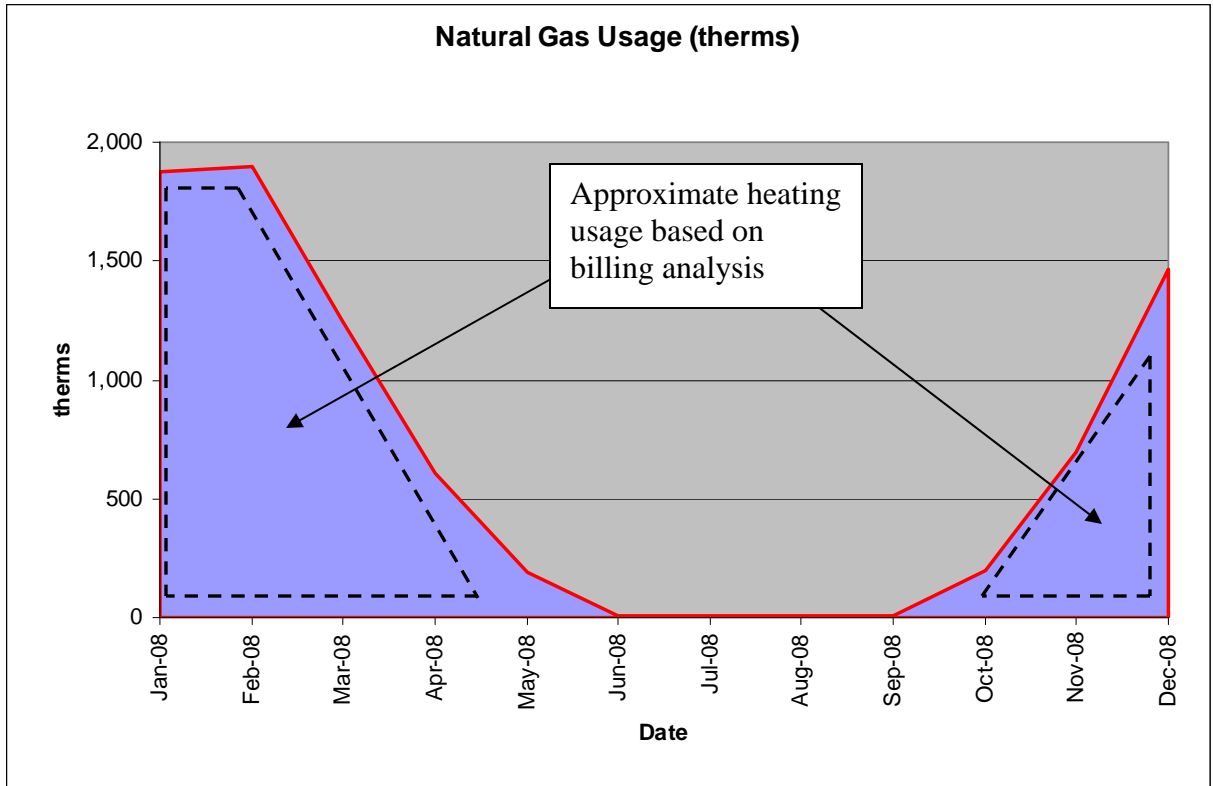
The following chart shows the natural gas usage for the DPW building base on utility bills for the year 2008.

In the above chart, the natural gas usage follows a heating trend as expected. During the summer it is clear that the natural gas usage is very minimal which reflects that heat is not being used and the DHW load is minimal. This usage is similarly reflected in the chart below, taken from the eQUEST model. This chart also shows an estimated breakdown of natural gas by end use.

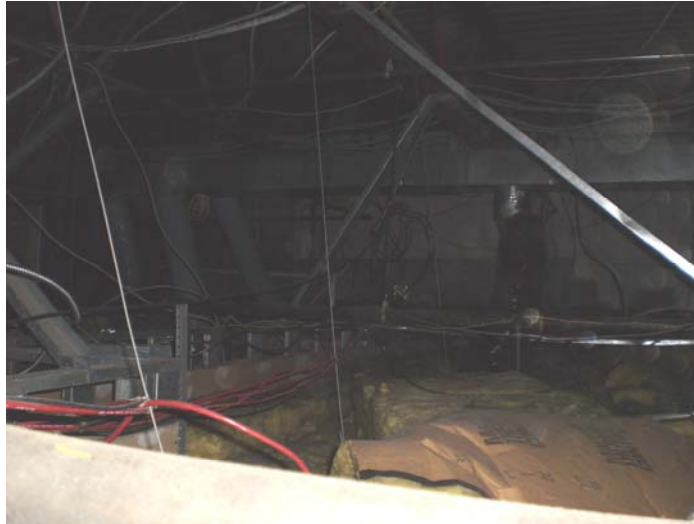
The plenum above the office area between the ceiling and roof was observed and showed some deficiencies in insulation. Below is a photograph of the insulation located on the ceiling, located within the plenum above the office area.

Plenum above office – batt insulation is compressed and out of place

SWA observed that the R-19 batt insulation located in this plenum was compressed and moved around over time as the roof was accessed for different reasons. SWA recommends air-sealing and replacing deficient R-19 batts with insulation of a higher R-value. SWA recommends caulking the ceiling tiles in-place to form a tighter airseal, re-using batts that are in good shape and substituting new batts for deficient ones and also adding approximately R-11 worth of blown insulation on top of the batt insulation. Since there is equipment located in this plenum that will occasionally have to be accessed, SWA recommends creating designated areas for plenum access so that blown insulation will not fall down every time the plenum is accessed.

SWA observed deficient R-19 batt insulation located in the plenum above the drop-ceiling tiles of the office area. The insulation was observed to be compressed and also moved around, reducing the effective R-value of the insulation. On the day of the site visit, the outside temperature was approximately 41°F and the indoor temperature of the office space was 70°F. When the plenum was accessed, the temperature above the ceiling measured 71°F. Since hot air rises, it is evident that the heating from the building is allowed to freely trespass into the plenum. The plenum is 8 feet high by 5,000 square feet which provides a volume of 40,000 square feet that is not thermally separated from the rest of the building. Since the plenum is not properly thermally separated from the office building, heat travels right through the ceiling tiles into the plenum which greatly increases the heating load of the building. SWA recommends replacing the existing R-19 batts of insulation with new, decompressed batts of R-19 insulation with an additional six inches of blown insulation over the batts. The blown insulation will have an R-value of 11, raising the new total value of insulation to R-30. Ideally, the ceiling should also be air sealed between the insulation and drop ceiling, however this is difficult to do with a drop ceiling. SWA also recommends creating scuttle holes that allow access to key areas of the plenum in order to allow servicing of existing ducts and electrical conduits without disturbing the insulation value of the ceiling.

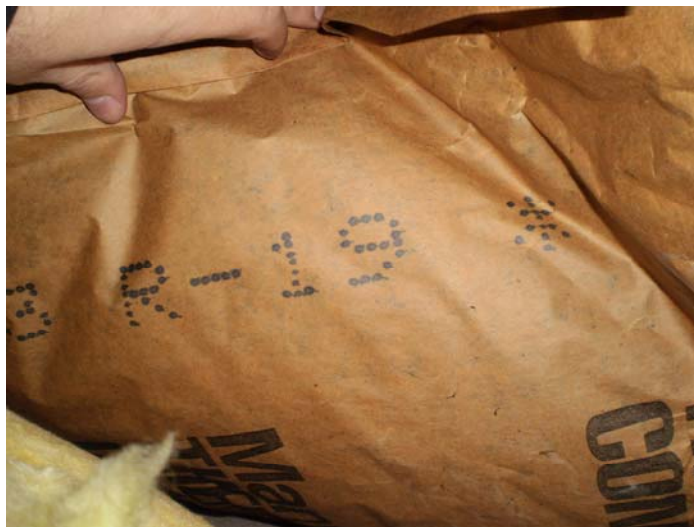
R-19 batt insulation observed in the plenum

On the day of the energy audit, the outside temperature was approximately 41°F outside and 70°F inside. When the plenum above the office was accessed, the temperature inside of the plenum was measured to be around 72°F. The higher temperature in the plenum is proof that hot air is leaking through the insulation on the ceiling and being trapped in the plenum. Allowing heat to transfer into the plenum is essentially enlarging the volume of conditioned space for the building. By completely air-sealing and re-insulating the attic, SWA believes a

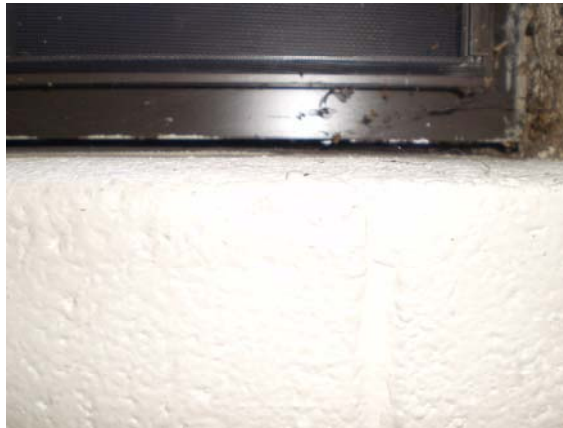
All of the windows in the building are single-pane, metal framed windows. These windows have a poor insulating quality and allow heat to transfer out of the building during the heating season and allow heat to transfer in during the cooling season. In addition to the windows being poorly insulated, many of the windows were noticed to be poorly sealed to the envelope of the building and daylight could be seen around the frame of the window. Below is a picture showing a typical window for the DPW building, with an approximate 1/4" gap around the frame of the window.

Poorly sealed window located in sign shop

On the day of the site visit, SWA observed that the windows and exterior doors of the office building were leaky and provided a minimal thermal barrier to the outside. The windows were metal-framed with single pane glasses and are not deemed cost-effective to replace at this time. The frames of both the windows and doors were not sealed well to the masonry of the building and allowed a significant amount of leakage around them. SWA recommends that air leakage is minimized by air sealing around all of the windows and doors of the office portion of the building. Air sealing would not be cost effective at this time in the garage areas due to nature of the building and leakage from areas besides windows and doors.

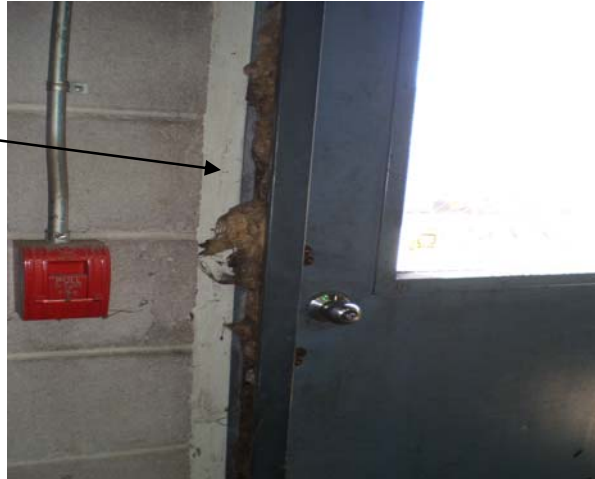
The entranceways for the DPW building consist of a mix of insulated and un-insulated metal doors. A majority of these doors are poor insulators and allow expensive, conditioned air to leak out of the building. These doors consisted of metal frames as well as metal doors. The doors were observed to be missing weather-stripping so that they did not seal well to the frames. In many cases, the frame assembly was not sealed well to the building and gaps were left between the masonry and the door frame. Areas where there were large gaps between the masonry and door frame were absorbed to be stuffed with compressed insulation that has a compromised insulation value. SWA recommends air sealing around all of the doors and windows in the office portion of the building in order to prevent conditioned air from leaking outside of the building. Below is a picture of a door located in the DPW garage that was not sealed well to the frame and also lacked weather-stripping. The DPW portion of the building also could benefit from air sealing but due to the nature of the garage and how often the overhead doors open and shut, SWA deems it not cost-effective to airseal these doors at this time; however, insulated panels should be installed as these doors are replaced and a tight air seal around the doors should be kept consistent.

Unsealed door frame  
with compressed  
insulation

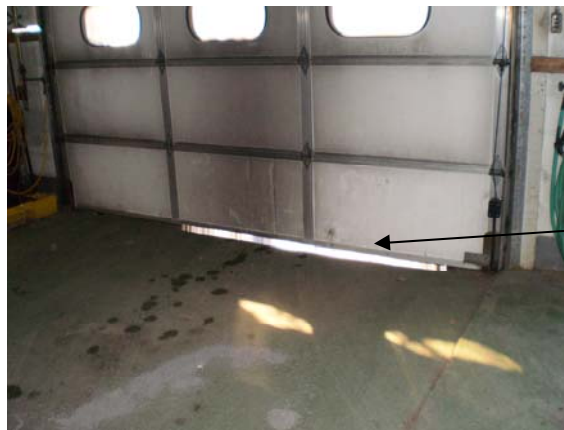
Since the DPW building also houses a large garage area, there are several large garage doors. These garage doors consist of minimally insulated panels and are also not sealed well to the frame of the building. SWA does not deem it cost-effective to replace these doors at this time but when these garage panel doors are replaced, they should be replaced with well-insulated panels and weather-stripping the doors well enough to make a seal when the door is closed. During winter months especially, the leakage through and around these doors allow conditioned air to flow outside wasting energy. Below is a picture of one of these doors.

Daylight seen  
around doors

The DPW garage and offices both have unique air tightness. The DPW garage has an extremely leaky shell with poor air sealing to separate conditioned air from outside air. Due to the nature of the garage, overhead doors are constantly opening and closing which lessen the effects of air sealing in the building envelope itself. The DPW offices are relatively air tight with the exception of the plenum above the drop ceiling. The drop ceiling provides a poor air and thermal seal from the plenum above and therefore, the volume of the building that requires heat is expanded. Conditioned air is allowed to leak into the plenum, which is approximately 8' by 5,000 square feet (40,000 cubic feet), and therefore increases the heating demand on the boiler. The plenum essentially creates a large and unnecessary heating load on the heating system.
