**Local Government Energy Program
Energy Audit Report**

***Denville Township
Main Street Fire House
2 Indian Road
Denville, NJ 07834***

Project Number: LGEA08

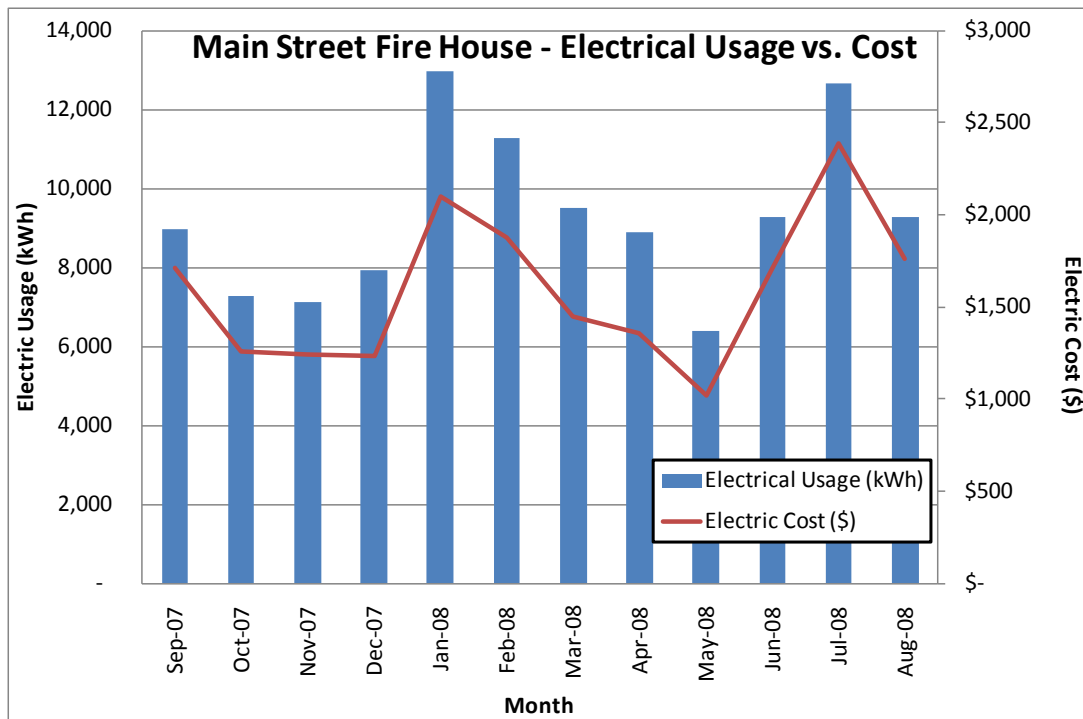
The following chart shows electricity use versus cost for the Main Street Fire House building based on utility bills for the 12 month period of September 2007 to September 2008.

Electricity use peaks during the winter months due to some electric heaters that are still being used. The cost of electricity fluctuates as expected with usage.

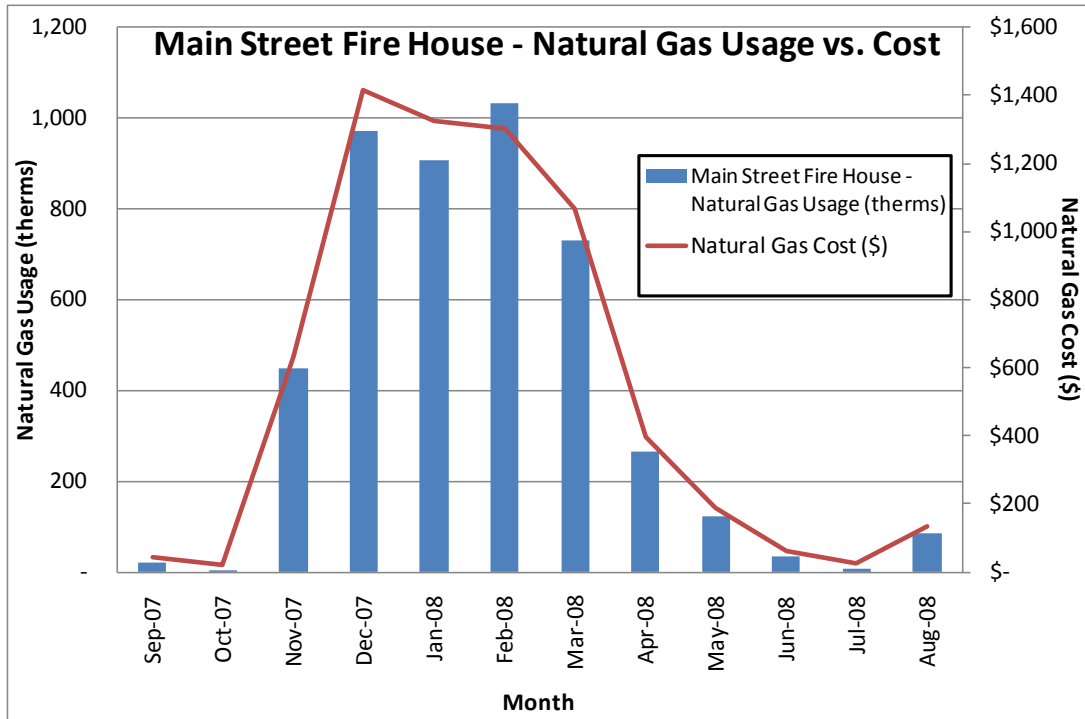
The following is a chart of the natural gas annual load profile for the building versus natural gas costs, peaking in the coldest months of the year and a chart showing natural gas consumption following the “heating degree days” curve.

In the above chart, the natural gas use follows a heating trend as expected. During the summer it is clear that the natural gas use is very minimal which reflects that heat is not being used and the domestic hot water (DHW) load is minimal. In January 2008, the Main Street Fire House building was overbilled for natural gas and this was reconciled in February 2008.

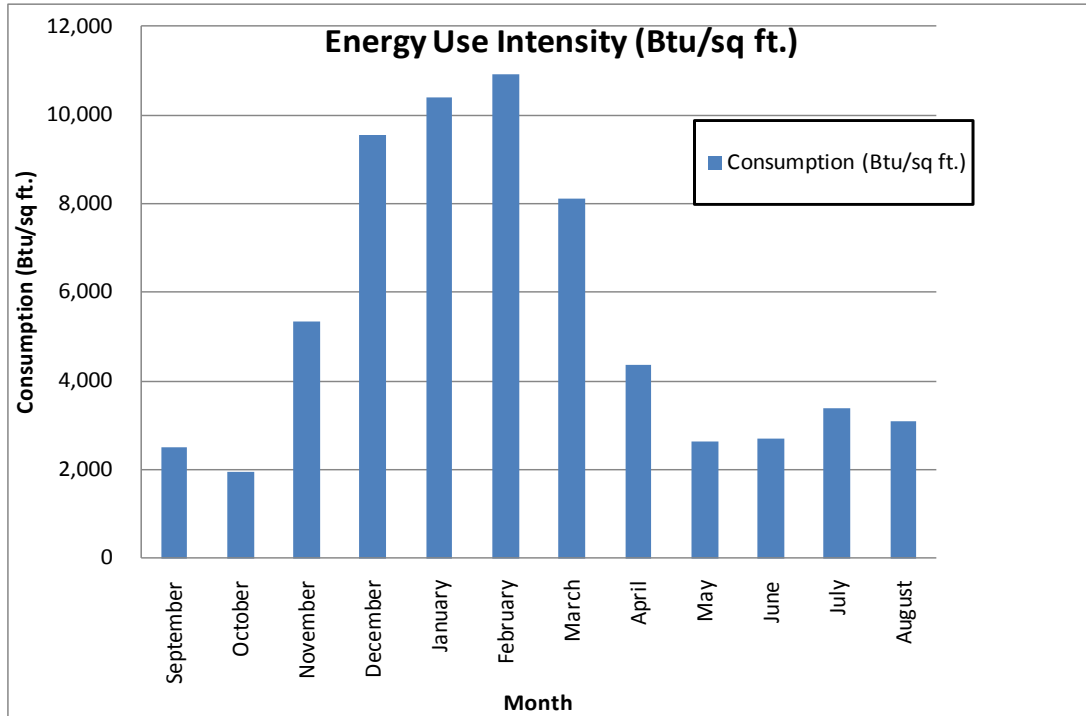
The following chart shows combined natural gas and electric consumption in Btu/sq ft for the Main Street Fire House building based on utility bills for the 12 month period of September 2007 to September 2008.

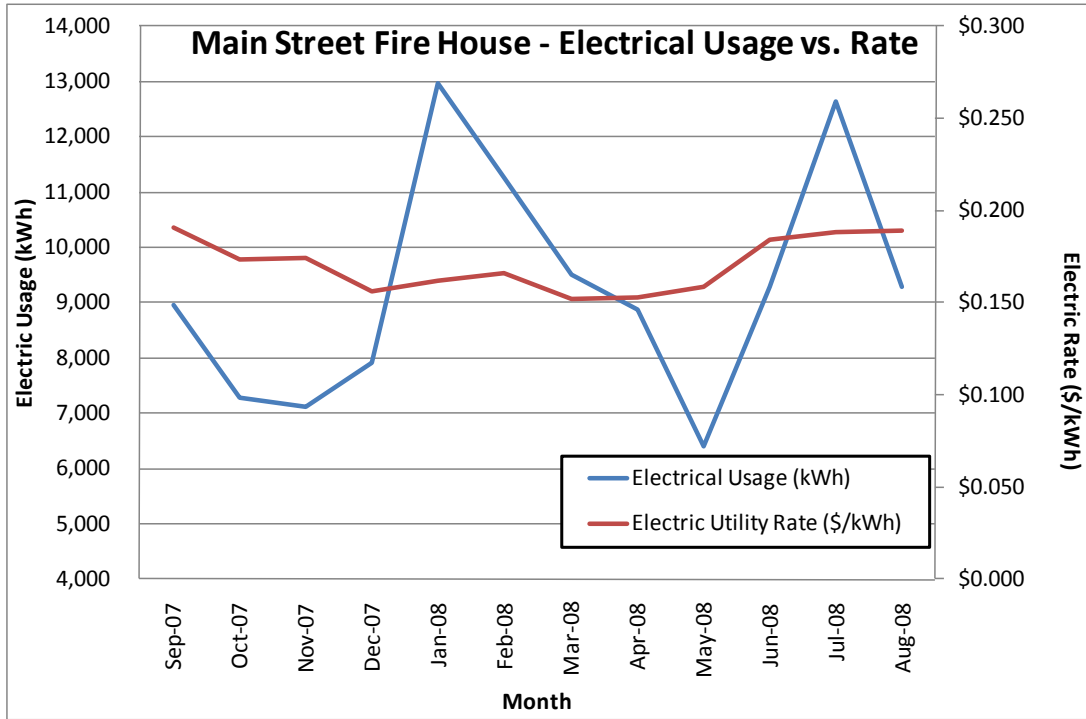
The Main Street Fire House building currently purchases electricity from JCP&L at a general service market rate for electricity use (kWh) with no separate (kW) demand charge. The Main Street Fire House building currently pays an average rate of approximately \$0.171/kWh based on the 12 months of utility bills of September 2007 to September 2008. Demand prices are reflected in the utility bills and can be verified by observing the price fluctuations throughout the year. The electric rate does not show large fluctuations throughout the year and therefore appears to be the appropriate rate for the building.

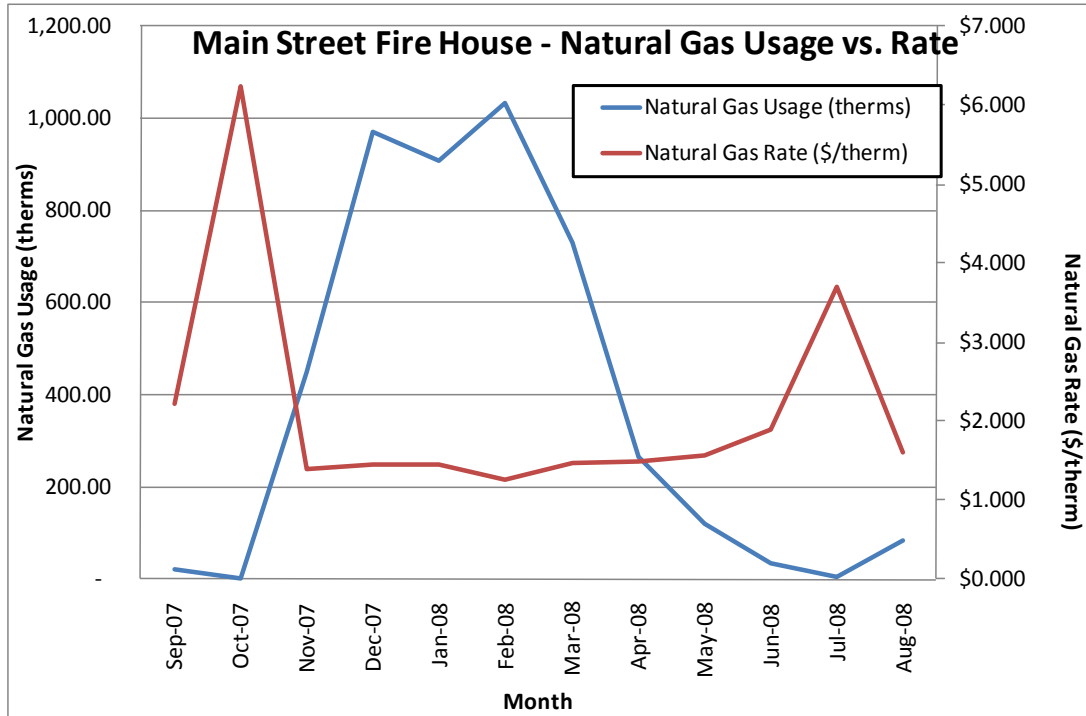
The Main Street Fire House building currently purchases natural gas supply from the NJNG at a general service market rate for natural gas (therms). There is one gas meter that provides natural gas service to the Main Street Fire House building currently. The average aggregated rate (supply and transport) for the meter is approximately \$1.43/therm based on 12 months of utility bills for September 2007 to September 2008. The suppliers' general service rate for natural gas charges a market-rate price based on use and the Main Street Fire House billing does not breakdown demand costs for all periods. Demand prices are reflected in the utility bills and can be verified by observing the price fluctuations throughout the year. Typically, the natural gas prices increase during the heating months when natural gas is used by the rooftop furnace units. The high gas price per therm fluctuations in the summer may be due to high energy costs that occurred in 2008 and low use caps for the non-heating months. Thus the building pays for fixed costs such as meter reading charges during the summer months.

Some of the minor unusual utility fluctuations that showed up for a couple of months on the utility bills may be due to adjustments between estimated and actual meter readings.

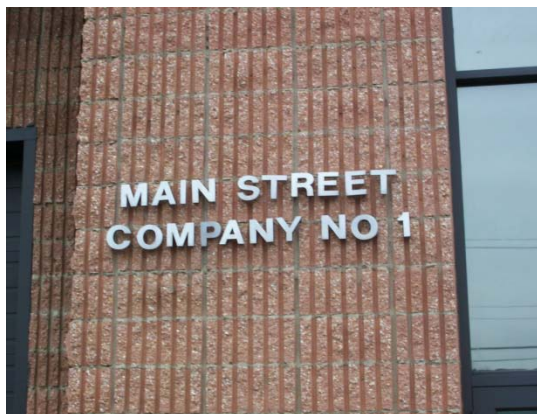
The Fire House walls are concrete blocks with a ribbed face. The exterior walls are a reddish color and showed no major thermal weaknesses. The interior side of the block walls is steel framed, 16" on center. Due to warm temperature conditions at the time of the field visits, insulation levels could also not be verified with help of infrared technology.

Overall, exterior and interior wall finishes of the envelope were found to be in age-appropriate, good condition with no major signs of unusual water or air leakage.

Concrete blocks with ribbed face

- Repair / seal wall cracks and penetrations - SWA recommends as part of the maintenance program to install weep holes, install proper flashing, and correct masonry efflorescence and seal wall cracks and penetrations wherever necessary in order to keep insulation dry and effective.

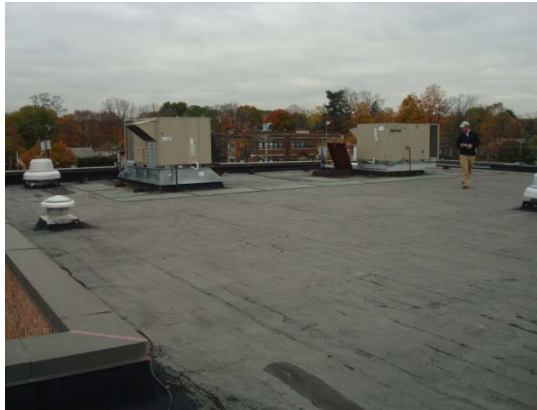
The Fire House has a flat roof that has a dark grey surface consisting of built-up roofing. The roof is supported by steel I-beams and no insulation. The roof, which is believed to be original to the building, is in deteriorating condition and shows signs of water damage. It was observed that there are several structurally weak spots on the roof.

Built-up roofing

The Fire House has a flat roof that has a dark grey surface consisting of built-up roofing. The roof is supported by steel I-beams and no insulation. The roof is in deteriorating condition and shows signs of water damage. It was observed that there are several structurally weak spots on the roof. The roof is believed to be original to the building and will need to be replaced soon.

SWA has determined that the roof has reached the end of its useful life and should be replaced in order to form a proper ceiling at the top of the building. Replacing the roof will prevent future water leaks as well as provide the opportunity for insulation to be added in order to keep warm air from rising directly out of the building. Roof replacements do not typically have a positive return on investment due to the high installation cost but should be incorporated into a capital improvement plan.

- Maintain roofs - SWA recommends regular maintenance to verify water is draining correctly.
- Maintain downspouts - Repair / install missing / disconnected / damaged downspouts as needed to prevent water / moisture infiltration and insulation damage.

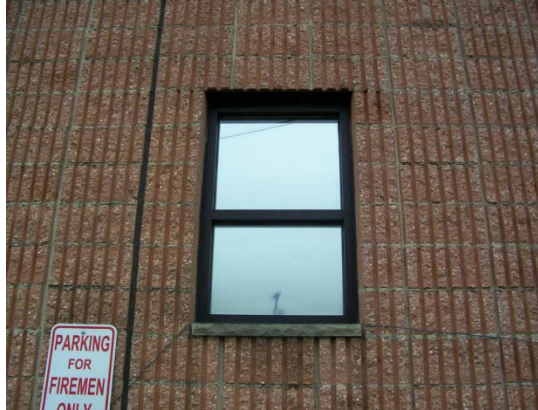
The windows are mostly double-hung operable windows with aluminum frames and double glass panes. The three windows in the conference hall are awning-type operable windows with fixed lights above. The windows are in fair condition, although some of the weather-stripping is in deteriorating condition. The expense of installing new windows would not be cost-effective, especially considering the limited occupancy of the building.

Typical Fire House Window

As a best practice, SWA recommends that all windows be inspected at least once a year. Any gaps, cracks, or damage to weather-stripping or caulking should be repaired or replaced, as needed, to minimize energy loss around those openings. Building staff should also verify that windows open and close properly and repair, as needed.
