**Local Government Energy Program
Energy audit report**

***Hamilton Board of Education
Klockner Elementary School
Hamilton, NJ 08610***

Project Number: LGEA01

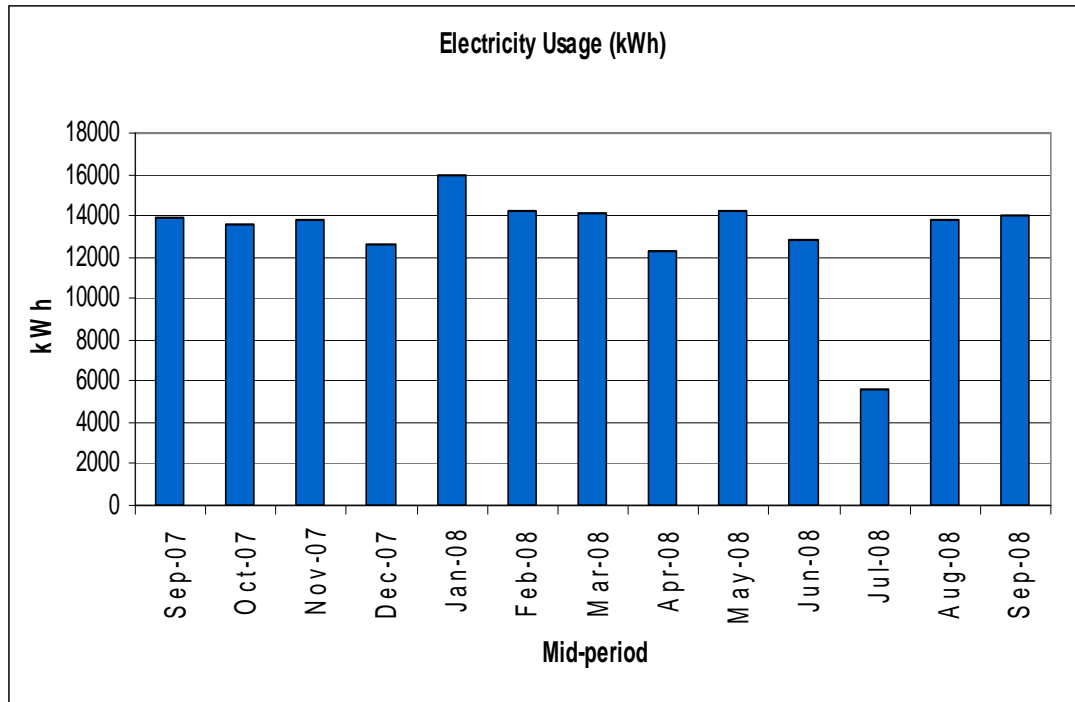
The following chart shows electricity usage for the Klockner Elementary School based on utility bills for the year 2008.

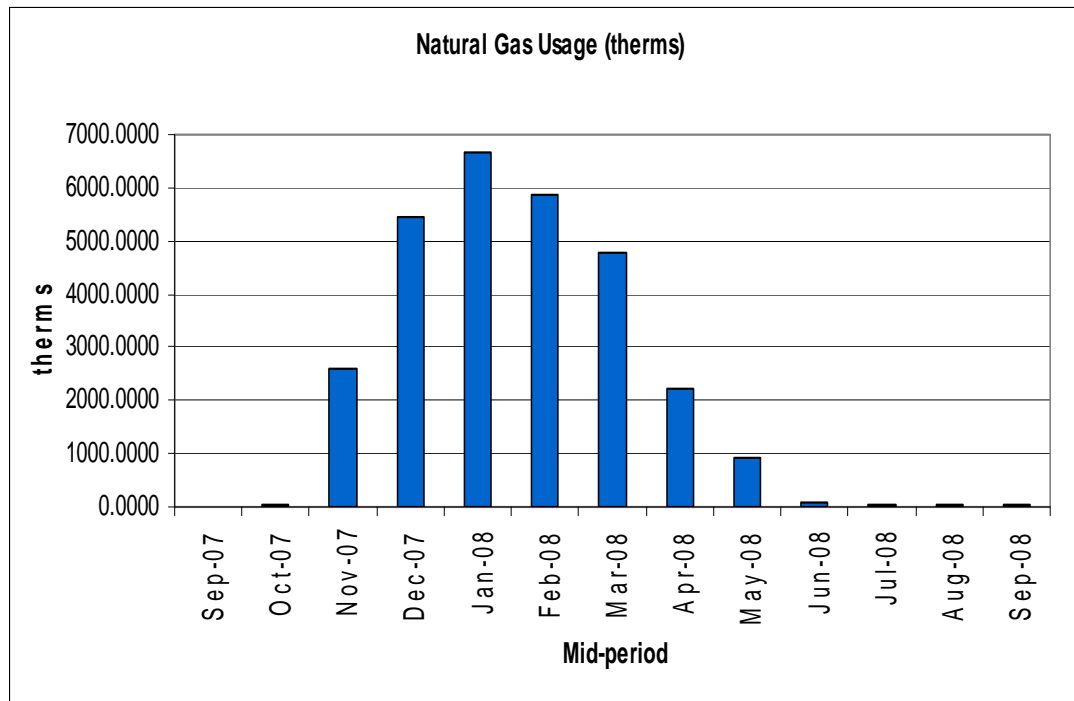
The following chart shows the natural gas usage for Klockner Elementary School base on utility bills for the year September 2007 to September 2008.

In the above chart, the natural gas usage follows a heating trend as expected. During the summer it is clear that the natural gas usage is very minimal which reflects that heat is not being used and the DHW load is minimal.

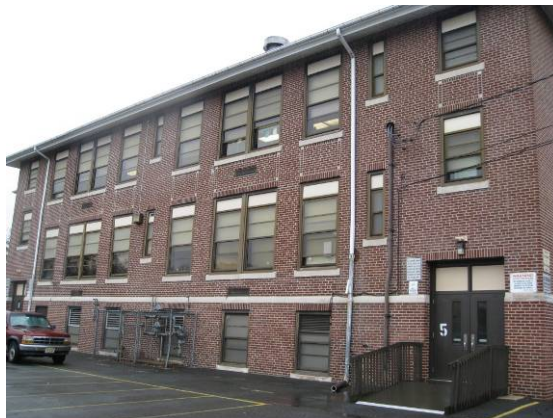
The exterior walls of both buildings consist of concrete masonry unit structure with a medium red face brick exterior facade. There is no evidence of any insulation in the exterior walls and maintenance staff could not recall ever seeing any wall insulation.

Brick exterior on back of school

Adding insulation to this type of wall construction is difficult and not cost effective. If any portion of the building is renovated or improved as part of a capital improvement plan, it may be possible to installation on the interior side of the walls during construction.

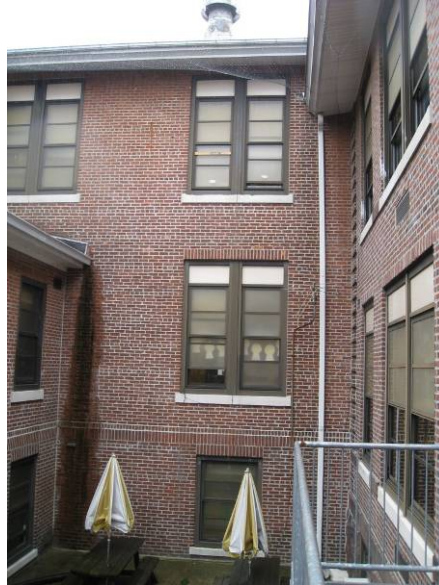
The windows at the Klockner School are an atypical application. Rather than a standard window/storm window installation, there are two completely separate single-hung, single glazed windows, each in its own aluminum frame within the same window opening. The two windows are separated by approximately 2.5 inches of space. It was unclear to SWA whether the additional glazing units had been installed to improve comfort, security, aesthetics, or energy-efficiency. Overall, the windows appear to be in very good condition.

In a standard dual glazed window, the air trapped between the panes of glass provides much of the insulating value. In this system, with two completely separate window installations separated by several inches of space, it is difficult to assess the energy performance of the assembly as a whole. Temperature measurements taken in the field did show, however, that the interior surfaces of the windows were between 18 and 21 degrees colder than the ambient temperature of the classroom.

Klockner Windows at Courtyard

SWA recommends that both of the window installations be carefully inspected and any loose or deteriorated weather-stripping be replaced. The perimeter of both window frames should be completely caulked and sealed. Given the configuration, it may be necessary to seal the interior side of the interior unit and the exterior side of the exterior unit, taking care not to seal the weep holes. Although SWA is not aware of the decision-making rationale behind the selection of this installation, it may not provide anticipated energy savings but will likely require additional maintenance to prevent air leakage and condensation problems.

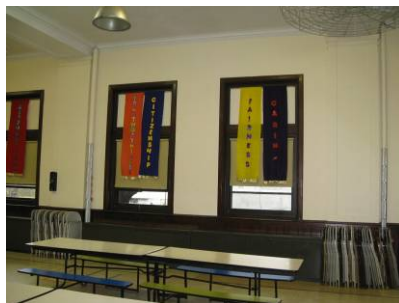
Although natural day lighting has been shown to improve occupant health, solar heat gain and glare from older glazing often negatively impact activities and comfort within the space. During the time of our visit (spring break week) shades were half drawn throughout the school. To understand the comfort concerns and identify those classrooms with the most significant problems, building staff can conduct an occupant survey. For problem areas, it may be beneficial to install tinted glazing or a window film to reduce the glare and solar heat gains. This recommendation will not provide energy savings but may improve occupant comfort.

Multipurpose room with shades drawn

SWA recommends taking advantage of lighting on different switches and use only lighting needed in classrooms.

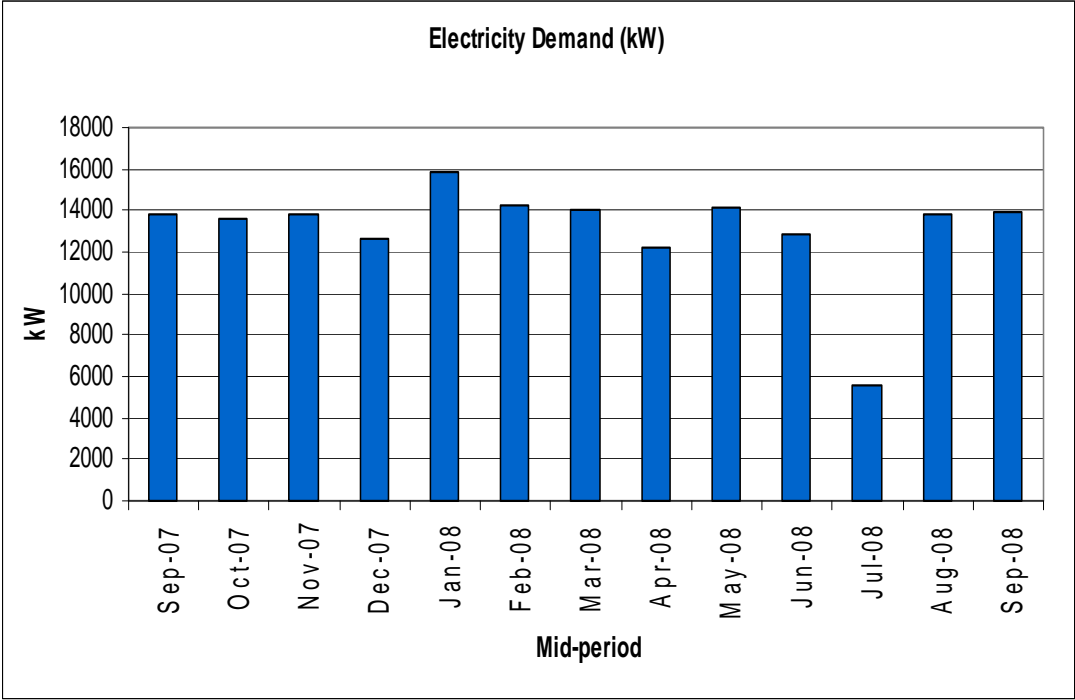
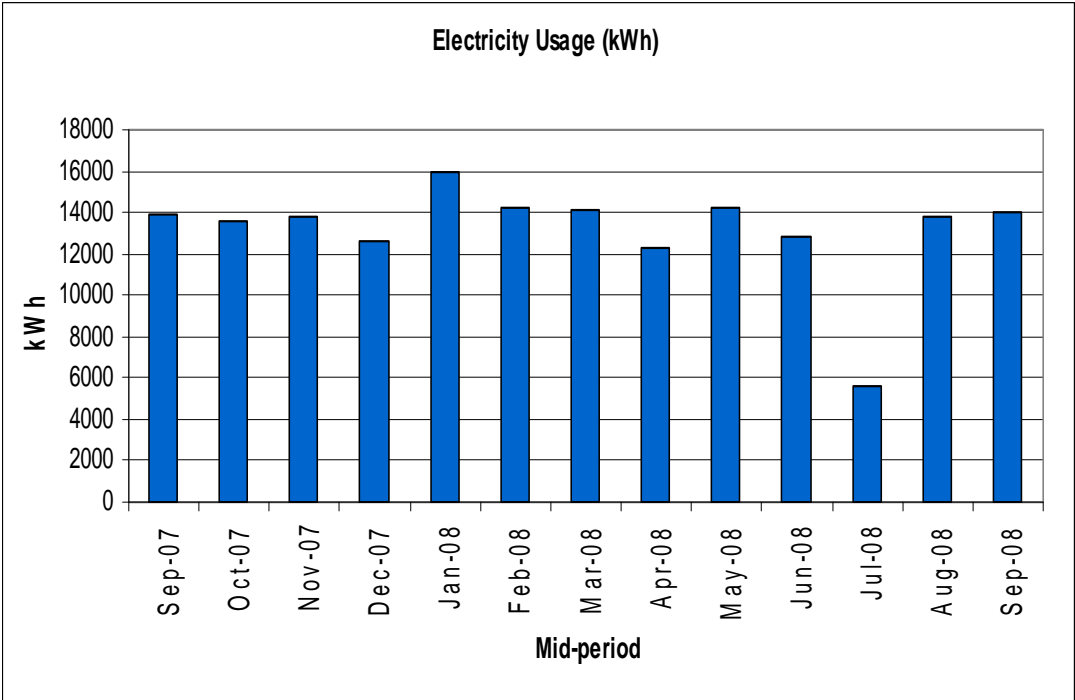
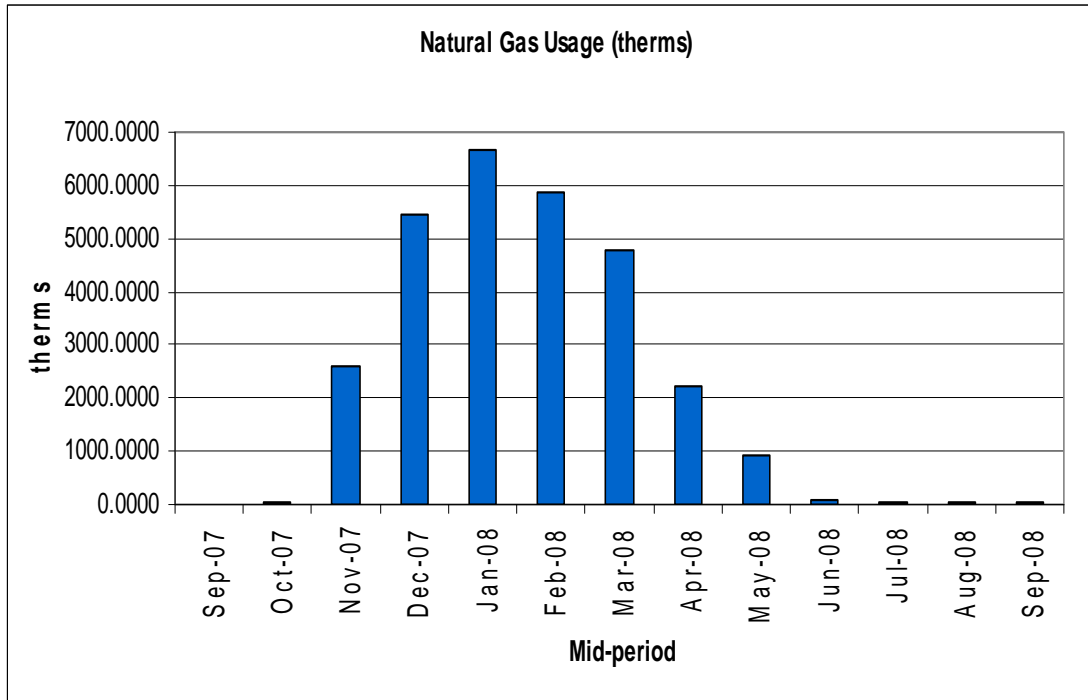
The average electrical peak demand for the previous year was 66.1 kW and the maximum peak demand was 74.3 kW. The electric and gas load profiles for this project are presented in the following charts. The first chart shows electric demand (in kW) for the previous 12 months and the other two charts show electric and gas usage (in kWh), respectively.
