**Local Government Energy Program
Energy audit report**

***Hamilton Board of Education
Lalor Elementary School
Hamilton, NJ 08610***

Project Number: LGEA01

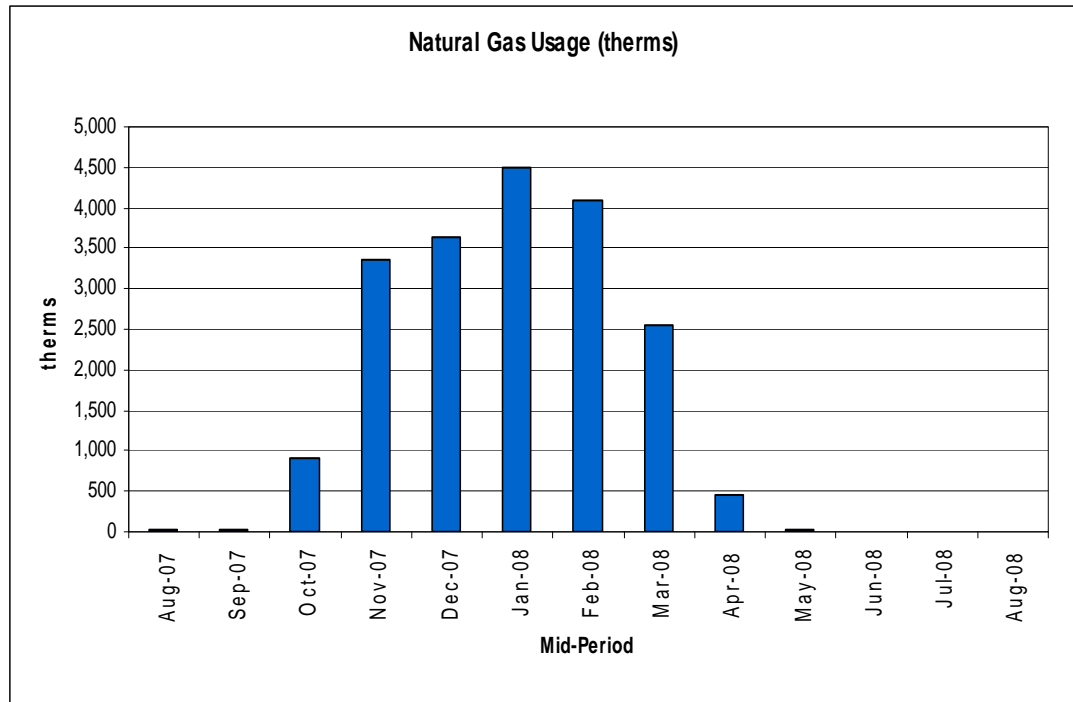
The following chart shows the natural gas usage for the school based on utility bills for the year September 2007 to September 2008.

In the above chart, the natural gas usage follows a heating trend as expected. During the summer it is clear that the natural gas usage is very minimal which reflects that heat is not being used and the DHW load is minimal.

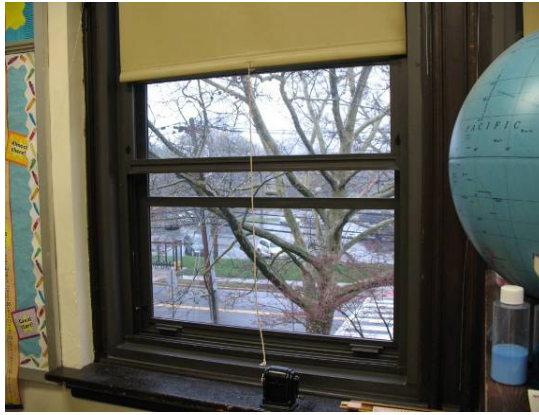
All of the windows in the building are single-pane, metal framed windows with plexi-glass inserts for child safety. These windows have a poor insulating quality and allow heat to transfer out of the building during the heating season and allow heat to transfer in during the cooling season. In addition to the windows being poorly insulated, many of the windows were noticed to be poorly sealed to the envelope of the building and daylight could be seen around the frame of the window. Below is a picture showing a typical window for Lalor Elementary School.

Typical classroom window

- Window Replacement – Some of the buildings in the school district have already undergone upgrades to the windows. In the past, the existing window frames have been maintained and only new glazing was installed. Since the existing window units typically contain only single pane glazing and have metal frames, this upgrade typically offers little energy savings during the heating season. Since the buildings do not have central air conditioning, there are no cost savings associated with windows during the summer months. While window replacement may provide comfort and safety benefits, SWA does not recommend this as a high priority investment with respect to energy efficiency.

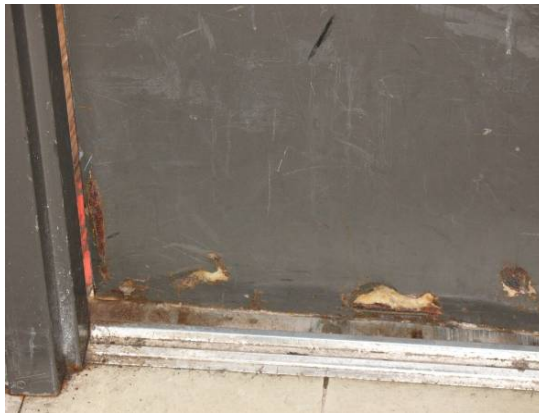
The entranceways for Lalor Elementary School consist of a mix of insulated and un-insulated metal doors. A majority of these doors are poor insulators and allow conditioned air to leak out of the building. These doors consist of metal frames as well as metal doors. The doors were observed to be missing weather-stripping so that they did not seal well to the frames. In many cases, the frame assembly was not sealed well to the building and gaps were left between the masonry and the door frame. Areas where there were large gaps between the masonry and door frame were observed to be stuffed with compressed insulation that has a compromised insulation value. SWA recommends air sealing around all of the doors and windows in the office portion of the building in order to prevent conditioned air from leaking outside of the building.

Exterior door needing replacement

- Weather Stripping/Air Sealing - SWA observed that exterior door weather-stripping was beginning to deteriorate. Doors and vestibules should be observed annually for deficient weather-stripping and replaced as needed. The perimeter of all window frames should also be regularly inspected and any missing or deteriorated caulking should be re-caulked to provide an unbroken seal around the window frame. Any other accessible gaps or penetrations in the thermal envelope penetrations should also be sealed with caulk or spray foam.

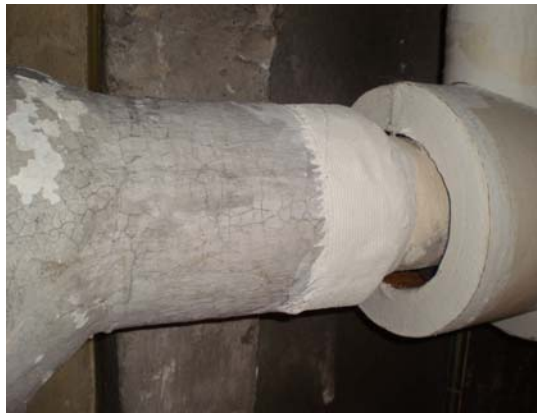
Asbestos insulation on piping

Asbestos was observed on the piping and equipment in the mechanical room. Although this assessment focuses on energy-efficiency, the health and safety concerns associated with asbestos should be noted. Asbestos abatement is primarily a safety issue and is not directly associated with a cost payback. However, the existence of asbestos very often impacts the ability of building operators to perform routine maintenance procedures without undertaking appropriate safety measures and incurring associated costs.

Any asbestos-like-material should be removed from the premises before energy efficient upgrades are conducted, such as air sealing or adding insulation, which may have an effect on air quality within the building.

students and staff, SWA recommends that asbestos abatement be addressed prior to undertaking any other significant investments in capital improvements.

- Asbestos Abatement – As noted previously, asbestos was observed in the buildings and is considered a health and safety hazard. In addition, the existence of asbestos impacts the ability of the building operations staff to conduct routine maintenance without incurring additional costs associated with proper safety measures. Regardless of the recommendations adopted to upgrade the energy-efficiency of the facility, SWA recommends abatement as the first priority.

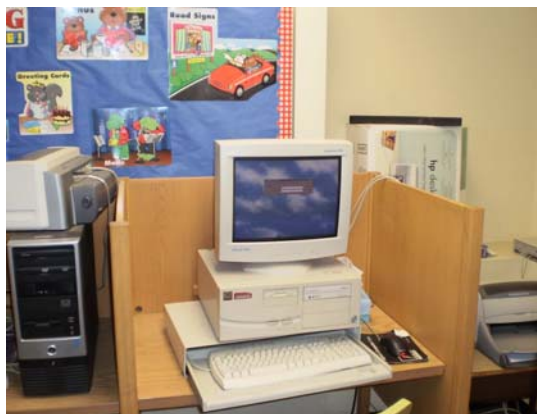
Computers left on in classrooms consume a lot of energy. A typical desk top computer uses 65 to 250 watts and uses the same amount of energy when the screen saver is left on. Televisions in classrooms use approximately 3-5 watts of electricity when turned off. SWA recommends all computers and all classrooms appliances (i.e. fridges, coffee makers, televisions, etc.) be plugged in to power strips and turned off each evening just as the lights are turned off. There were at least 5 computers left fully on when the building was audited during spring break week.

Computer left on during spring break week

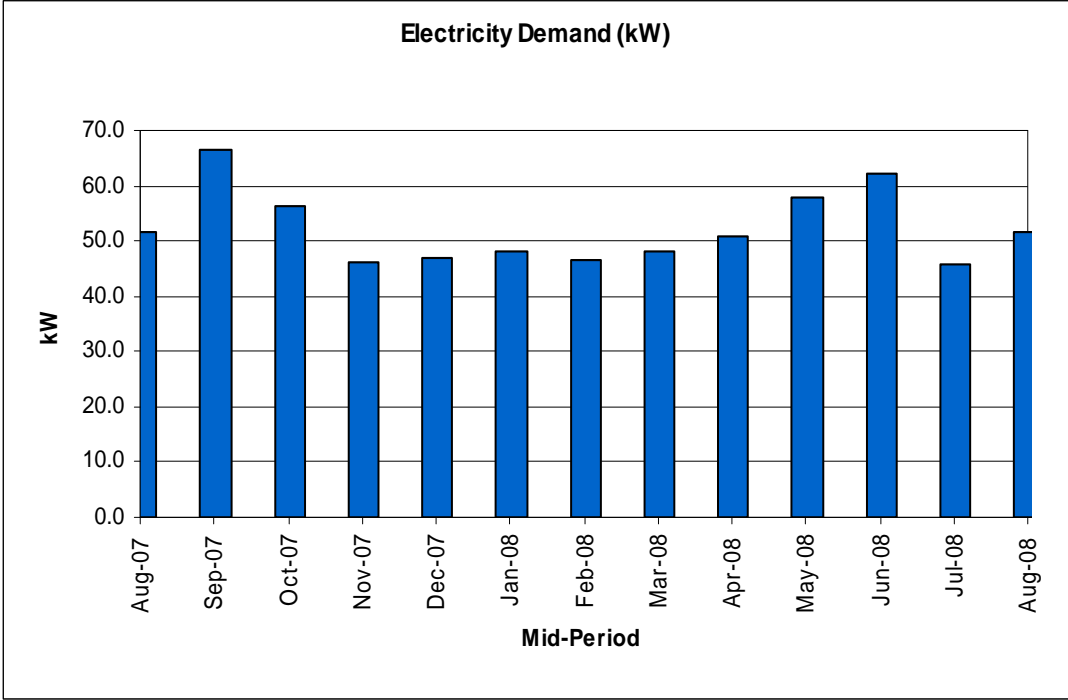
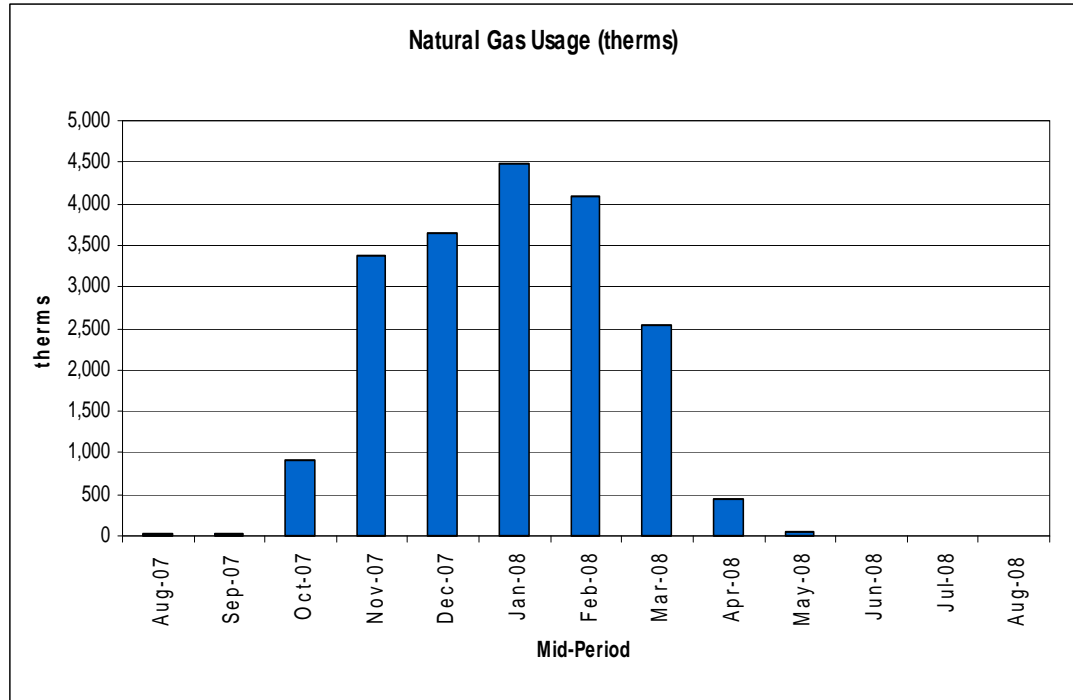
The average electrical peak demand for the previous year was 52.2 kW and the maximum peak demand was 66.6 kW. The electric and gas load profiles for this project are presented in the following charts. The first chart shows electric demand (in kW) for the previous 12 months and the other two charts show electric and gas usage (in kWh), respectively.
