**Local Government Energy Program
Energy Audit Final Report**

***The Monroe Hall
Township of Hanover
Whippany, NJ 07981***

Project Number: LGEA14

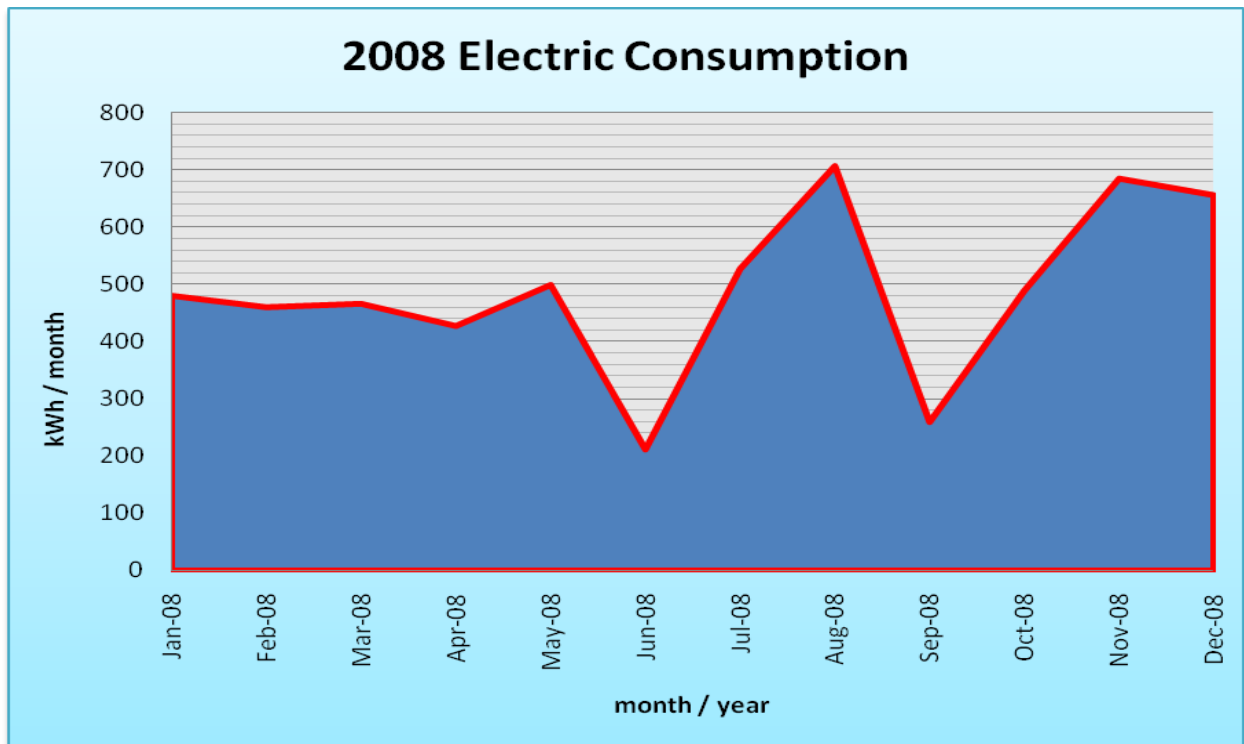
The following chart shows electricity use for the Monroe Hall building based on utility bills for the 12 month period of January 2008 - December 2008: electric blower use for heating in the winter and air conditioning electric use during the summer.

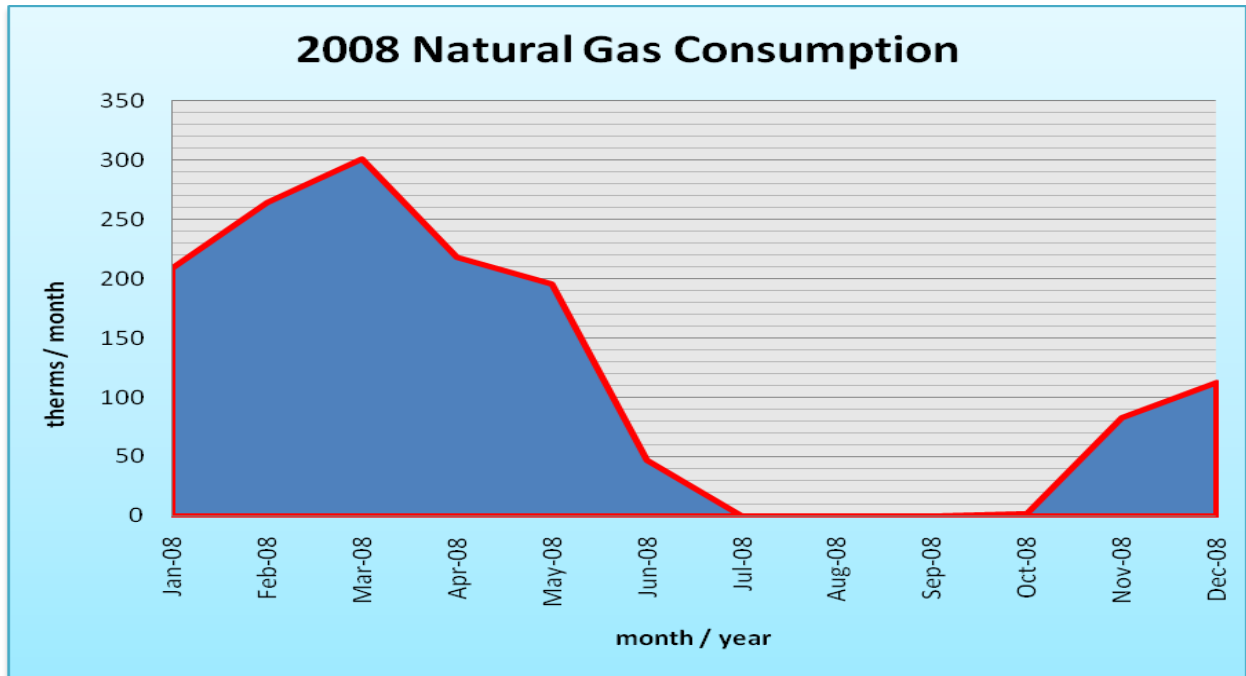
The following chart shows the natural gas consumption for the Monroe Hall building, based on utility bills for the 12 month period of January 2008 - December 2008.

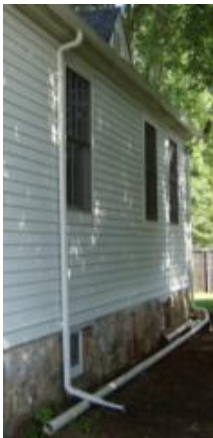
Gutter Extension should be directed away from Exterior Walls

- Prevent efflorescence and mold growth - SWA recommends re-grading the perimeter of the building as much as possible to generate a slope away from the basement walls in addition to leading any down spouts away from the same wall at least 4 feet. In a second step SWA recommends an impermeable sealer to be applied to the inside walls and slab where possible.

- Prevent efflorescence and mold growth - SWA recommends re-grading the perimeter of the building as much as possible to generate a slope away from the basement walls in addition to leading any down spouts away from the same wall at least 4 feet. In a second step SWA recommends an impermeable sealer to be applied to the inside walls and slab where possible. Since it appears that there is a small office in the basement, SWA recommends that once walls are sealed more wall insulation be provided to the area.

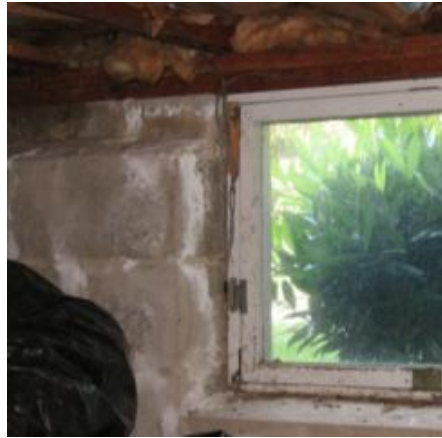
The exterior walls consist of (painted) wood clapboards. SWA was told by Township of Hanover maintenance that the exterior walls are poorly or non-insulated. Most basement walls appeared to be in poor condition. Moisture penetration from the outside is apparent, through the original brick and mortar stem walls and the window frames. As a first and cost effective measure, SWA recommends re-grading the perimeter of the building as much as possible to generate a slope away from the basement walls in addition to leading any down spouts away from the same wall at least 4 feet. In a second step SWA recommends an impermeable sealer to be applied to the inside walls and slab where possible. In areas where the brick foundation walls show excessive deterioration, CMU blocks should be used for replacement as already done in some areas.

Signs of Water Penetration on Updated Foundation Walls

- Maintain foundation walls - In areas where the brick foundation walls show excessive deterioration, CMU blocks should be used for replacement
- Water Efficient Fixtures & Controls - Retrofitting with more efficient water-consumption fixtures / appliances will save both energy and money through reduced energy consumption for water heating, while also decreasing water / sewer bills.

- Maintain foundation walls - In areas where the brick foundation walls show excessive deterioration, CMU blocks should be used for replacement
- Water Efficient Fixtures & Controls - Adding controlled on / off timers on all lavatory faucets is a cost-effective way to reduce domestic hot water demand and save water. Building staff can also easily install faucet aerators and / or low-flow fixtures to reduce water consumption. There are many retrofit options, which can be installed now or incorporated as equipment is replaced. Routine maintenance practices that identify and quickly address water leaks are a low-cost way to save water and energy. Retrofitting with more efficient water-consumption fixtures / appliances will save both energy and money through reduced energy consumption for water heating, while also decreasing water / sewer bills.

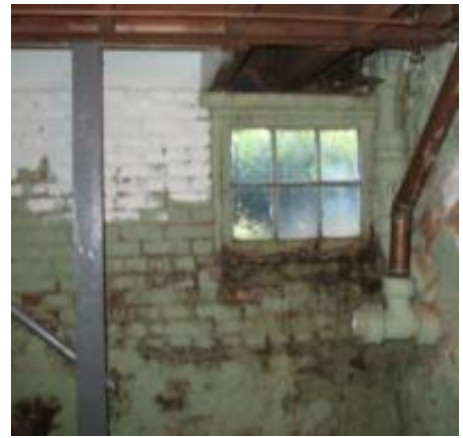
Signs of Water Penetration on Original Foundation Walls

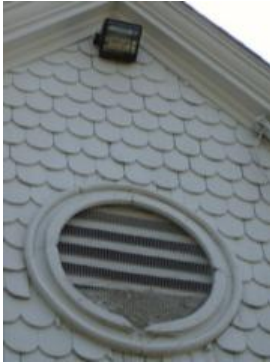
Gable End Louvered Vent were found to be either partially clogged or closed at the time of the field visit

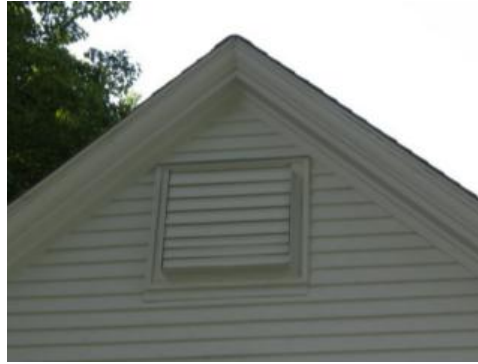
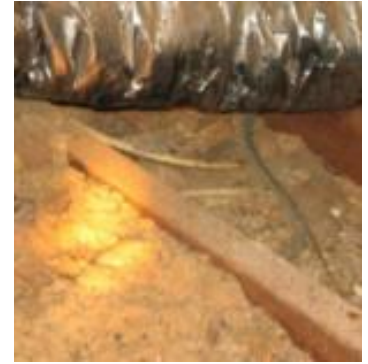
The recently replace asphalt shingle roof seems to be in good condition. Insulation on the attic floor was found to be inadequate, outdated insulation material with signs of infiltration from below and sagging ceiling tiles. SWA recommends replacing the current attic insulation with a blown-in type to reflect current minimum code requirements ideally at the same time when dealing with the asbestos flue insulation as mentioned below. SWA does not recommend installing an active gable end fan but rather reconditioning the existing passive gable end louver vents for appropriate attic ventilation. With reconditioning of the gable vents and existing ridge vents, the ventilation will be sufficient for the building. As mentioned under 2.3.1 Exterior Walls, a separate envelope inspection should be conducted during cooler months. SWA suggests basing further insulation related improvement discussions on the outcome of those future findings.

Outdated, Compacted and un-uniform Attic Insulation

- Building Envelope Insulation - The existing building is poorly insulated based on age and practice of construction when it was built in 1890 and follow-up renovations. An opportunity to install adequate insulation could be at the time that asbestos abatement (in the tiles and abandoned flue stack) will occur. Building windows have already been upgraded to double pane low-E type. This recommendation cannot be cost justified by energy savings alone. However, the age and condition of the building warrant attention and this recommendation is intended to provide guidance to help the building management staff prioritize upgrades within the facility. The existing sparse insulation is inadequate relative to newer technology, and based on discussions with building staff. SWA recommends installing the highest energy insulation systems available and that can be reasonably installed in ceilings and outside walls. SWA recommends adding blown-in cellulose over the current attic insulation to reflect current minimum code requirements, ideally right after dealing with the asbestos flue insulation.

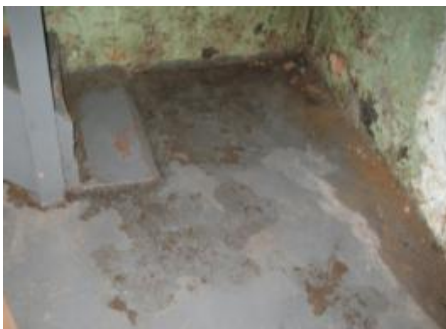
The building's base seems to be a 4" concrete slab in the basement with a perimeter original brick and mortar footing. As mentioned in 2.3.1, a coating of concrete sealer is recommended to eliminate moisture penetration through the slab surface into the basement. Also, the main floor should be inspected and fiberglass insulation (R-19) added between the floor joists or replaced where missing / defective.

Water Penetrating from Basement Slab

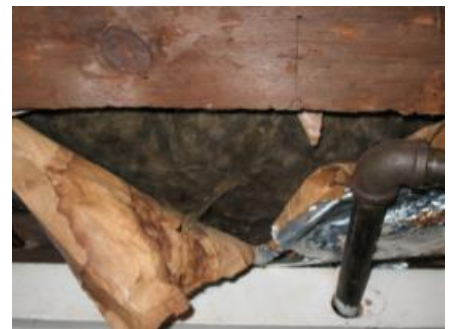
Defective Fiberglass Insulation under Main Floor

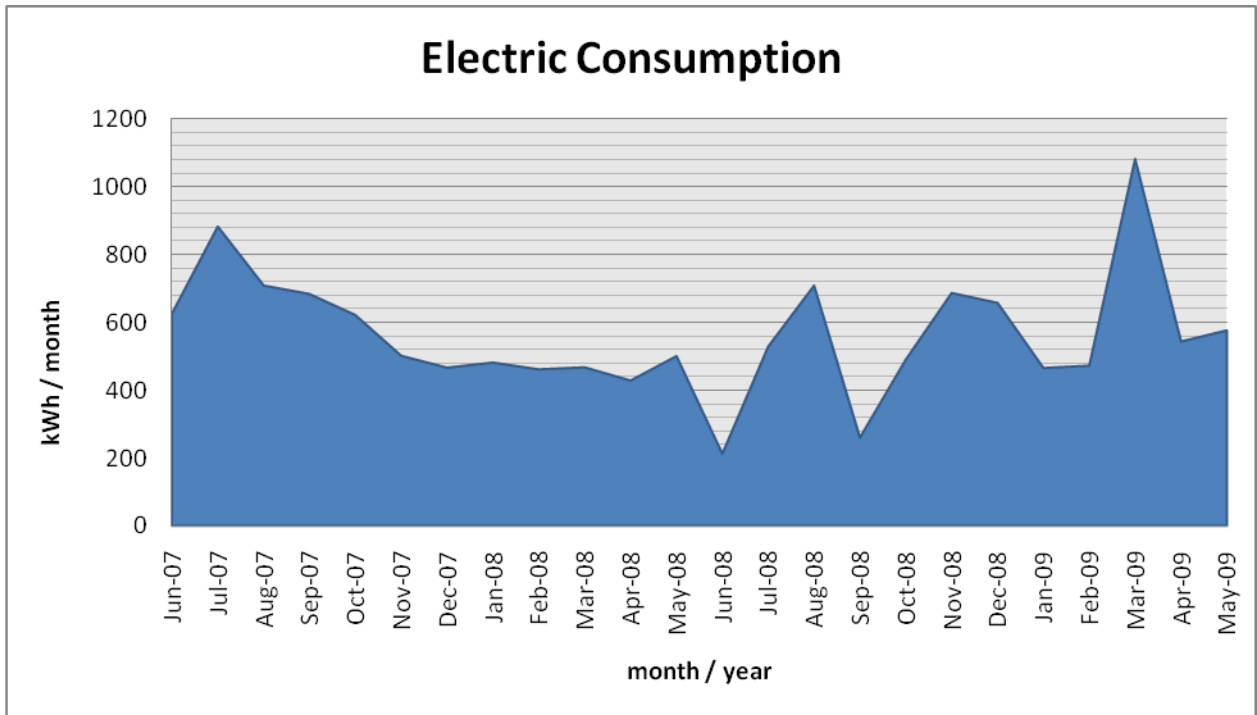
The following are charts that show the annual electric and natural gas load profiles for the Monroe Hall building.

The unusual electric fluctuations shown in Jul 08, Sept 08 and Mar 09 may be due to adjustments between estimated and actual meter readings.

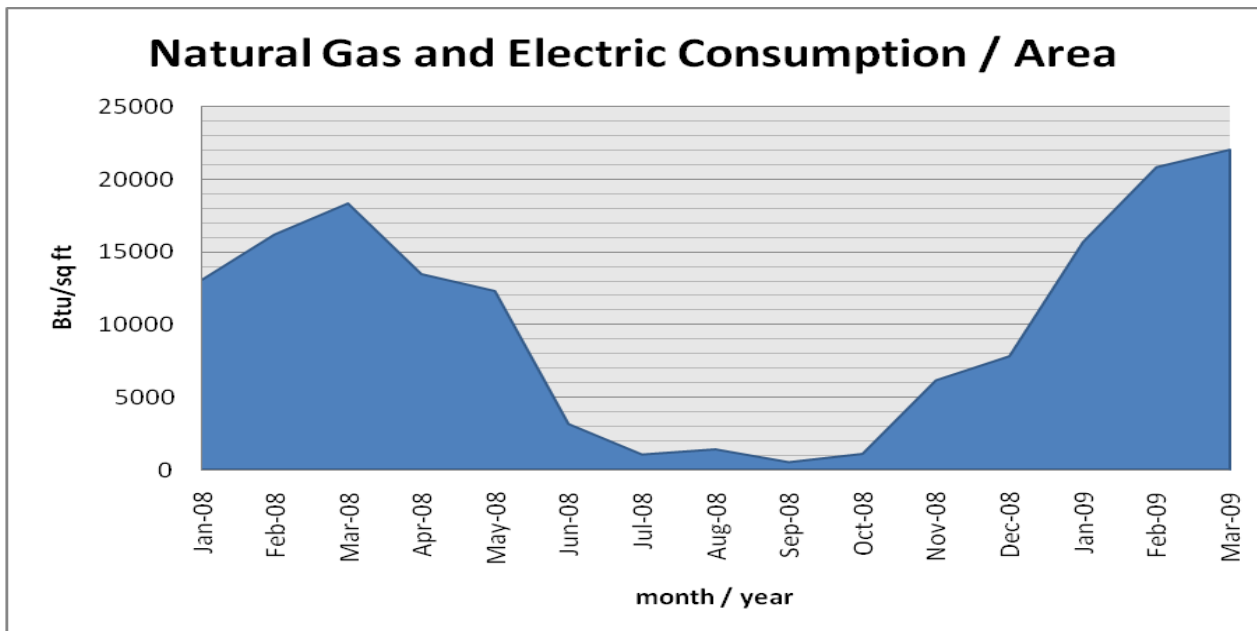
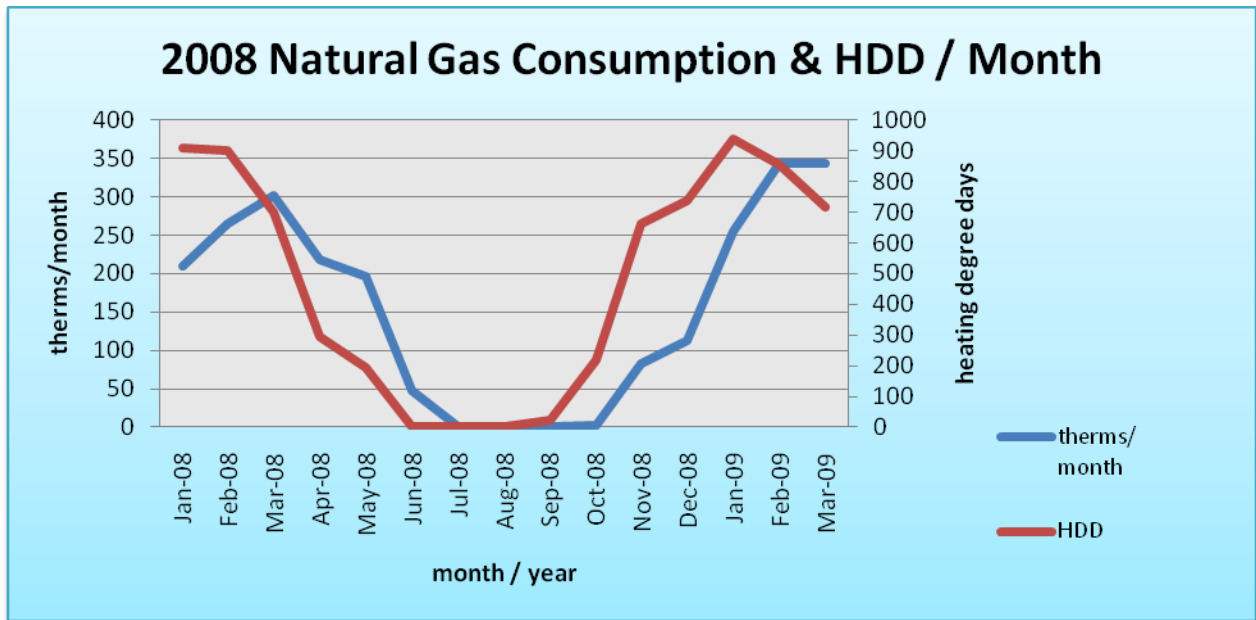
The following are charts of the natural gas and electric consumption per sq ft and natural gas annual load profile for the building, peaking in the coldest months of the year and a chart showing gas consumption mimicking the “heating degree days” curve.
