January 20, 2010

**Local Government Energy Program
Energy Audit Final Report**

***The Monroe Hall
Township of Hanover
Whippany, NJ 07981***

Project Number: LGEA14

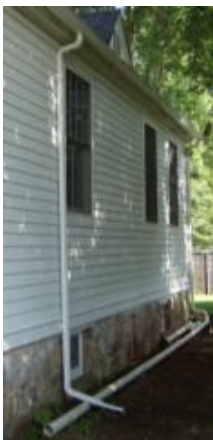
Gutter Extension should be directed away from Exterior Walls

- Prevent efflorescence and mold growth - SWA recommends re-grading the perimeter of the building as much as possible to generate a slope away from the basement walls in addition to leading any down spouts away from the same wall at least 4 feet. In a second step SWA recommends an impermeable sealer to be applied to the inside walls and slab where possible. Since it appears that there is a small office in the basement, SWA recommends that once walls are sealed more wall insulation be provided to the area.

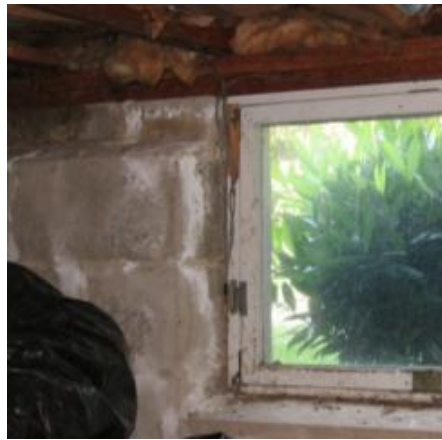
The exterior walls consist of (painted) wood clapboards. SWA was told by Township of Hanover maintenance that the exterior walls are poorly or non-insulated. Most basement walls appeared to be in poor condition. Moisture penetration from the outside is apparent, through the original brick and mortar stem walls and the window frames. As a first and cost effective measure, SWA recommends re-grading the perimeter of the building as much as possible to generate a slope away from the basement walls in addition to leading any down spouts away from the same wall at least 4 feet. In a second step SWA recommends an impermeable sealer to be applied to the inside walls and slab where possible. In areas where the brick foundation walls show excessive deterioration, CMU blocks should be used for replacement as already done in some areas.

Signs of Water Penetration on Updated Foundation Walls

- Maintain foundation walls - In areas where the brick foundation walls show excessive deterioration, CMU blocks should be used for replacement
- Water Efficient Fixtures & Controls - Adding controlled on / off timers on all lavatory faucets is a cost-effective way to reduce domestic hot water demand and save water. Building staff can also easily install faucet aerators and / or low-flow fixtures to reduce water consumption. There are many retrofit options, which can be installed now or incorporated as equipment is replaced. Routine maintenance practices that identify and quickly address water leaks are a low-cost way to save water and energy. Retrofitting with more efficient water-consumption fixtures / appliances will save both energy and money through reduced energy consumption for water heating, while also decreasing water / sewer bills.

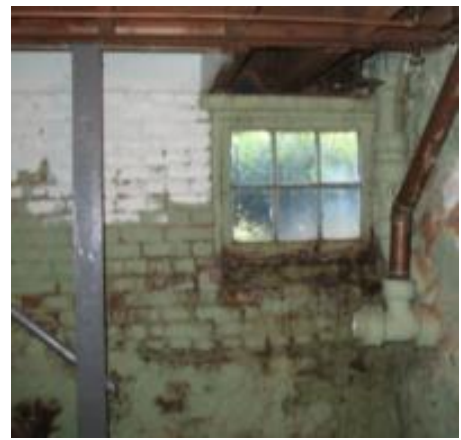
Signs of Water Penetration on Original Foundation Walls

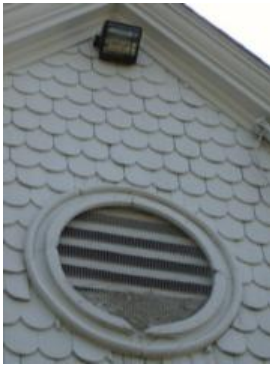
Gable End Louvered Vent were found to be either partially clogged or closed at the time of the field visit

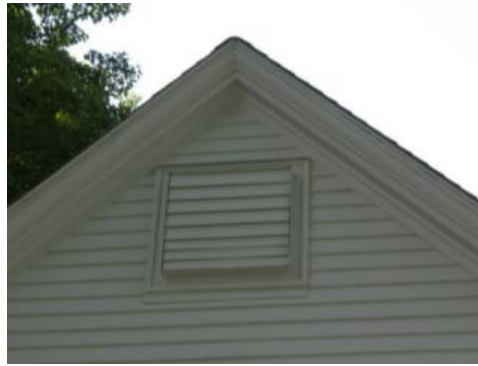
The recently replace asphalt shingle roof seems to be in good condition. Insulation on the attic floor was found to be inadequate, outdated insulation material with signs of infiltration from below and sagging ceiling tiles. SWA recommends replacing the current attic insulation with a blown-in type to reflect current minimum code requirements ideally at the same time when dealing with the asbestos flue insulation as mentioned below. SWA does not recommend installing an active gable end fan but rather reconditioning the existing passive gable end louver vents for appropriate attic ventilation. With reconditioning of the gable vents and existing ridge vents, the ventilation will be sufficient for the building. As mentioned under 2.3.1 Exterior Walls, a separate envelope inspection should be conducted during cooler months. SWA suggests basing further insulation related improvement discussions on the outcome of those future findings.

Outdated, Compacted and un-uniform Attic Insulation

- Building Envelope Insulation - The existing building is poorly insulated based on age and practice of construction when it was built in 1890 and follow-up renovations. An opportunity to install adequate insulation could be at the time that asbestos abatement (in the tiles and abandoned flue stack) will occur. Building windows have already been upgraded to double pane low-E type. This recommendation cannot be cost justified by energy savings alone. However, the age and condition of the building warrant attention and this recommendation is intended to provide guidance to help the building management staff prioritize upgrades within the facility. The existing sparse insulation is inadequate relative to newer technology, and based on discussions with building staff. SWA recommends installing the highest energy insulation systems available and that can be reasonably installed in ceilings and outside walls. SWA recommends adding blown-in cellulose over the current attic insulation to reflect current minimum code requirements, ideally right after dealing with the asbestos flue insulation.

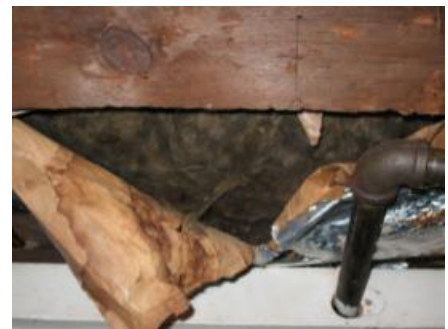
The building's base seems to be a 4" concrete slab in the basement with a perimeter original brick and mortar footing. As mentioned in 2.3.1, a coating of concrete sealer is recommended to eliminate moisture penetration through the slab surface into the basement. Also, the main floor should be inspected and fiberglass insulation (R-19) added between the floor joists or replaced where missing / defective.

Defective Fiberglass Insulation under Main Floor
