**Local Government Energy Program
Energy Audit Final Report**

***The Municipal Athletic Complex & Snack Bar
Township of Hopewell
Titusville, NJ 08560***

Project Number: LGEA16

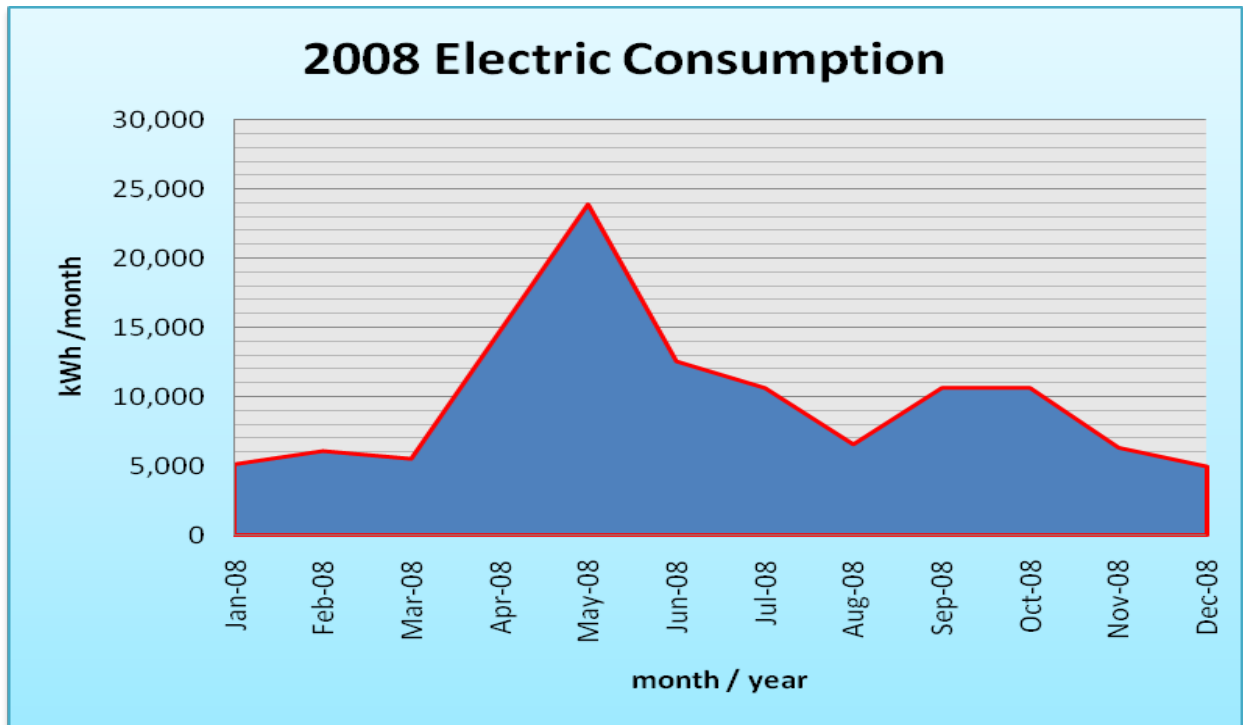
The following chart shows electricity use for the Athletic Complex & Snack Bar building based on utility bills for the 12 month period of 2008. The annual electric use is 402 MM-Btus.

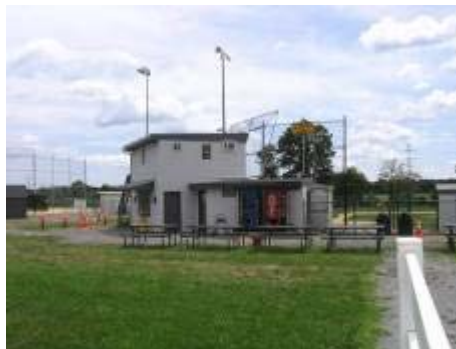
The exterior walls consist of un-insulated 8” CMU blocks. As the building is only operated seasonally, it is not cost effective to add insulation. Regular maintenance should be performed on the exterior walls to maintain appropriate conditions.

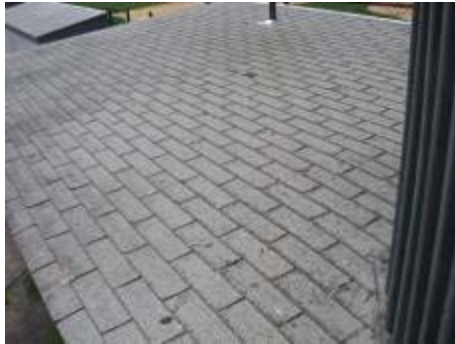
The sloped roof areas with medium gray colored asphalt shingles appeared to be in poor condition. At the time of the audit the 2nd level could not be accessed and there are no drawings on record for this building. SWA suspects no roof insulation. Due to the current occupancy uses for the building, SWA does not have additional recommendations for adding insulation. SWA recommends the roof be replaced as signs of wear and tear increase with age.

- Roof Replacement - The Snack Bar building sloped roof areas with medium gray colored asphalt shingles appear to be in poor condition due to age. SWA recommends that the Township of Hopewell put in its capital spending plans this roof with insulation for replacement.

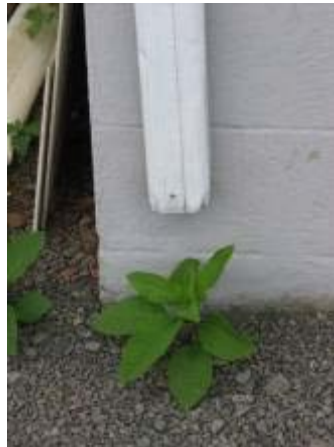
The building's base could not be verified due to a lack of building drawings. SWA suspects there is no slab or perimeter insulation. The slab edge or perimeter insulation could not be verified and should be confirmed at the time of an insulation inspection during cooler months for usable infrared data evaluation. SWA recommends extending the gutter downspouts two feet or more from the building. Currently rain run-off is deposited around the perimeter of the building, settling near the foundation of the building. This may result in future foundation issues.

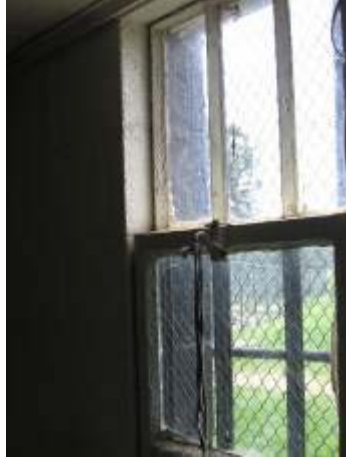
The windows at the Athletic Complex Snack Bar are single pane, wood framed windows. If increased use for the building changes, SWA recommends replacement with double paned, low-e rated windows.

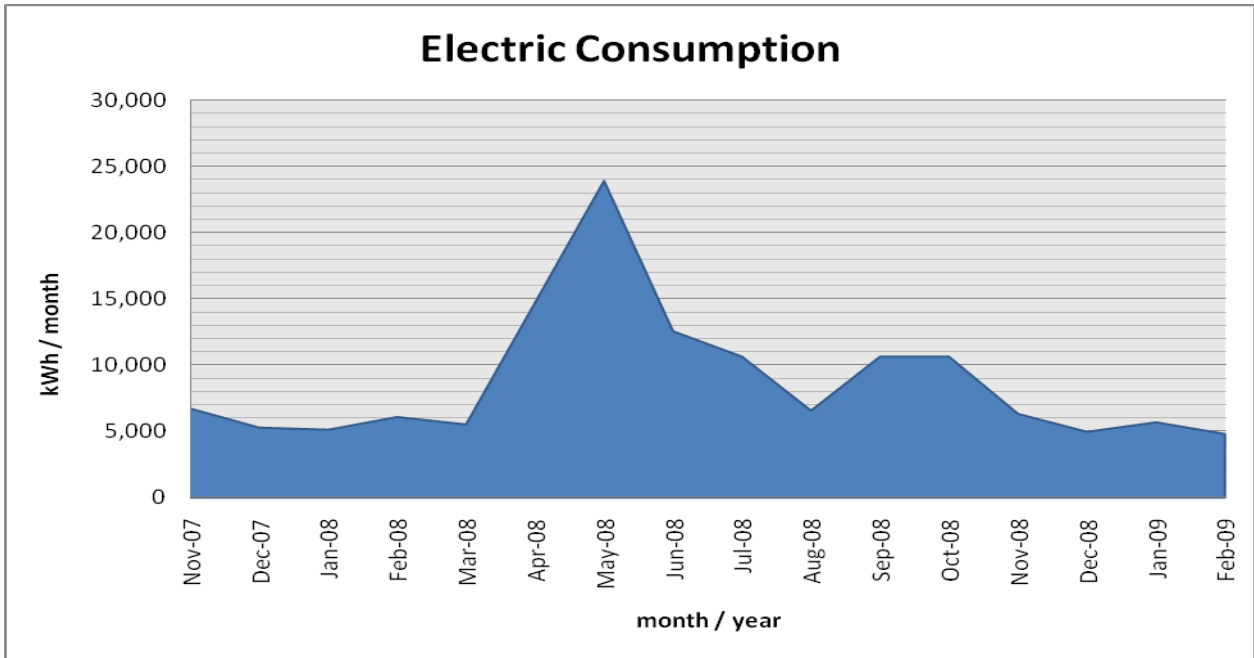
The following are charts that show the annual electric load profiles for the Athletic Complex & Snack Bar building.

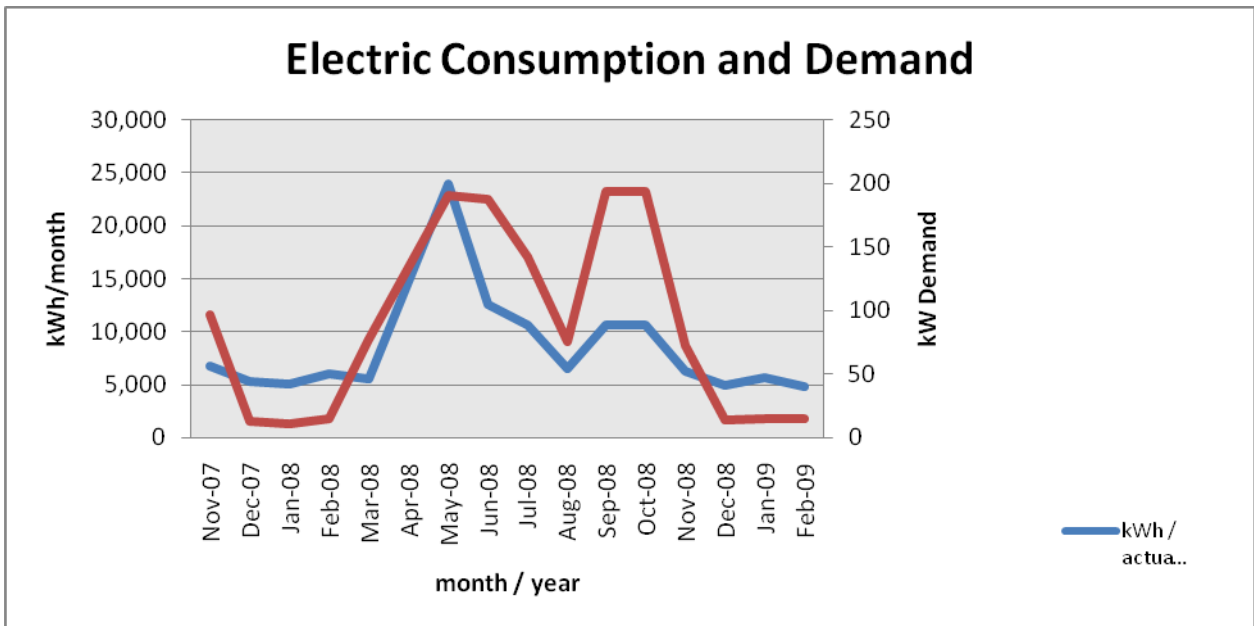
Also, note on the following chart how the electrical Demand peaks follow the electrical consumption peaks.

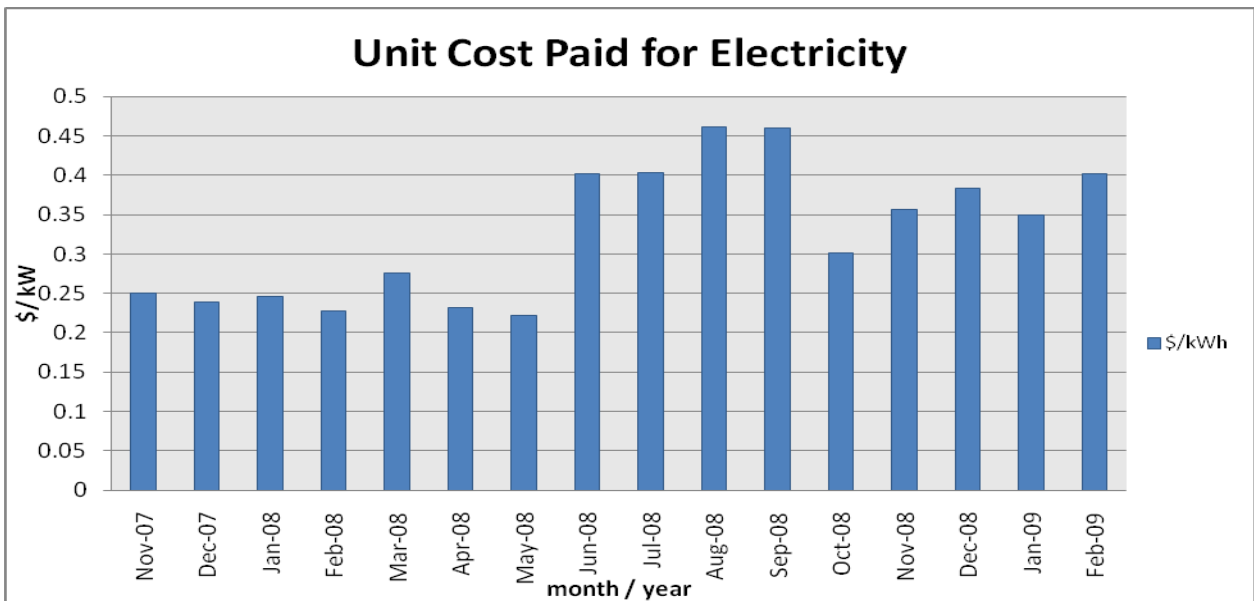
The Athletic Complex & Snack Bar does not have natural gas service. Electricity is purchased directly for the Athletic Complex & Snack Bar from PSE&G without an ESCO. There isn't an ESCO engaged in the process. An Energy Services Company (ESCO) is a consultancy group that engages in a performance based contract with a client firm to implement measures which reduce energy consumption and costs in a technically and financially viable manner. SWA analyzed the utility rate for electricity supply over an extended period. Electric bill analysis shows fluctuations in excess of 100% over the 12 month in 2008. Some of these fluctuations may have been caused by adjustments between estimated and actual meter readings, demand, others may be due to unusual high and escalating energy costs in 2008. SWA recommends that the Township of Hopewell further explore opportunities of purchasing electricity from ESCOs in order to reduce rate fluctuation and ultimately reduce the annual cost of energy for the Athletic Complex & Snack Bar. Appendix B contains a complete list of third party energy suppliers for the Township of Hopewell service area. The Township of Hopewell may want to consider partnering with other school districts, municipalities, townships and communities to aggregate a substantial electric use for better leveraging in negotiations with ESCOs and of improving the pricing structures. This sort of activity is happening in many parts of the country and in New Jersey. Also, the Athletic Complex would not be eligible for enrollment in a Demand Response Program, because there isn't the capability at this time to shed a minimum of 100 kW electric demand when requested by the utility during peak demand periods, which is the typical threshold for considering this option. The following charts show the Athletic Complex & Snack Bar monthly \$/kW spending for energy in 2008.
