**Local Government Energy Program  
Energy Audit Final Report**

***Livingston Heritage Middle School  
Livingston, NJ 07039***

***Project Number: LGEA37***

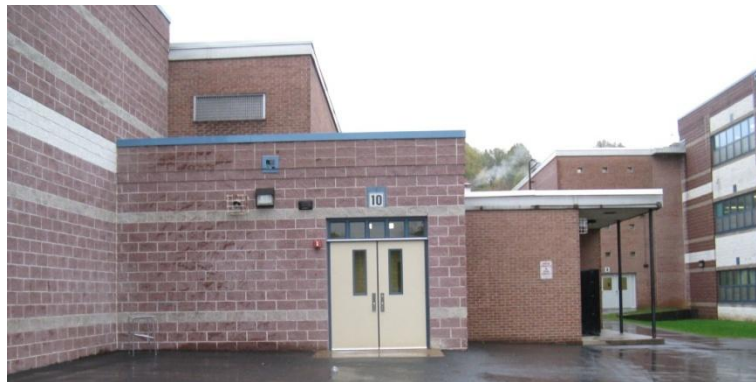
The exterior wall envelope consists of a mixture of 4” brick veneer (original building sections) and split face masonry units (2002 additions). Interior wall finishes are a mix of painted CMU and gypsum wall board. The original building wall assemblies do not contain wall insulation. During the next major construction, SWA recommends insulating the exterior walls of the original structure by adhering 2” polyiso boards (Polyisocyanurate) together with furring strips and gypsum wall boards to the inside of the painted CMU walls.

The 2002 additions of the building wall assemblies contain 2” of rigid insulation between the interior and exterior CMU walls.

*Two types of exterior wall finishes*

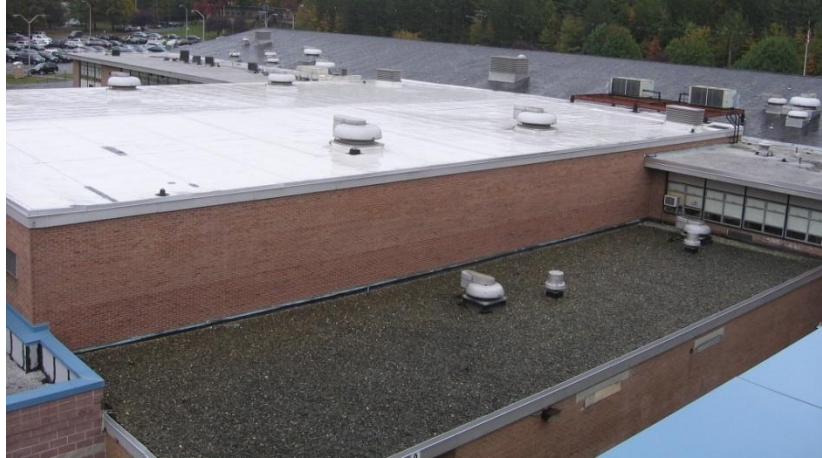
The older gym is covered with a white colored Hypalon roof system. This area is insulated with 1 to 2 inches of tapered insulation. At the time of the audit, maintenance personnel indicated this section is consistently leaking and has required numerous repairs over the years. The built-up roofing systems (installed in 2001 & 2004) over the newest additions has continuous insulation above the deck. Architectural plans exist for these areas, but do not specify a thickness of the insulation. A notes just indicates, “Cold Process Built-Up Roofing System over ‘Uniform’ Insulation (TYP.)”. These roofs are in good condition and no major issues were reported by the maintenance staff. The single-ply EPDM roofing is in poor condition. There weren’t any plans for these sections, and during the site visit, conditions were too warm to gage the condition of insulation via Infrared Technology. Experience with the other schools in the Livingston Public Schools district with similar roofs show these EPDM roofs to have very little and uneven insulation. The pitched light grey asphalt shingle roof sections were replaced in 2004 and appear to be in good condition. Maintenance staff reported problems with leaks around the structure that holds the mechanical equipment that penetrates the shingled portion. 1” faced batt insulation is installed under the pitched portions of the roof. Regular maintenance should be performed on all roof areas to prevent leaks and ensure damaged roof areas, such as the one in the following image, are avoided.

*Image shows 4 different roofing materials*

SWA recommends replacement of the older built-up roof sections with an Energy Star certified roof membrane and rigid insulation (3”) assembly in addition to replacing asphalt shingle roofs with and architectural type asphalt shingle for better durability and life-span.

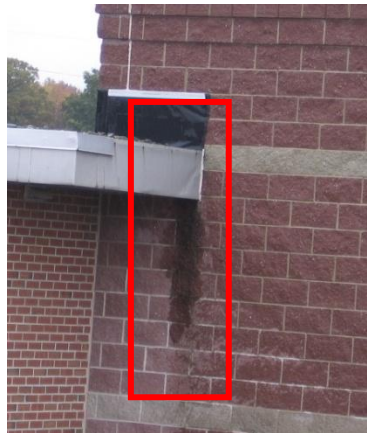
The above image shows damage to the exterior brick veneer due to improper flashing. Noted in section 2.3.2, special attention should be given to roof drainage to avoid water damage to exterior wall assemblies. At the time of the audit, the exterior walls appeared to be in age appropriate condition. Attention and maintenance should be given to these areas as uncontrolled roof water runoff can potentially penetrate exterior walls and cause energy losses and structural damage.

*Roof water run-off causing water to penetrate exterior wall finish*

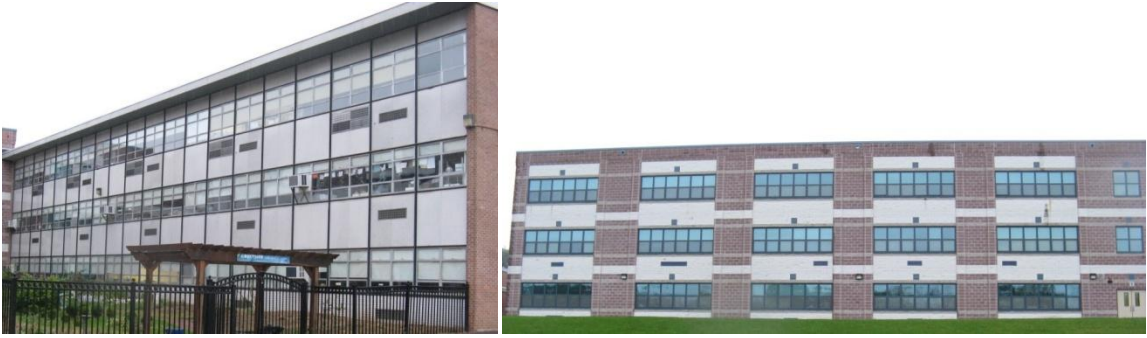
A section of the building's windows are original, full height aluminum, single glazed and in need of replacement. Due to the fact that the windows are non-thermal break single glazed with un-insulated panels above them, they are very energy inefficient. Spacers between the older windows are cracked and brittle. SWA recommends replacing approximately 386 windows with double-glazed thermal break low-E aluminum framed windows. Regular maintenance should be performed, re-caulking around the perimeter of windows (exterior and interior) to ensure a tight seal. The newer building sections contain double glazed windows found to be in very good condition.

*Older wall section with aluminum single pane windows; New addition with low-e double pane windows*

- Replace windows - SWA evaluated, as part of a capital improvement plan, replacing approximately 386 single-pane windows with newer models with thermal breaks, dual glazing and a low-e rating. Proper flashing and caulking should be performed upon installation of the new windows.

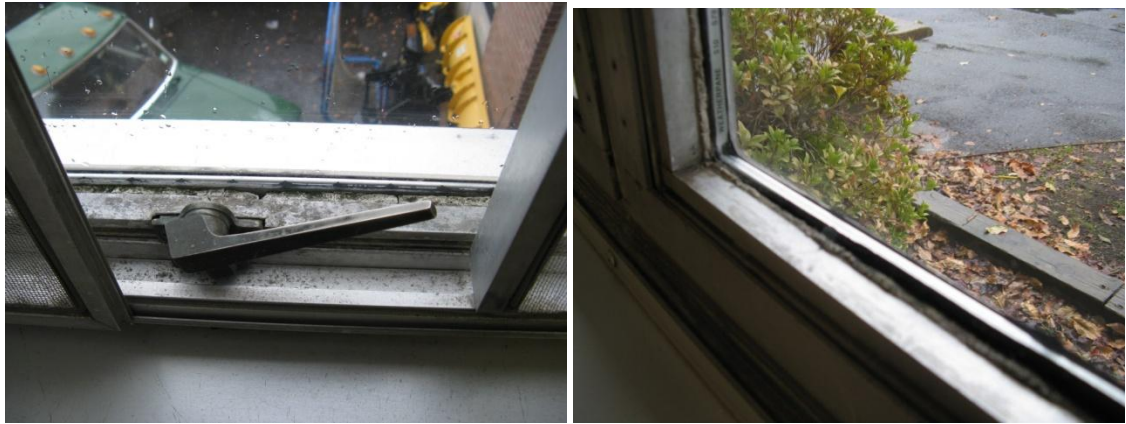
*Older windows showing cracked and damaged caulk*

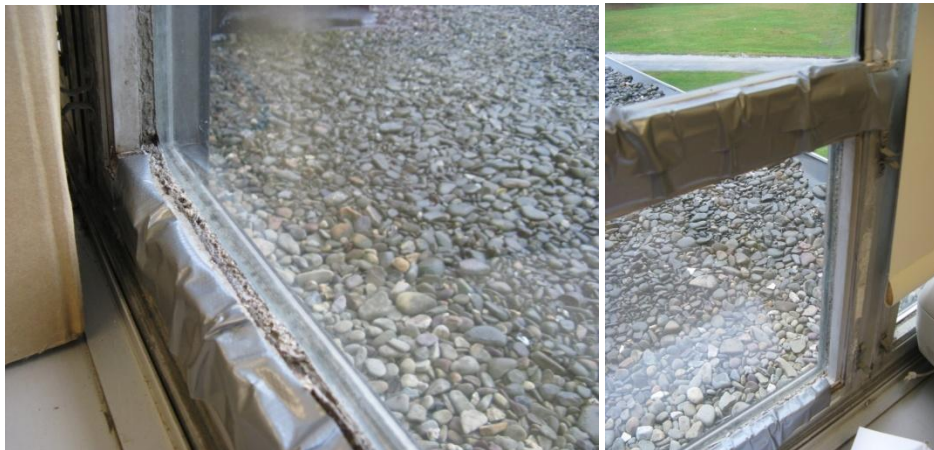
*Duct tape used in classroom to try to prevent air infiltration*

Additionally, window AC units should be removed for winter conditions. If removal of these units is not feasible, SWA recommends airtight covers (such as Chill Stop-R) or a gasketed cover for optimal performance.

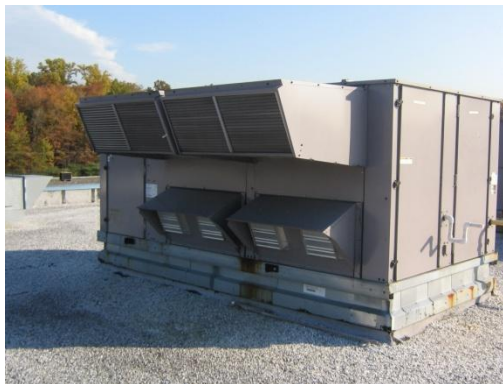
The 2002 classroom wing addition has a variety of HVAC systems. The Second (top-most) Floor is served by two Carrier rooftop gas-fired Variable Air Volume (VAV) HVAC units for heating, ventilating and air conditioning, with each Second Floor classroom having its own VAV box and distribution ductwork to ceiling diffusers. The second floor corridors of the classroom addition, the adjacent Special Education Resource Rooms and the lower, first and second floor Special Education Resource Rooms just inside the original building from the addition are also served by this VAV system.

*One of the two VAV Packaged Rooftop Units on the 2002 Addition*

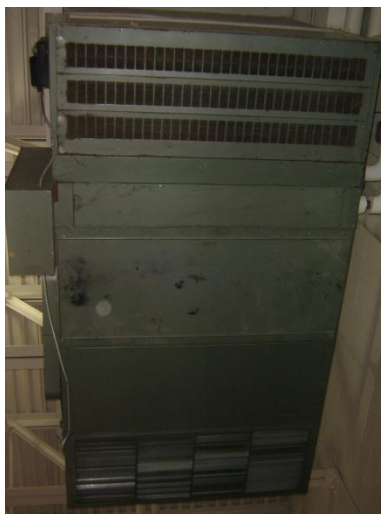
The Gym has four (4) H&V units, one suspended from the roof structure in each corner, along with four (4) exhaust fan assemblies. Each of the locker rooms has a newer McQuay horizontal unit ventilator as well as two (2) electric unit heaters. The Auditorium is heated by (2) heating & ventilating units located in the attic space.

*One of Four Heating & Ventilating Units Serving the Original Gym*

- Replace (4) H&V units serving the 1964 Gym - The hot water heating only ventilation system for the 1964 Gym is operating beyond its expected service life. SWA recommends that this equipment is replaced as part of a capital improvement project, and that it is designed to provide code minimum ventilation rates. The Livingston Public Schools may wish to consider providing DX cooling as part of this system to make the room more functional in warm weather, but should recognize that this will increase energy usage versus providing a heating and ventilation system only. If cooling is desired, it is strongly recommended that a system is provided that utilizes a heat recovery wheel for pretreatment of the outside air. This is a replacement in kind recommendation which offers negligible energy savings.

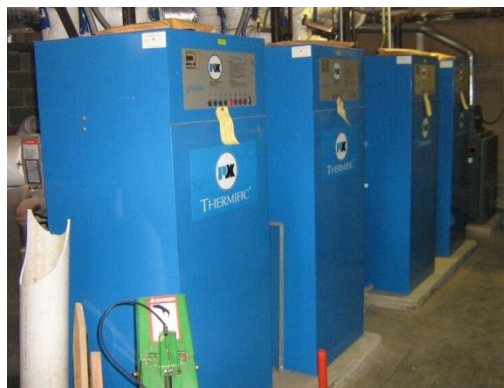
The heating hot water is produced by four (4) Patterson Kelly boilers of equal capacity located in the boiler room. The boilers were installed in the year 2001 approximately. According to their age, the boilers have more than 20 years remaining on their expected service life of 30 years, as published in the 2007 ASHRAE HVAC Applications Handbook. The burners are integral to these boilers.

The heating system piping is set up in a primary-secondary loop system. Each boiler has a small pump that injects hot water into the building hot water heating system loop. There are two pairs (main and backup) of base-mounted hot water circulating pumps, one pair for the old wing and one pair for the new wing. It is assumed that the circulating pumps were installed as part of the 2000 installation of the boilers. The pump motors are about half way through their expected service life of 20 years. SWA recommends that the pump motors are replaced with premium efficiency motors.

*Boilers*

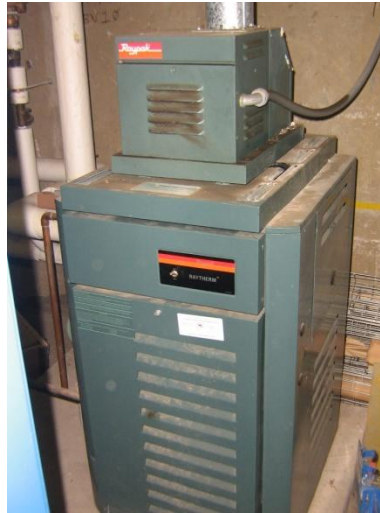
There are two domestic hot water heaters in the Boiler Room. One is a gas-fired Raypack water heater and the other is a Ruud electric tank type water heater. The former appears to be in good working condition as well as its circulating pumps. It is reported that the latter tank is not used (at one time it may have been used for a kitchen dishwasher booster heater). Further evidence of this conclusion is that this dishwasher appears to be used for storage of cleaning supplies.

*Domestic Water Heater*

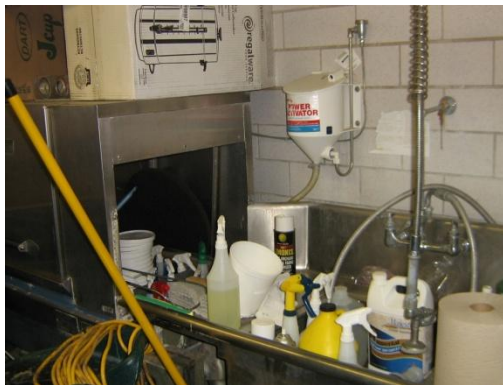
There are also several pieces of commercial-style cooking equipment, including a gas-fired 6-burner oven range, a fryer, (2) electric convection ovens, an electric conveyor pizza oven and a tall heated storage cabinet. There is a large kitchen hood provided for this equipment. There is also a commercial kitchen style dishwasher with hood, but it did not appear that this dishwasher was used since it appeared to be used for storage of cleaning supplies. It does not appear that any dedicated makeup air is provided for the kitchen hoods. The makeup air is likely provided via transfer from the adjacent Cafeteria air handling units or via infiltration from nearby exterior doors and windows.

*Commercial Dishwasher in Kitchen*
