**Local Government Energy Program  
Energy Audit Report**

***Township of Livingston  
Circle Fire Station  
375 West Northfield Road  
Livingston, NJ 07039***

***Project Number: LGEA50***

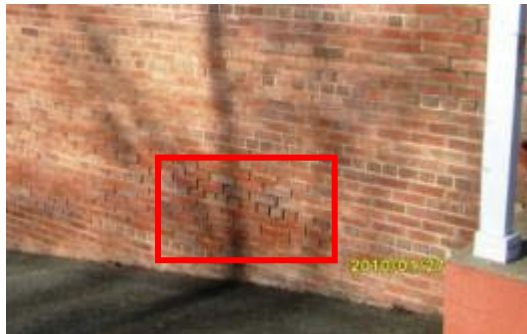
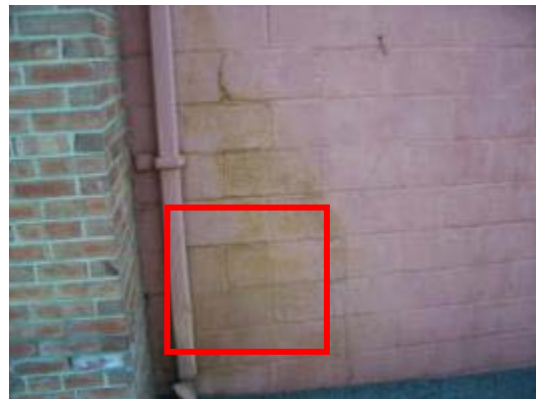
During the field audit exterior and interior wall surfaces were inspected. They were found/ reported to be in overall good condition with only a few signs of uncontrolled moisture, air-leakage and/ or other energy-compromising issues located mostly at the side(s) of the building.

Examples of cracked and missing caulk and signs of water damage

1. Replace cracked/ ineffective caulk.
2. Apply appropriate air-sealing strategies around all exterior wall penetrations (incl. electrical, plumbing and HVAC).
3. Maintain and inspect all exterior wall surfaces with a focus on the condition of caulking, displaced masonry, and signs of water damage and locations that correspond to areas of known infiltration.

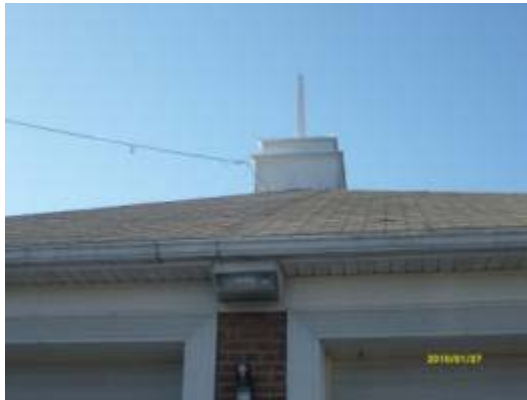
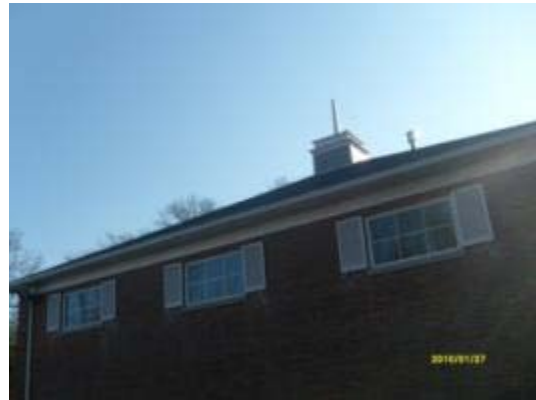
During the field audit roofs, related flashing, gutters and downspouts were inspected. They were found/ reported to be in overall good/ age appropriate condition with no signs of uncontrolled moisture, air-leakage and/ or other energy-compromising issues detected on all roof areas.

Typical Asphalt Shingle Roof

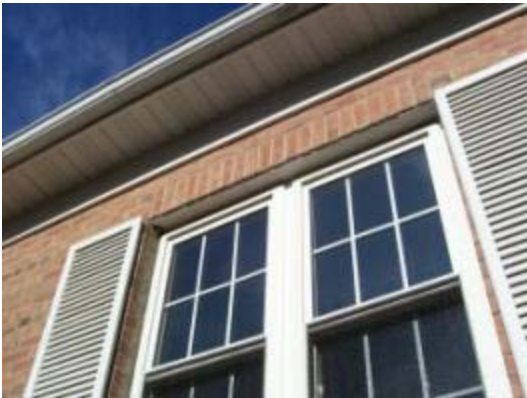
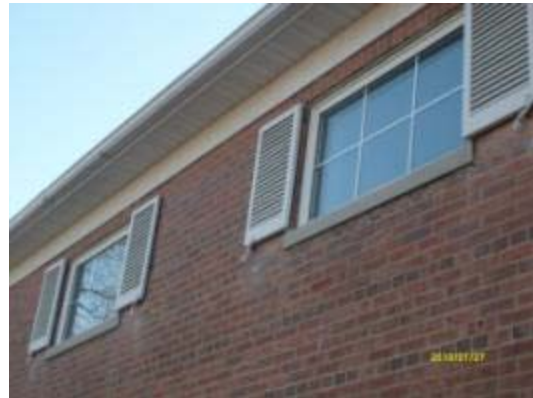
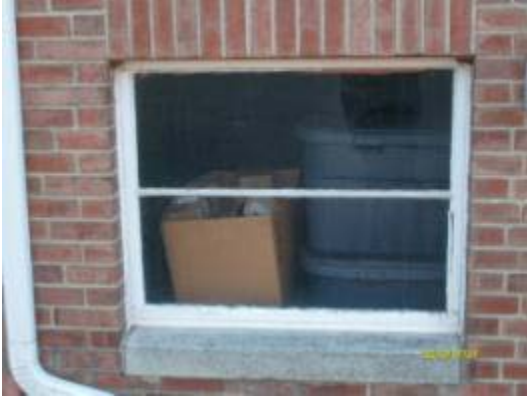
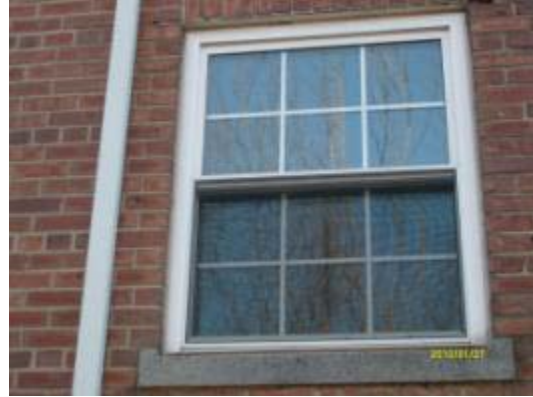
Windows, shading devices, sills, related flashing and caulking were inspected from the exterior and interior as far as accessibility allowed. Based on signs of moisture, air-leakage and other energy compromising issues, overall the windows were found and/or reported to be in acceptable/ age appropriate condition with some signs of uncontrolled moisture, air-leakage and/ or other energy-compromising issues.

Exposed and damaged frames that are major sources of thermal bridging

1. Replace all original/ single glazed windows with a low-E, double glazed type.
2. Install operable interior shading devices on windows
3. Add insulation and molding/ trim around windows where necessary.
4. Maintain and inspect all exterior windows with a focus on the condition of the frames,

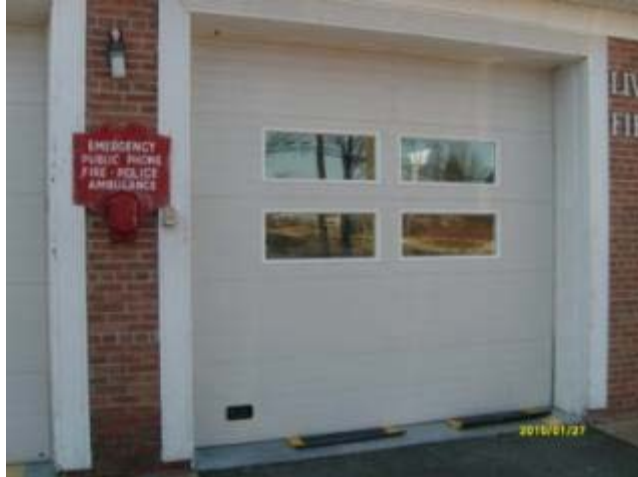
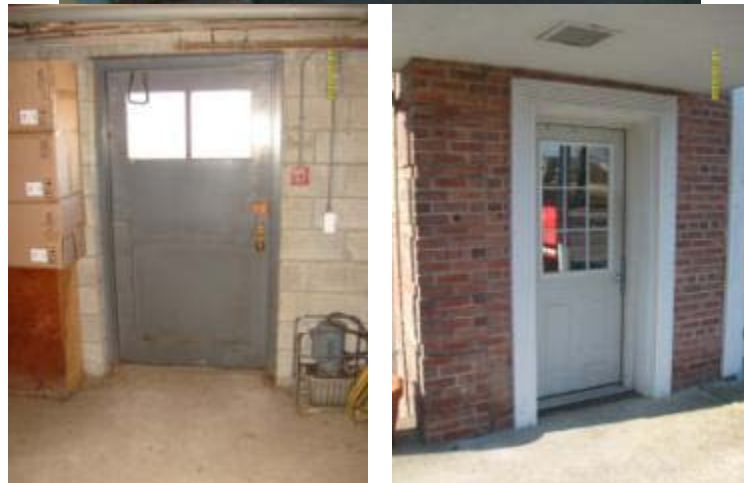
Missing/ worn weather stripping

1. Replace deteriorated weather stripping around all exterior doors and roof hatches.
2. Maintain and inspect all doors with a focus on the condition of the weather-stripping, door frame, air tight seal and signs of water damage and infiltration.

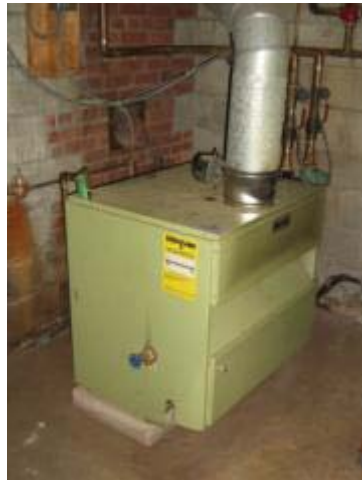
The entire building is heated via a Penanco gas fired boiler. This boiler is circa 1998 and provides 225,000 Btuh of output. It has an estimated remaining life of 55%. Hot water is supplied to radiators in office, restroom and storage room, and to a forced air unit heater hanging in the garage. All heaters are older of unknown age.

Gas fired boiler in lower level storage room

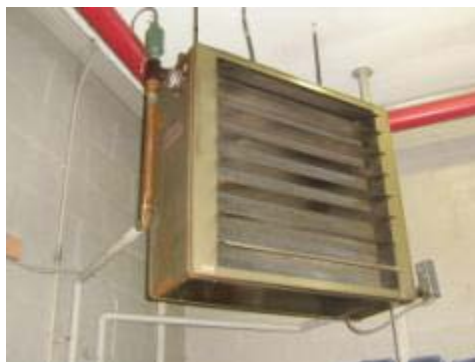
Unit heater in garage.

- Replace heating terminal units- such as cast iron radiators in the office, restroom and storage room, and hydronic unit heater in the garage. This equipment is in fair condition, but age and wear have reduced the heat transfer capacity. This equipment should be replaced with more modern equipment suited for the intended use. These changes cannot be justified based on energy savings alone. However, replacement is strongly recommended along with upgrades to other portions of the heating system. This is a replacement in kind recommendation which offers negligible energy savings.
- Single Glazed Window Replacement - Replace all original/ single glazed windows with a low-E, double glazed type.

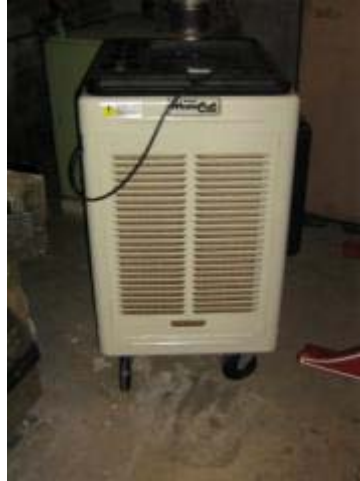
There is no cooling in this building. There was a portable A/C unit in the storage room that may be used in hotter months. Age and operation of this unit is unknown, although it does appear to be relatively new.

Portable A/C unit

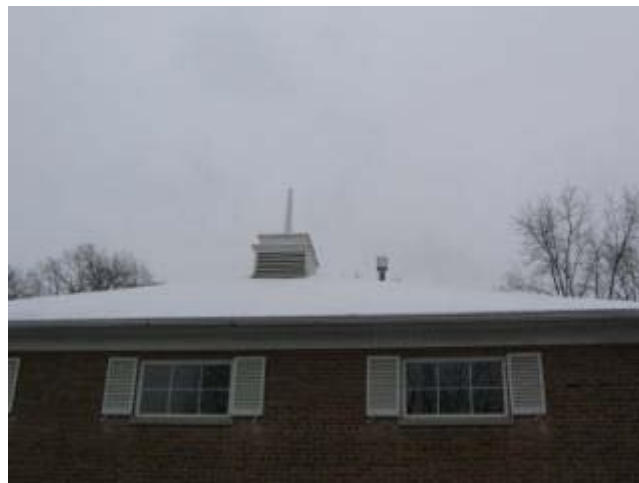
The garage area is ventilated via a vehicle exhaust fan. The fan was not accessible at the time of the survey (believed to be located in attic space above garage).

Vehicle exhaust duct up through roof

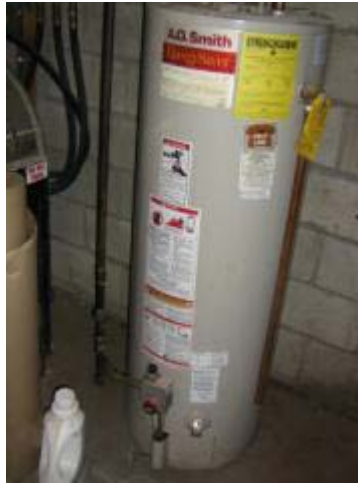
The domestic hot water for the building is provided by a gas-fired, 40 gallon, 32 MBH tank-type water heater, located in the mechanical room. This water heater is from 1997 and is at the end of its expected life span.

Domestic water heater

5.2	Incremental cost to replace domestic water heater with 95% efficient unit	similar projects	500	300	200	0	0.0	40	1.5	0	56	15	845	3.6	322	21	27	472	468	
<b>TOTALS</b>			-	3,381	610	2,771	3,523	1.2	340	20	184	1,599	-	16,262	1.7	-	-	-	-	8,804

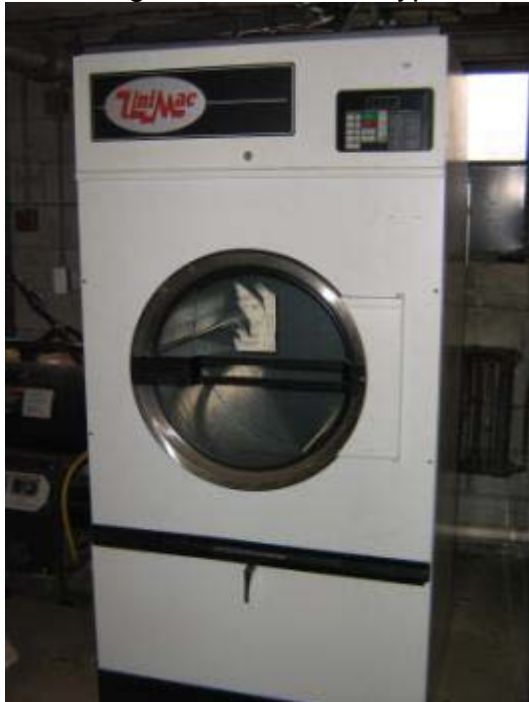
Electric clothes dryer

- Water levels in the expansion tank and the integrity of the tank bladder should be checked to confirm proper operation.
- Use Energy Star labeled appliances - such as Energy Star refrigerators and commercial washer and dryer that should replace older energy inefficient equipment.

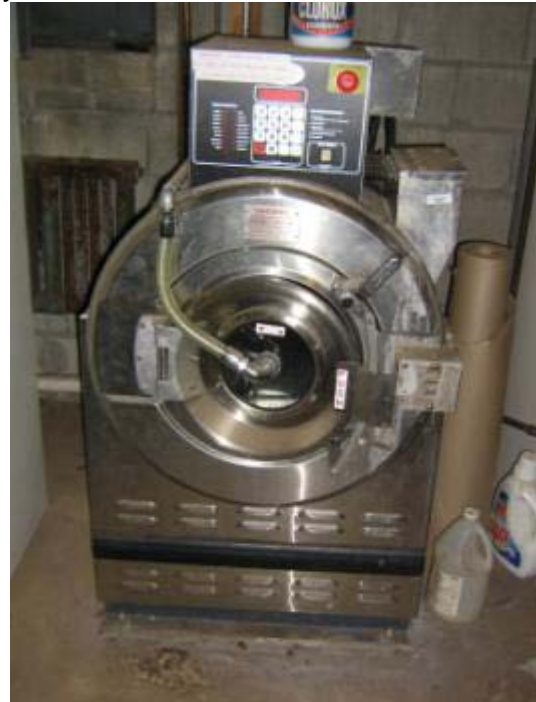
Electric washing machine
