**Local Government Energy Program
Energy Audit Report**

***Township of Livingston
Main Fire Department
62 South Livingston Avenue
Livingston, NJ 07039***

Project Number: LGEA50

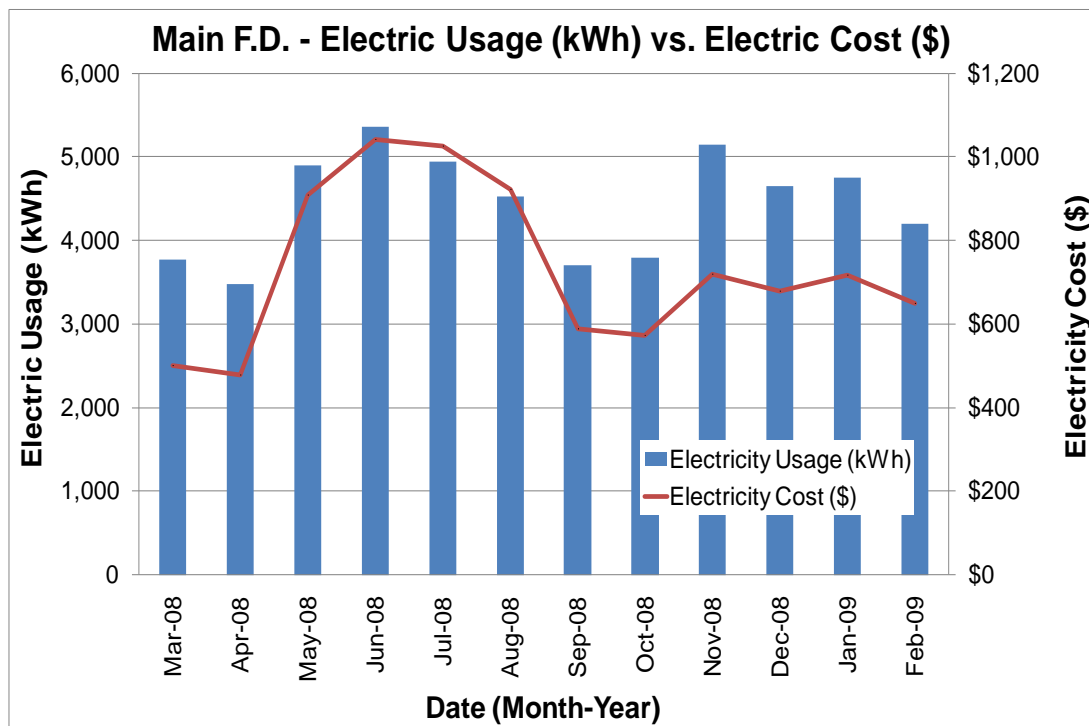
The following chart shows electricity use versus cost for the Main Fire Department based on utility bills for the 12 month period of March 2008 to February 2009.

Electricity use follows a trend that is expected for this building with usage peaking during the summer due to DX cooling and also peaks in the winter due to the electric heating equipment. The cost of electricity fluctuates as expected with usage peaking in the summer during the time of highest usage.

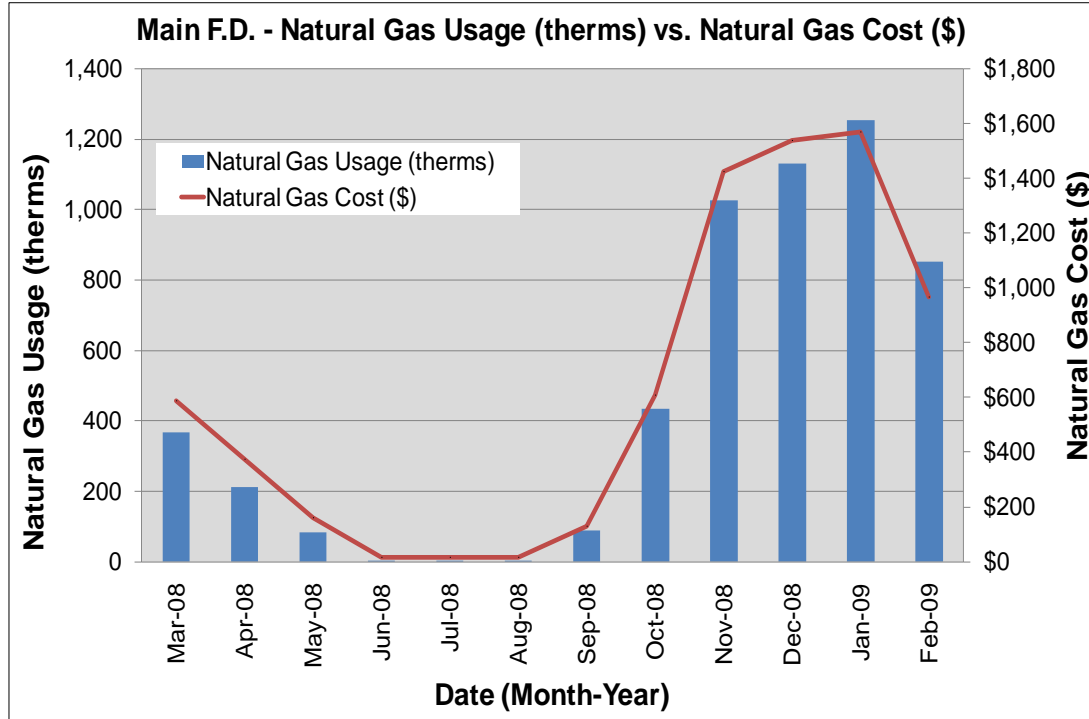
The following is a chart of the natural gas annual load profile for the building versus natural gas costs, peaking in the coldest months of the year and a chart showing natural gas consumption following the “heating degree days” curve.

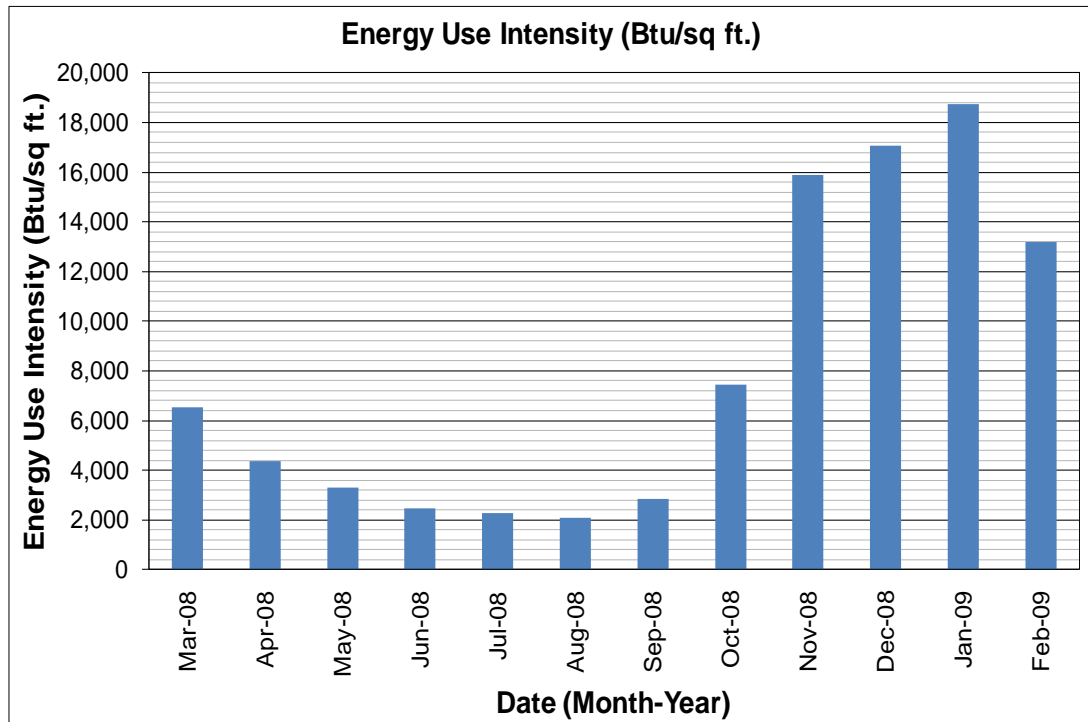
The following chart shows electric consumption in Btu/sq ft for the Main Fire Department based on utility bills for the 12 month period of March 2008 to February 2009.

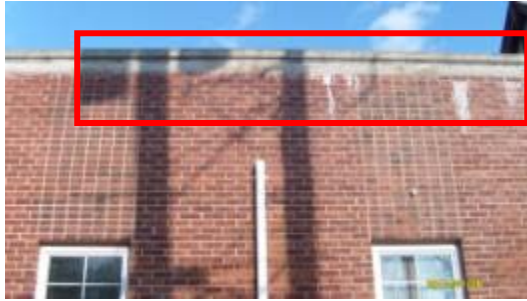
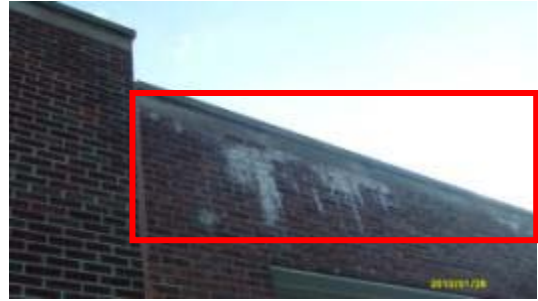
During the field audit exterior and interior wall surfaces were inspected. They were found to be in overall good condition with only a few signs of uncontrolled moisture, air-leakage or other energy-compromising issues located mostly at the sides of the building.

Examples of cracked and missing caulk and un-sealed exterior wall penetrations

1. Inspect and replace cracked/ ineffective caulk.
2. Efflorescence coated brick and masonry materials need to dry out and possible cause of water infiltration into wall cavities should be investigated.
3. Maintain and inspect all exterior wall surfaces with a focus on the condition of caulking, displaced masonry, and signs of water damage and locations that correspond to areas of known infiltration.

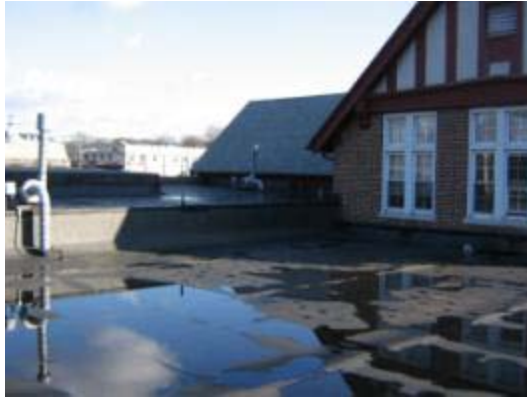
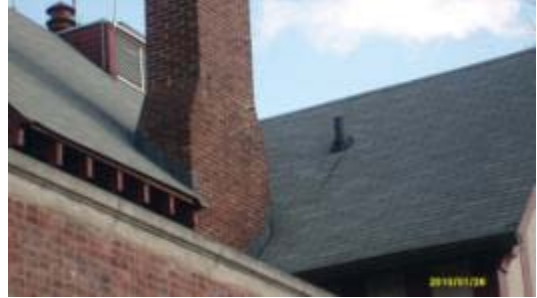
During the field audit roofs, related flashing, gutters and downspouts were inspected. They were found/reported to be in overall good/ age appropriate condition with some signs of water pooling, uncontrolled moisture, air-leakage and other energy-compromising issues mostly detected on flat roof areas.

The following typical roof was identified:

1. Unclog and maintain all roof drains/scuppers.
2. Maintain/ inspect all roof surfaces on a regular basis.

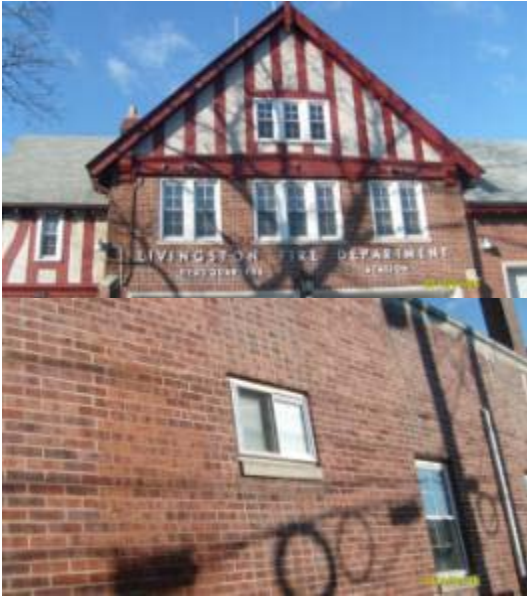
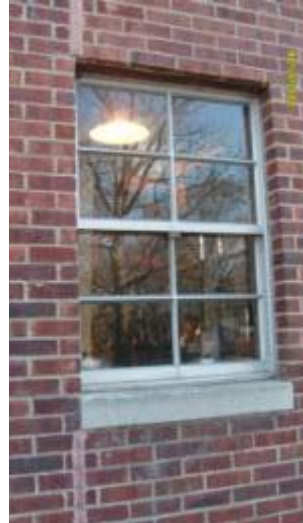
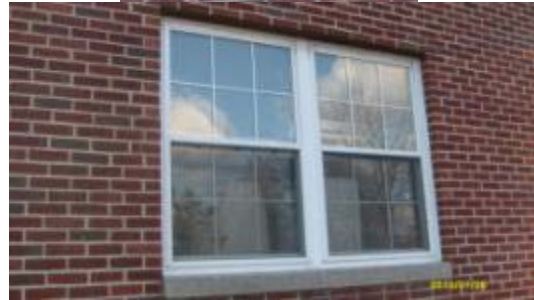
Exposed and damaged frames that are major sources of thermal bridging

1. Replace/ dd/maintain caulk around window frames and sills.
2. Replace all original/ single glazed windows with a low-E, double glazed type.
3. Maintain and inspect all exterior windows with a focus on the condition of the frames,

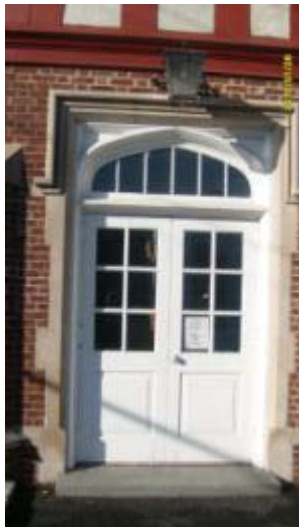
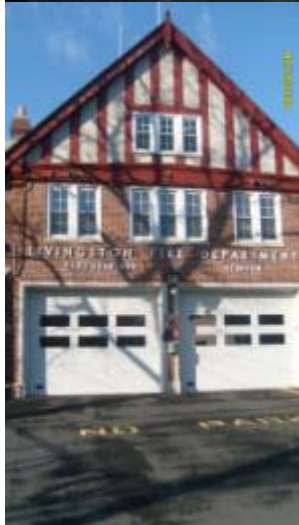
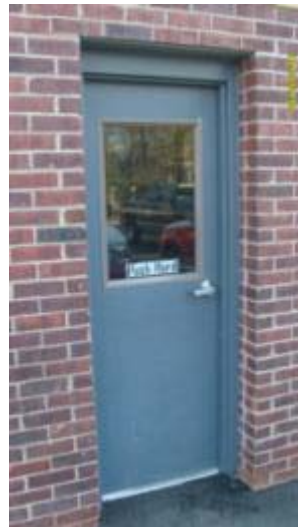
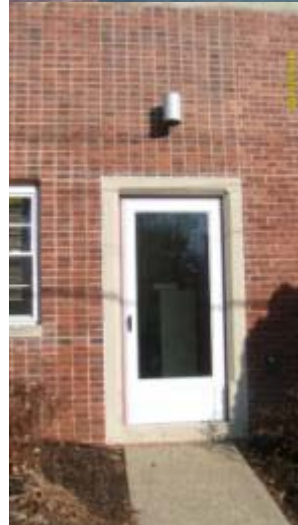
All exterior doors, thresholds, related flashing, caulking and weather-stripping were inspected. Based on signs of moisture, air-leakage and other energy compromising issues, overall the doors were found/ reported to be in acceptable/ age appropriate condition with only a few signs of uncontrolled moisture, air-leakage and/ or other energy-compromising issues.

The following typical installations were identified:

1. Maintain and inspect all doors with a focus on the condition of the weather-stripping, door frame, air tight seal and signs of water damage and infiltration.

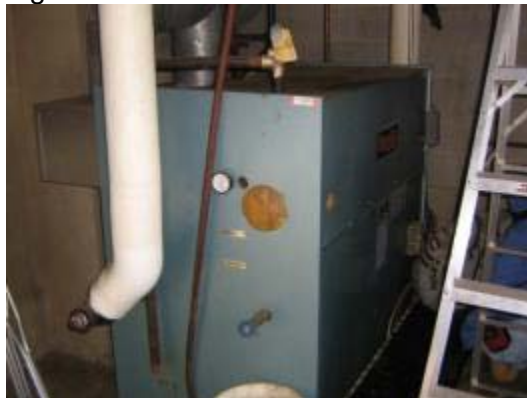
The entire building is heated via an H.B. Smith gas fired boiler. This boiler is circa 1997 and provides 652,000 btuh of output. It has an estimated remaining life of 55%. The heating system is separated into (4) zones, with a supply pump for each zone above the boiler. Hot water is supplied to radiators in each office room/area (both levels), to a radiator in the lower Attic level, and to (7) forced air unit heaters hanging in the garage. Heating is controlled by wall mounted manual thermostats in each zone which are also timers that prevent unnecessary heating. This combined with the standard operating procedure of turning off all heating equipment when the building is unoccupied makes programmable thermostats an ineffective source of savings.

Gas fired boiler in Mechanical Room

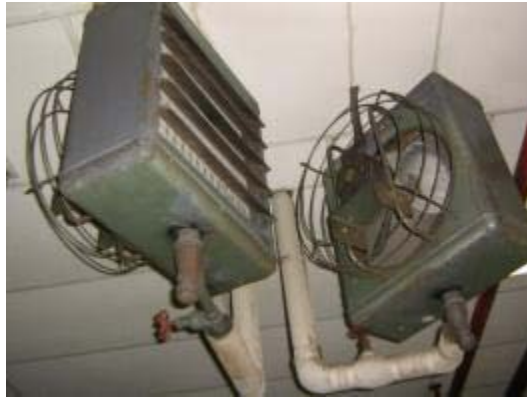
Unit heaters in garage

- Replace heating terminal units- such as baseboard radiators in the finished areas and hydronic unit heaters in the garage. This equipment is in fair condition and beyond its expected service life. Age and wear have reduced the heat transfer capacity. This equipment should be replaced with more modern equipment suited for the intended use. These changes cannot be justified based on energy savings alone. However, replacement is strongly recommended to improve the overall efficiency of the heating system. This is a replacement in kind recommendation which offers negligible energy savings.

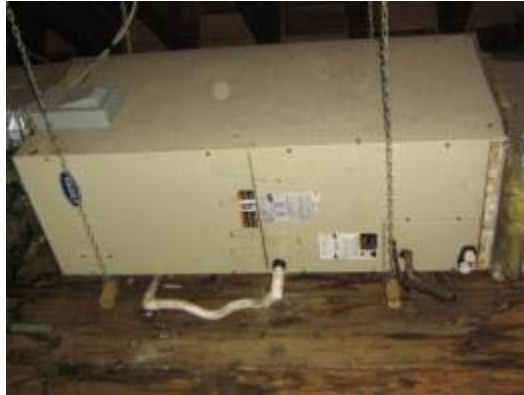
The office areas on both levels are provided with cooling. The main level office area is cooled via a split system with an air handler above the ceiling of the kitchen, and a condensing unit on grade outside. This system is over 20 years old (circa 1987) and is past its expected life span. The upper level office is cooled via a split system with an air handler in the attic, and a condensing unit on the roof. This system is circa 1995 and is at the end of its expected life span. The cold air is distributed throughout both levels by ductwork and diffusers. Cooling is controlled by a wall mounted thermostat on each level.

Split system air handler in attic

2.1	replace 3-ton HW heating / DX cooling split system with high efficiency system	similar projects	7,500	276	7,224	2,310	0.5	0	1.0	350	731	15	5,717	9.9	52	3	6	1,504	3,165

2.2	replace 4-ton HW heating / DX cooling split system with high efficiency system	similar projects	9,000	368	8,632	3,085	0.6	0	1.4	350	859	15	7,635	10.0	49	3	5	1,623	4,226
	TOTALS	-	28,089	1,374	26,715	12,675	2.6	0	4.8	896	3,023	-	34,848	8.8	-	-	-	9,131	17,364

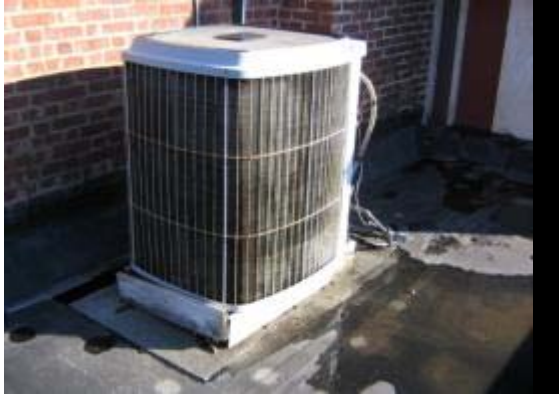
Split system condensing unit on roof

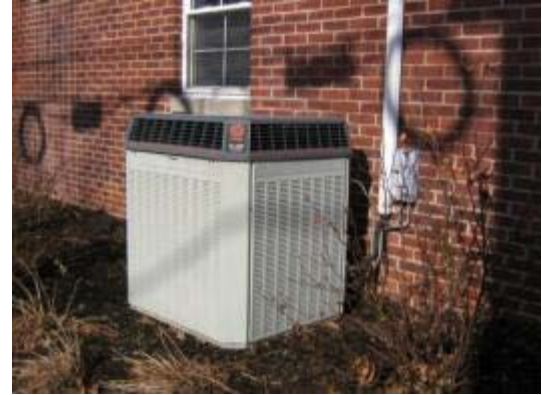
Split system condensing unit on grade

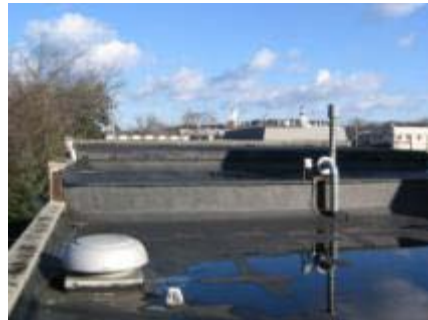
The office areas are ventilated by a combination of natural ventilation from windows and the previously described air handlers assigned to each area. The garage area is ventilated via vehicle exhaust fans, a sidewall exhaust fan, and a roof mounted fan. The attic also has a sidewall exhaust fan, and open louvers in the roof gable/ridge. Both sidewall fans are very old, actual age unknown. The roof exhaust fan is also very old, age unknown. The vehicle exhaust fans are both circa 1992, with an estimated 10% of their useful life remaining.

Exhaust fan (left) and vehicle exhaust (right, typical for (2)) on roof

- Replace toilet exhaust fan and sidewall attic fans – this equipment is run by fractional horsepower motors, so the replacements cannot be justified by energy savings alone and there are no NJ Clean Energy rebates available. However, due to the age and condition of the equipment, replacement is recommended.
