**Local Government Energy Program
Energy Audit Report**

***Township of Livingston
Northland Pool and Recreation Center
3 Madison Court
Livingston, NJ 07039***

Project Number: LGEA50

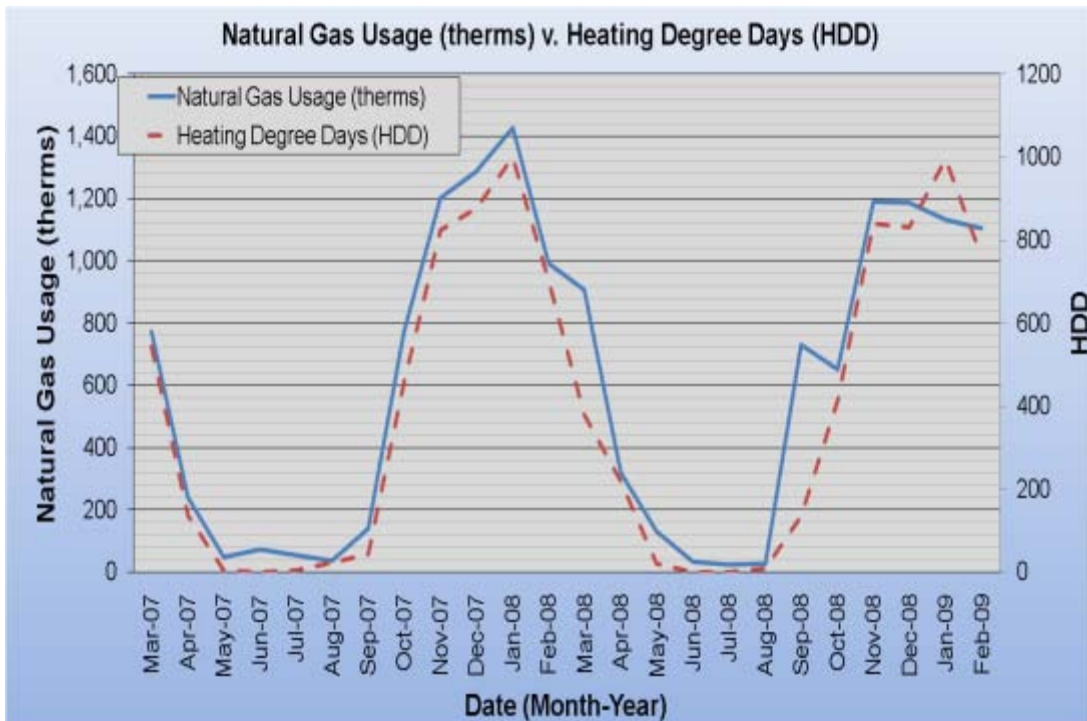
The following is a chart of the natural gas annual load profile for the building versus natural gas costs, peaking in the coldest months of the year and a chart showing natural gas consumption following the "heating degree days" curve.

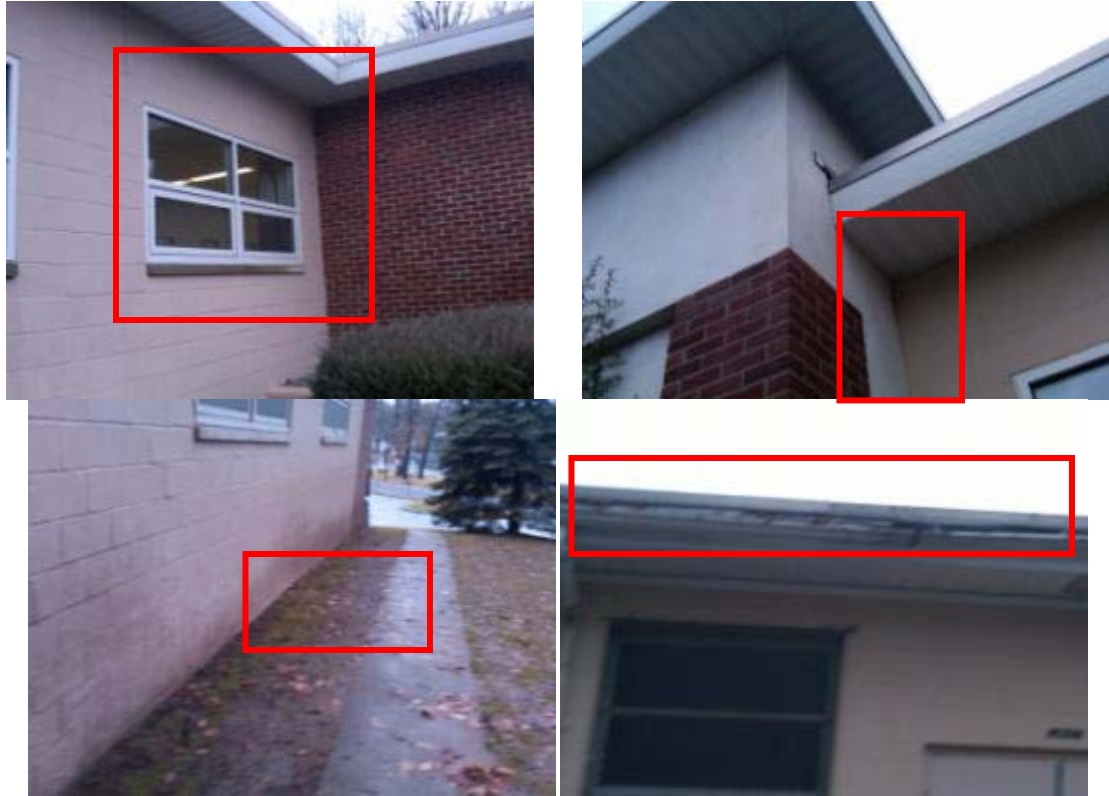
Signs of uncontrolled roof water runoff on walls due to missing/ defective roof flashing and missing gutters and downspouts as well as water damage at surface transitions, shifted concrete block and water damage due to poor site drainage.

1. Insulate original and un-insulated exterior wall sections. SWA suggests applying 2" XPS rigid foam boards to the interior and covering it with gypsum wallboard or other preferred interior finish.
2. Install footing drains and slope perimeter grade away from building. SWA suggests investigating interior footing drain option.
3. Install/ repair and maintain flashing to minimize uncontrolled wind driven and roof water run-off causing exterior wall damage.
4. Install/ repair and maintain gutters, downspouts and downspout deflectors to minimize uncontrolled roof water run-off causing exterior wall damage.
5. Maintain and inspect all exterior wall surfaces with a focus on the condition of caulking, displaced brick or concrete blocks, signs of water damage and locations that correspond to areas of known infiltration.

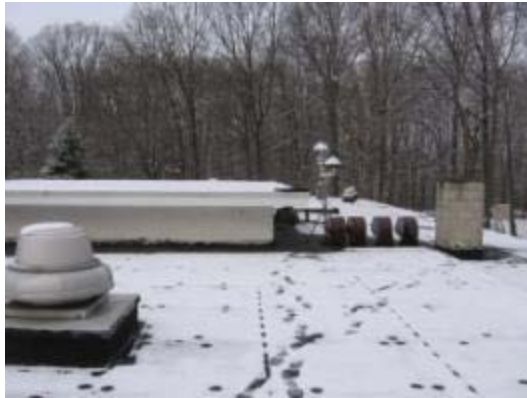
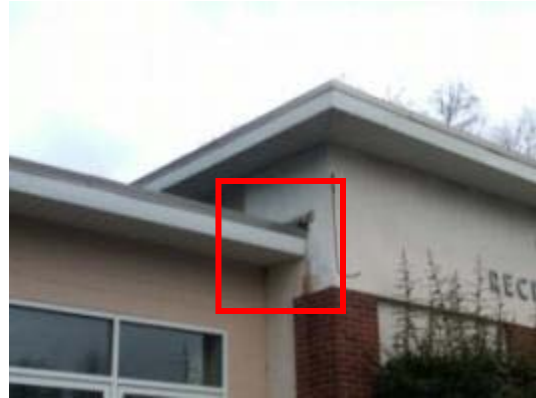
Missing/ ineffective flashing

1. Install/ repair and maintain roof flashing.
2. Maintain/ inspect all roof surfaces on a regular basis with a focus on the condition of the flashing, roofing membrane, drainage, signs of water pooling, signs of infiltration and locations that correspond to water damaged ceiling tiles.

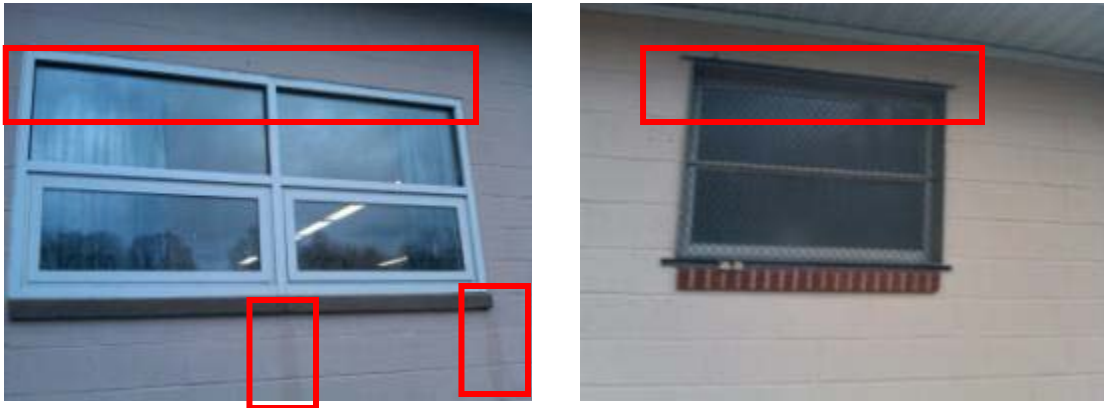
Missing window sill and drip-edge detail cracked/ aged caulk around frame/ sill on the exterior and exposed window lintels that act as thermal bridges.

1. Replace/ add/maintain caulk around window frames and sills.
2. Properly seal and insulate window lintel to eliminate thermal break.
3. Install/ repair pan or strip flashing and drip edge detail at window sill.
4. Maintain and inspect all exterior windows with a focus on the condition of the frames, water damage from the sills, air tight seal, and proper hardware operation.

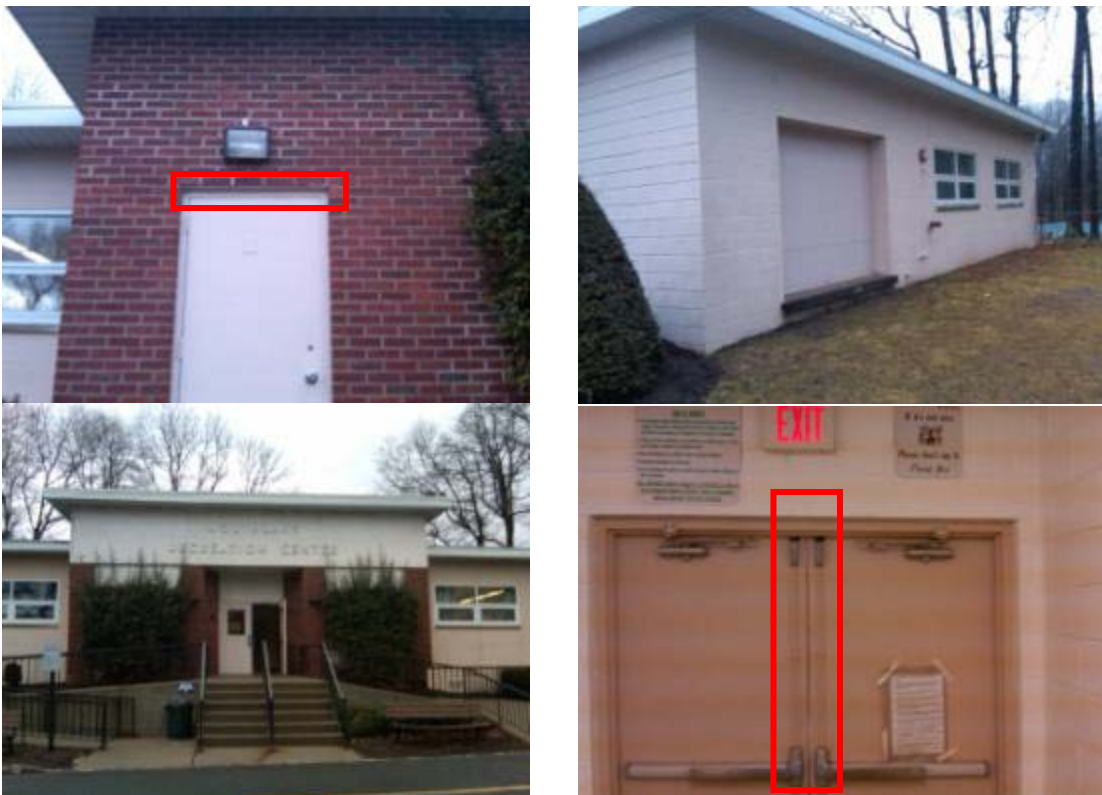
Examples of typical doors and problems such as deteriorated weather-stripping and exposed door lintels that are sources of thermal bridging.

1. Replace missing or damaged weather-stripping.
2. Install caulking and insulation around door lintels to prevent thermal bridging.
3. Maintain and inspect all doors with a focus on the condition of the weather-stripping, door frame, air tight seals and signs of water damage and infiltration.

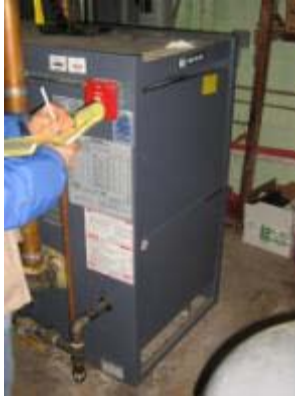
The main building is heated via a Weil-McLain 'Series 2' gas fired boiler. This boiler was recently replaced in 2008 and provides 421,200 btuh of output. It has an estimated remaining life of 95%. There are two (2) fractional horsepower hot water circulating pumps serving the building. Domestic hot water is produced by the boiler and stored in two Weil-McLain hot water storage tanks, believed to have been installed in 2008 with the new boiler. The heating hot water serves wall mounted radiators along the perimeter walls of the building. In the storage room in the basement, two hydronic hot water unit heaters are mounted up towards the ceiling at each end of the space. Although the heaters are estimated to be approximately 0-25% remaining of their expected useful life, no complaints were mentioned about the ability of the heaters to heat the space. The gun range, since abandoned, has no heating. The main pool pump room is heated by a single 10kw electric unit heater that has an estimated remain life of 50%. The smaller pump house for the pool's water features has no heating.

Gas-fired boiler in boiler room

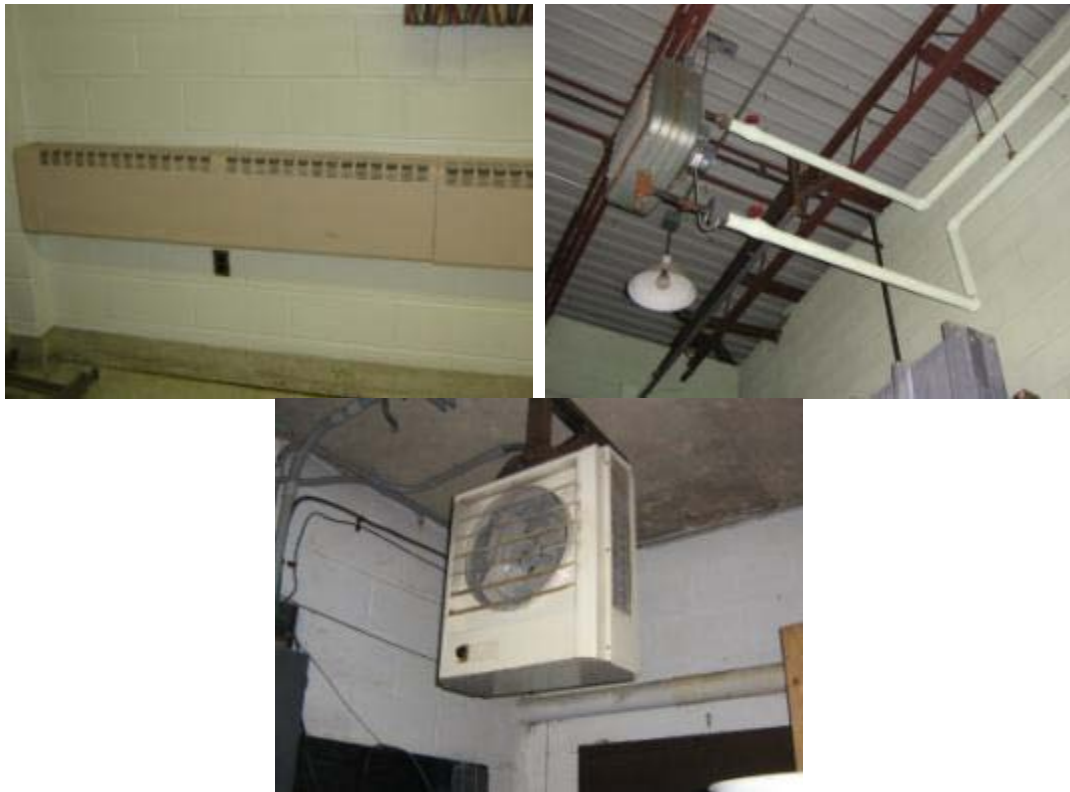
Radiators throughout the building, hydronic heaters in basement, and electric unit heater in pool's main pump house

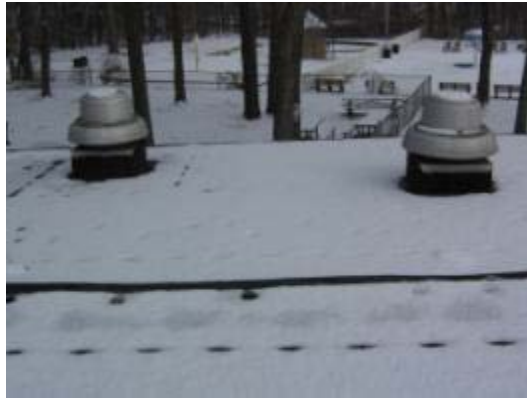
exhaust fan. All the fans appears to be at, or nearing, their useful life expectancy. SWA recommends replacing all the exhaust fans of the main building with models using premium efficiency motors.

Rooftop Exhaust Fans
