**Local Government Energy Program
Energy Audit Report**

***Township of Livingston
Water Department
59 Congressional Parkway
Livingston, NJ 07039***

Project Number: LGEA50

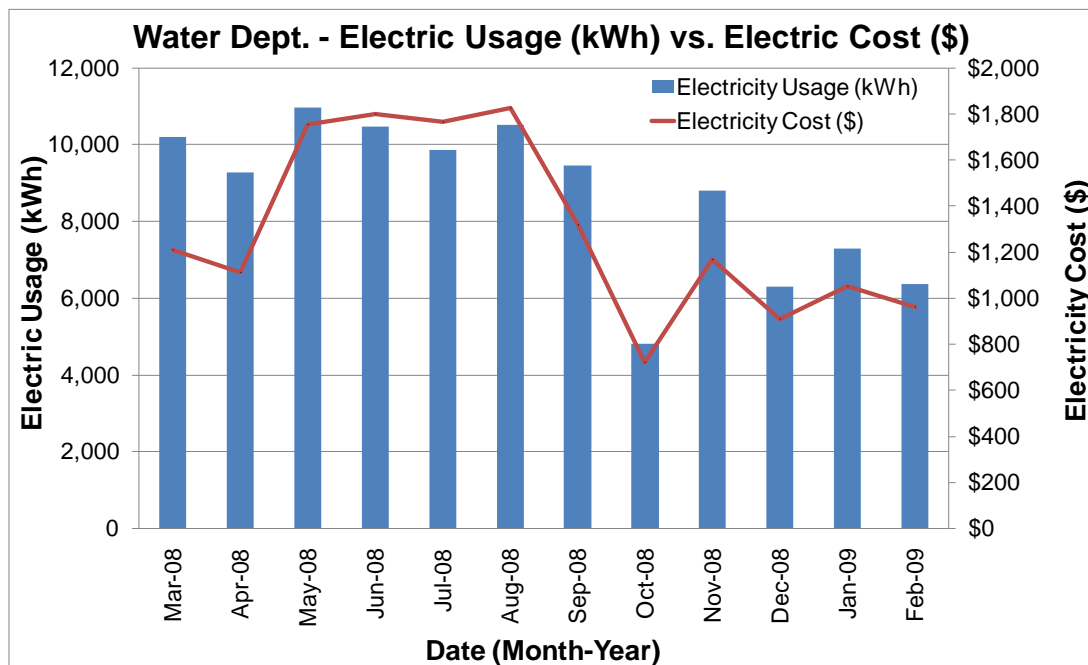
The following chart shows electricity use versus cost for the Water Department based on utility bills for the 12 month period of March 2008 to February 2009.

Electricity use follows a trend that is expected for this building with usage peaking during the summer due to an increased water demand in the summer. The cost of electricity fluctuates as expected with usage peaking in the summer during the time of highest usage.

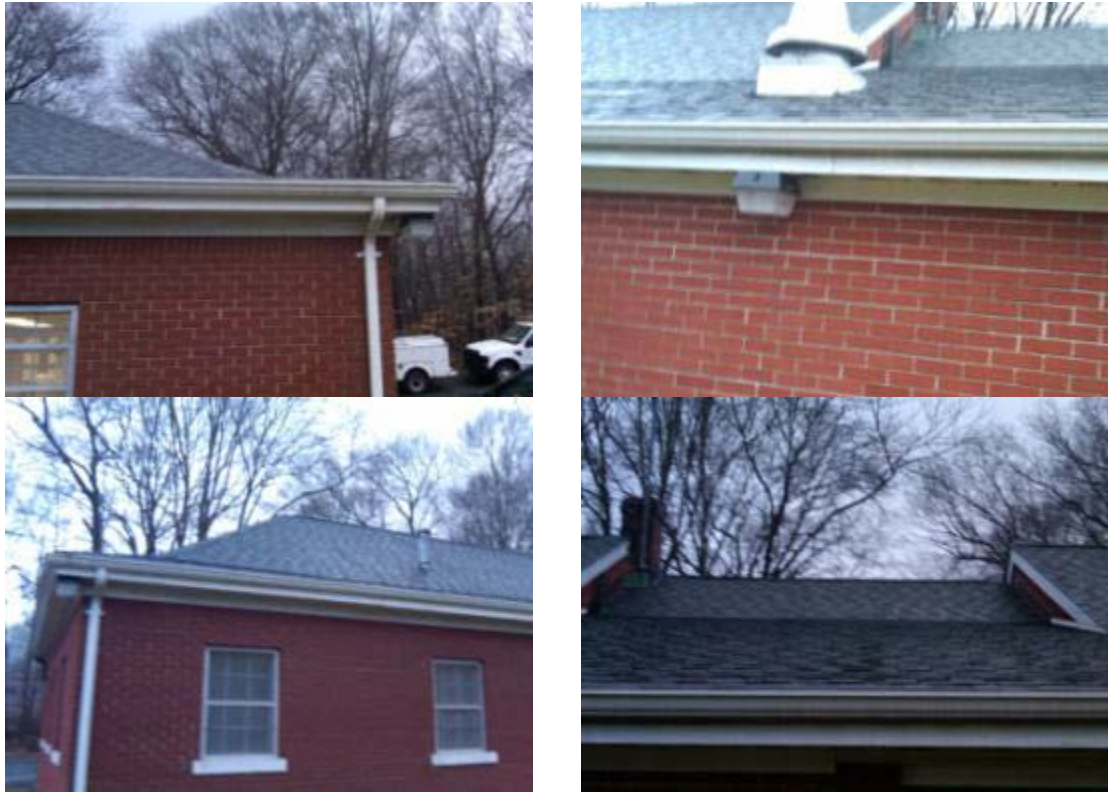
The building's roof is predominantly a medium-pitch gable type over a wood structure with an asphalt shingle finish. It was replaced recently. No roof insulation was observed.

Typical roofing system throughout building

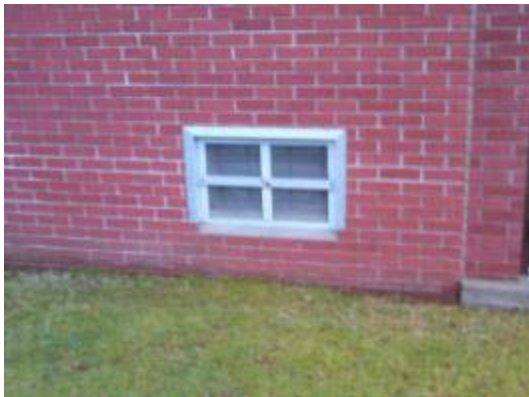
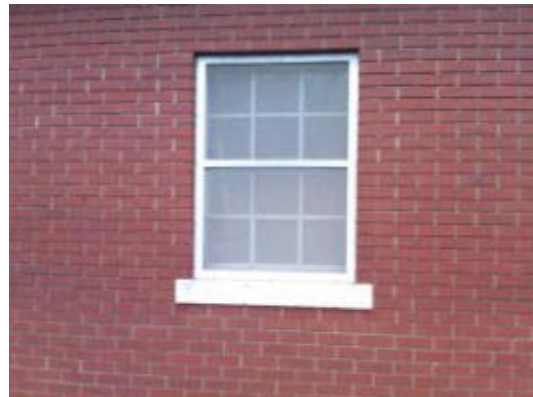
Typical windows and exposed window lintel that can lead to thermal bridging.

1. Biannually inspect and maintain windows with a focus on the condition of the frames, caulking, airtight seals, properly operating hardware and signs of infiltration and water damage.

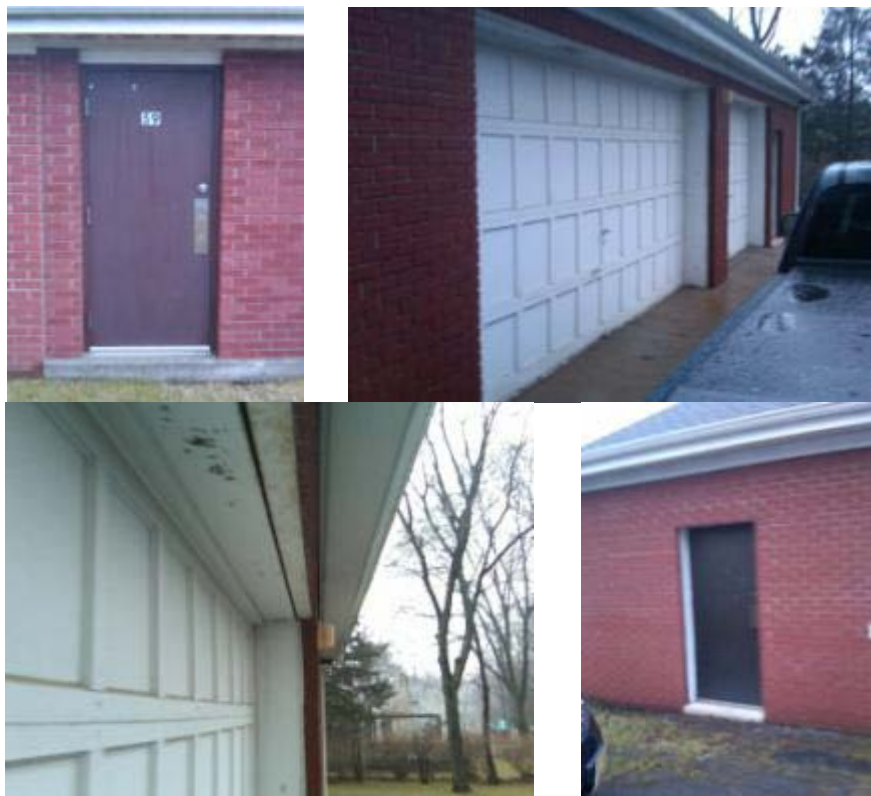
Exterior mold/ water damage signs on areas around doors and Damaged/ warped/ aged door frame

1. Repair damaged frames of overhead door units.
2. Biannually inspect and maintain exterior doors with a focus on the condition of the frames, weather-stripping, airtight seals, infiltration and water damage.

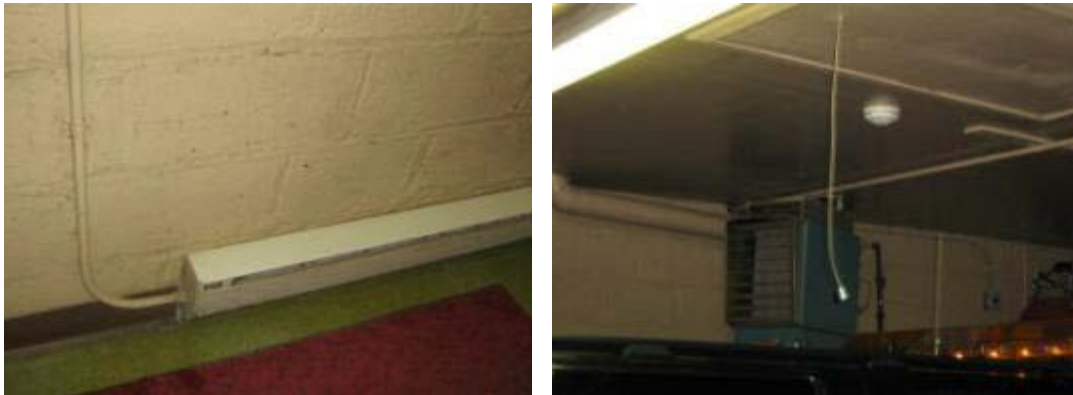
The office and central core areas are heated by electric baseboard heat. The heaters are in fair condition, but are estimated to be well beyond their expected useful life of ten (10) years. SWA recommends that the baseboard heating be replaced in their current locations. The garage bays are served by a pair of gas-fired unit heaters located near the ceiling, one in each bay. Both units were installed in the 1970's and have far exceeded their expected useful life of thirteen (13) years. SWA recommends these units be replaced with new, higher efficiency units. The replacement of these units should provide improved and lower cost heating for the garage spaces.

Electric baseboard heater, unit heater in garage

- Replace common area heating equipment - such as electric baseboard heaters in the office and central core area. This equipment is in fair condition, but age and wear have reduced the heat transfer capacity. This equipment should be replaced with more modern equipment suited for the intended use. These changes cannot be justified based on energy savings alone. However, replacement is strongly recommended along with upgrades to other portions of the heating system. This is a replacement in kind recommendation which offers negligible energy savings.

There are two (2) gas-fired unit heaters that serve the garage bays that are utilized for the winter months. These units typically achieve approximately 65-70% efficiency in natural gas usage considering their current age. This equipment is beyond its expected service life and should be replaced. The Water Department can realize energy savings by installing power vented, low static axial fan high efficiency unit heaters in place of the existing equipment. This type of heater can achieve up to 83% efficiency. The simple payback was calculated to be 10 years.

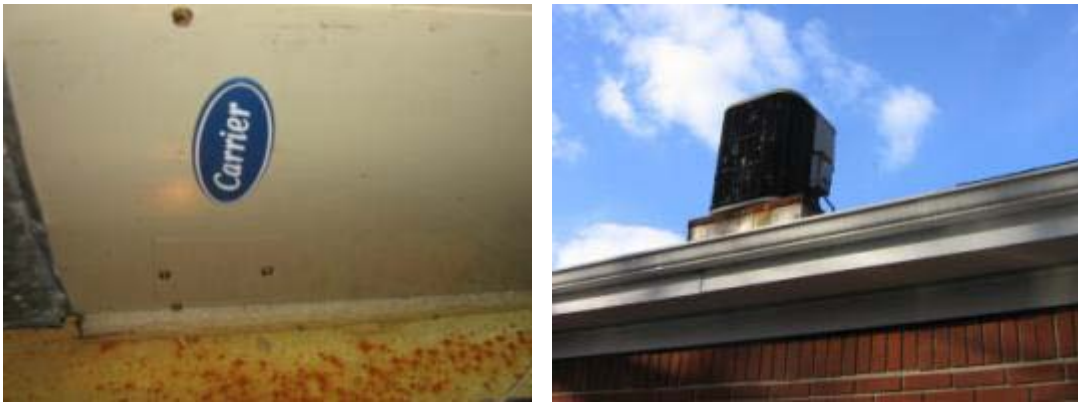
The only area to receive cooling is the office area. A direct expansion fan coil air handling unit is located in the attic space above the offices. The unit is paired with a condensing unit mounted on the roof on the rear side of the building. The air handling unit is nearing the end of its expected useful life and SWA recommends that the unit be replaced with a new model of the same capacity. The condensing unit mounted on the roof is in fair to good condition and has approximately 40% of its estimated useful life of twenty (20) years remaining. Despite the unit having just under half of its estimated useful life remaining, a possible energy saving measure would be to replace the unit with a higher efficiency model of the same capacity which operates using R410A refrigerant in lieu of the R-22 refrigerant of the existing unit which is no longer being produced.

Photos – Air handling unit and paired condensing unit on roof

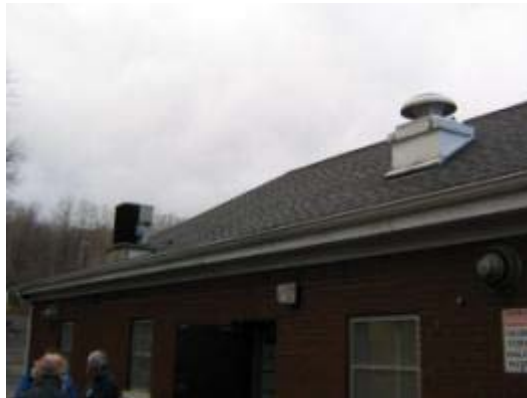
Three exhaust fans provide mechanical ventilation for the building. A single roof mounted fan and a pair of sidewall exhaust fans are located on the rear side of the building. Although no nameplate data was available, all fans appear to be nearing the end of their expected useful life and SWA recommends that the fans be replaced with higher efficiency models.

Sidewall and roof mounted exhaust fans serving the building

- Replace existing exhaust fans – The roof-mounted and wall-mounted exhaust fans are operating beyond their useful life. Due to age and condition of this equipment, SWA recommends that this equipment is replaced. Energy savings will be negligible since the motors are fractional horsepower, and there are no NJ Clean Energy rebates available since the motors are single phase.

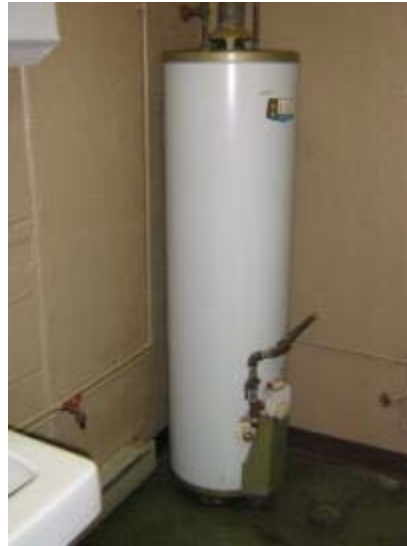
The domestic hot water for the building is provided by a gas-fired, 30 gallon, 46 MBH tank-type water heater, located in the toilet room. This water heater is from 1975 and has far surpassed its expected useful life span. SWA recommends that the water heater be replaced with a new higher efficiency unit with the same capacity.

Photo – Domestic water heater
