**Local Government Energy Program
Energy Audit Report**

***Township of Livingston
Well Houses No. 3, 4, 9 and 11)
Livingston, NJ 07039***

Project Number: LGEA50

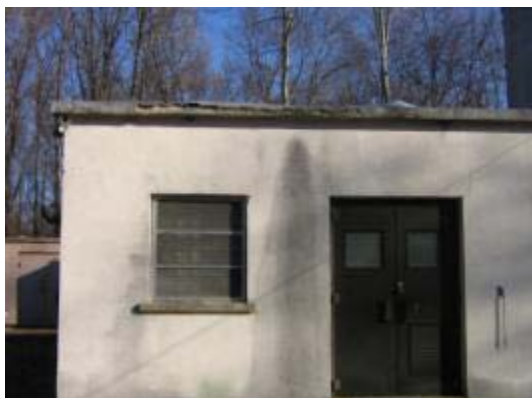
Well House No. 3 consists of two single story buildings, Deep Well #1 and Clear Well #2. Deep Well #1 is 530 gross square feet and approximately 50-60 years old. Clear Well #2 is 700 gross square feet and approximately 20 years old. Both are slab on grade with stucco veneer over CMU walls with a poured in place concrete roof.

Building # 1

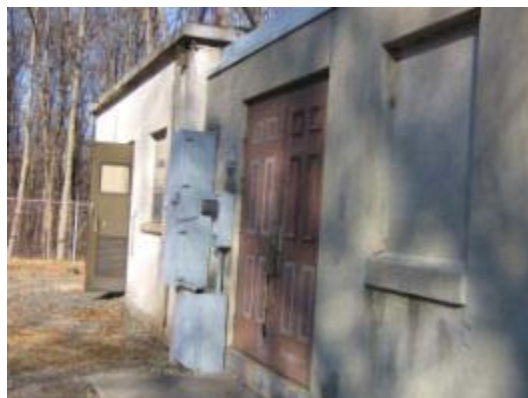
Buildings #1 and #2

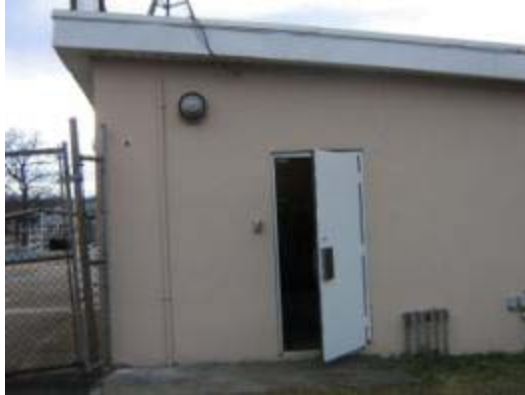
Well #4 consists of two buildings, Clear Well and Deep Well. Clear Well is a single story brick building of 700 gross square feet, slab-on-grade with a gable roof. Deep Well is a 300 gross square feet single story building, and is attached to the pool recreation building. It is also slab on grade with a stucco finish.

Building Entrance

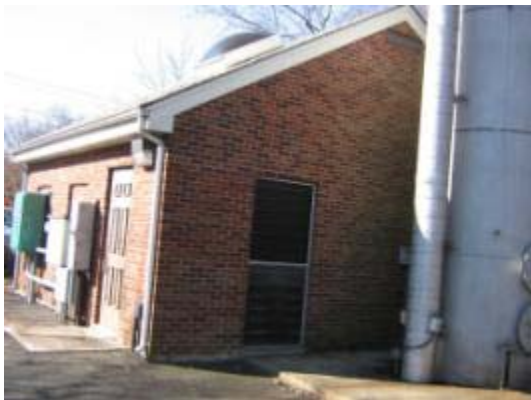
Well #9 consists of two buildings, Clear Well and Deep Well. The Clear Well appears to be approximately 30 years old, while the Deep Well is about 15 years old.. The Clear well is 530 gross square feet and Deep well is 550 gross square feet. Both buildings have a brick masonry exterior over CMU walls. The Clear Well has a gabled roof while the Deep Well has a hip roof. Both buildings have shingle roofing which has been recently installed.

Building # 1 Front and Side Facade

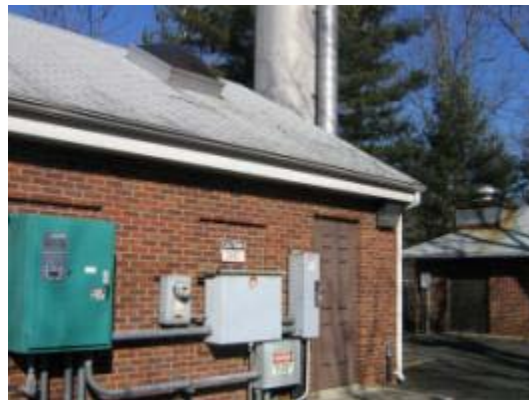
Building # 1 Main Entrance

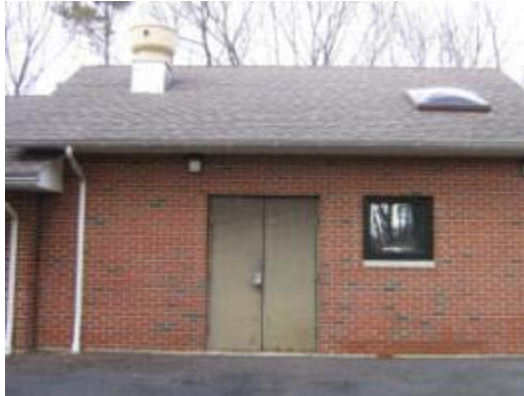
Partial Front Façade (typ.)

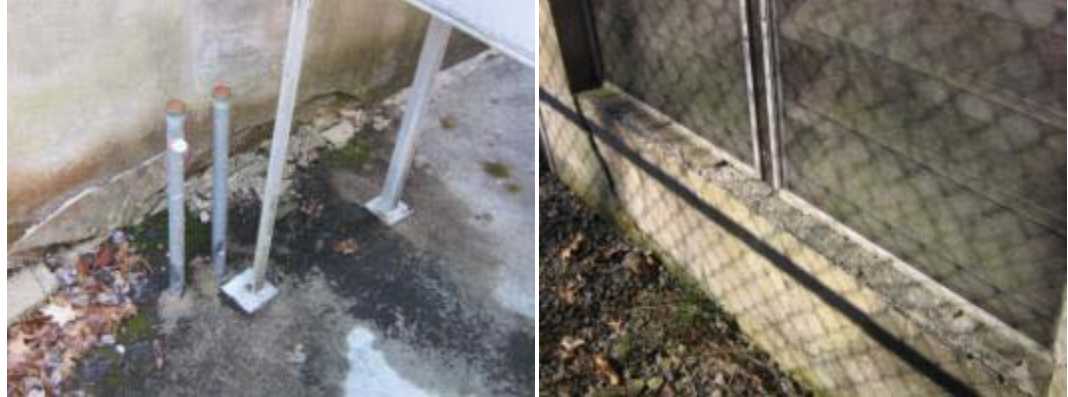
Both buildings are constructed of un-insulated CMU walls with a stucco veneer. The stucco veneer on Deep Well #1 is water marked, stained and deteriorated with significant cracking occurring along the underside of the roof the entire length of the west wall, as were numerous spider cracks on all other sides. Clear Well #2 has significant deterioration of the stucco at the base of the north wall, below the louvers on the east wall and at the N/W corner below the roof.

Serious deterioration of stucco on north and east sides of building

It is recommended that the stucco veneer of both Deep Well #1 and Clear Well #2 be repaired or replaced. Replacement would permit 1" rigid insulation board to be applied to the exterior of the CMU walls and a finished coat of stucco applied over the insulation.

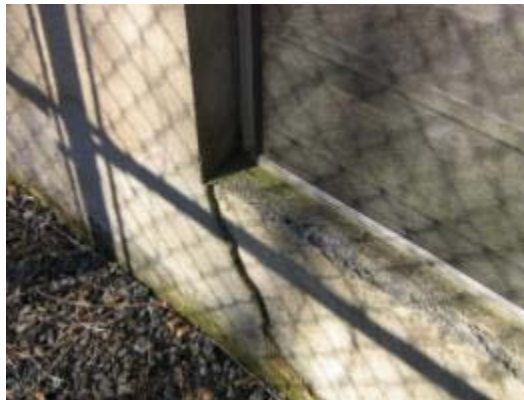
Serious deterioration of stucco on east side of building

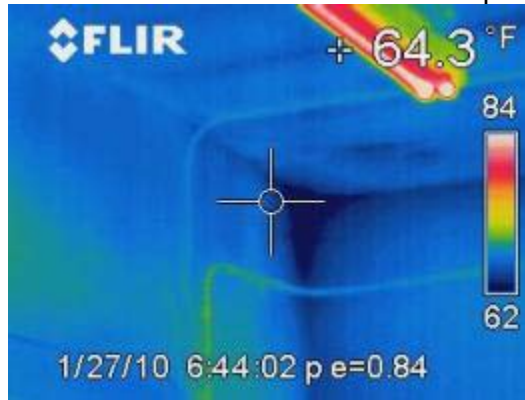
Infrared Image at Southwest Corner at Ceiling

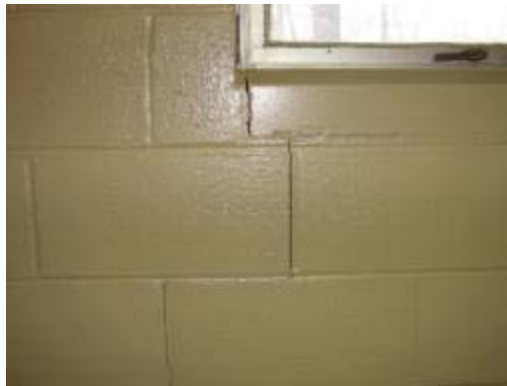
The exterior walls of both buildings are cavity walls constructed of a double wyeth of brick on the exterior and CMU on the interior separated by a cavity. Although the cavity could not be inspected it is assumed there is 1' rigid insulation within the cavity. The exterior of both building is in excellent condition. The only identifiable flaw is a crack through the N/W wall of the Deep Well at the window sill.

Through Wall Crack In Northwest Wall Of Deep Well

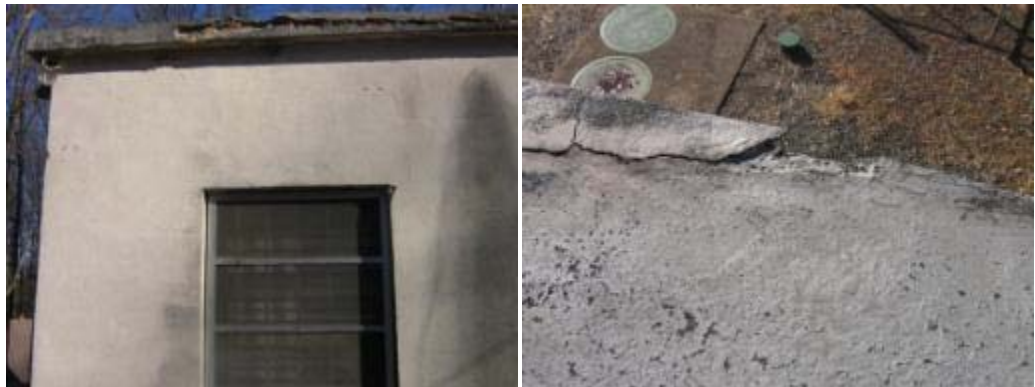
Deep Well #1 has structural damage to the S/W corner which must be repaired.

Deterioration of the coping on Deep Well #1

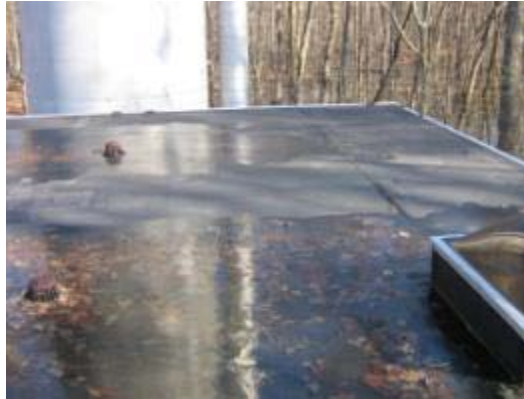
Water Pooling on Clear Well #2

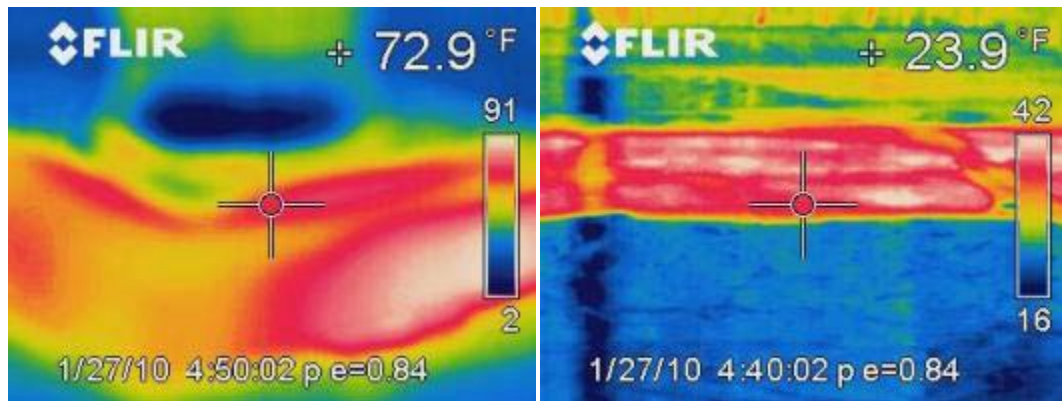
Thermal images of both roofs indicate significant heat loss from the buildings.

Thermal Images of Deep Well Roof

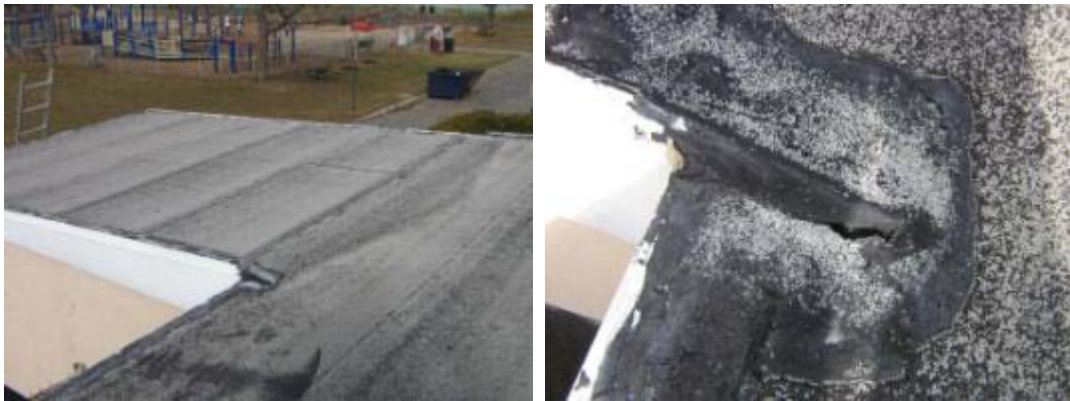
Roof of Deep Well; Roof Joint at Pool Building

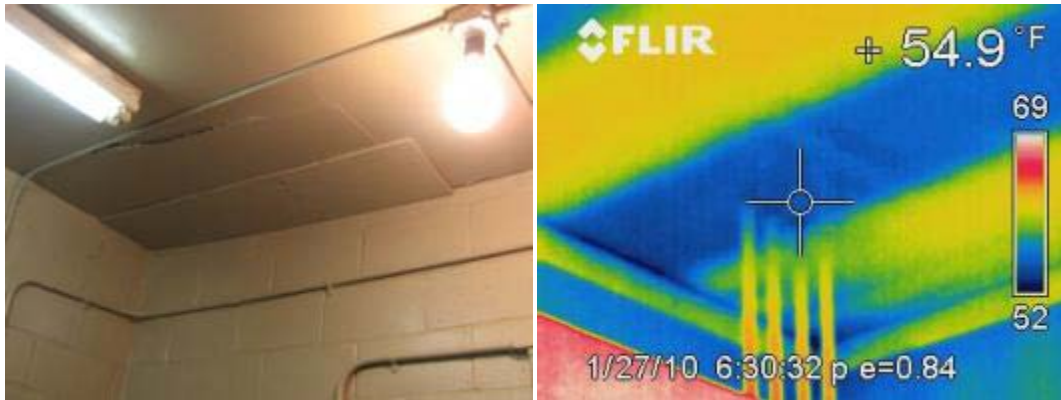
Digital Photo and Infrared Image of Plywood Panel

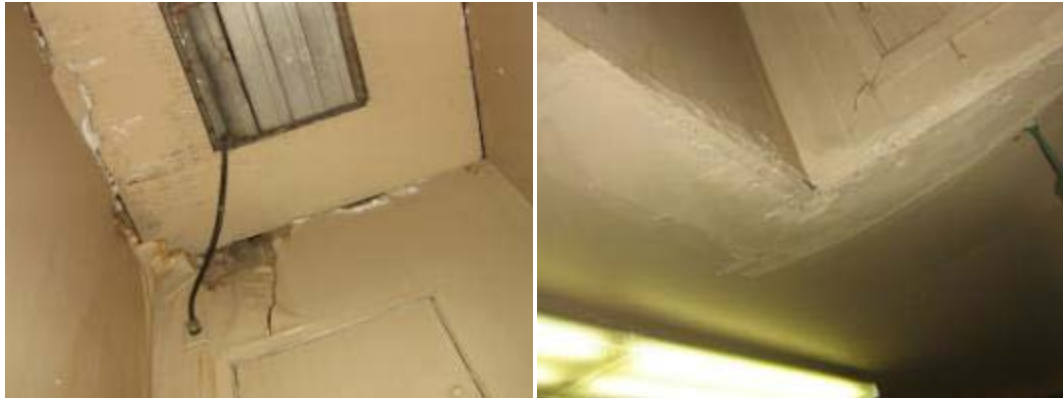
downspouts are installed on the Clear Well Building. The ceiling of the attic space has R-11 fiberglass batt insulation. The attic space is properly vented with gable vents. The Deep Well building has a hip roof structure. It has asphalt roof shingles over plywood sheathing. The roof was built with large overhangs, a single gutter collects rainwater along the southwest elevation. The gutter slopes west with no end cap or downspout. Rainwater spills out the west end of the gutter. The ceiling of the Deep Well has R-19 fiberglass batt insulation.

Typical water damage at the ceiling of the Deep Well building

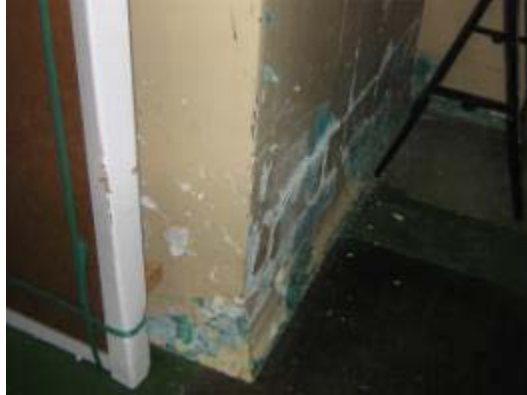
Peeling Paint

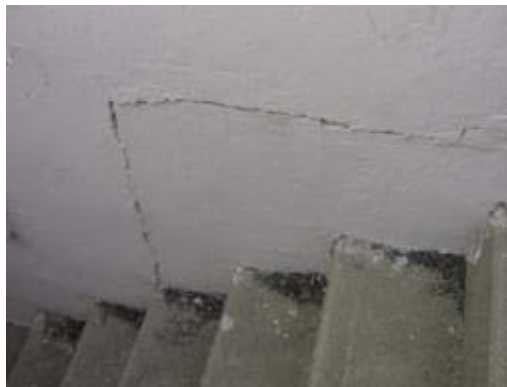
The Clear Well is built on an 8" concrete base and is in excellent condition. The Deep Well has a basement stair alongside its east wall leading to a basement below the pool building. There is deterioration along the east wall below the floor line of the Deep Well.

Deterioration Below Floor Line along East Wall of Deep Well

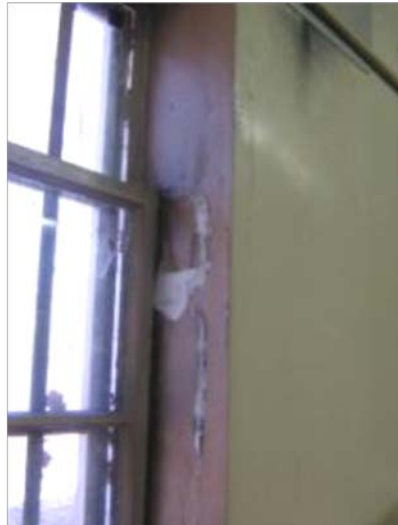
Windows installed in Deep Well #1 are steel industrial single hung with single glazing and no thermal break. Significant water infiltration was noticed along the jamb of the window on the west wall. It is recommended to replace the windows with fixed aluminum frame windows with a thermal break, double glazed.

Window Jamb

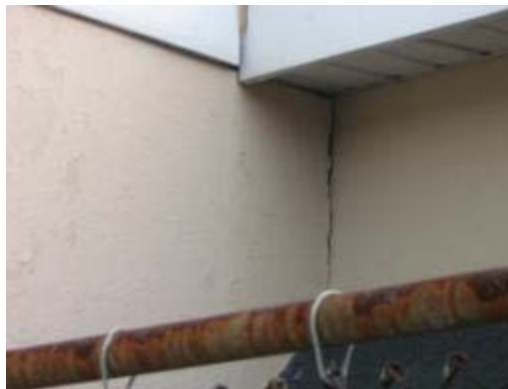
large crack through the north wall at the joint connecting it to the pool building. Both conditions should be corrected with installation of an expansion joint cut into both walls.

Large Crack Through Wall At Joint With Pool Building

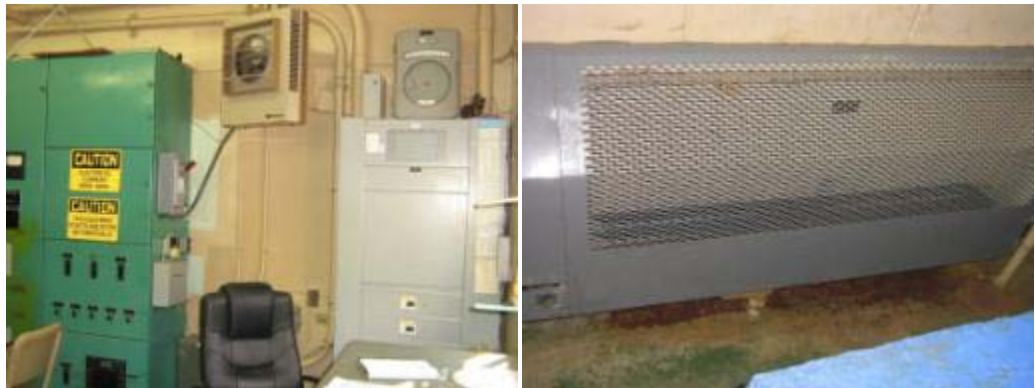
The heating for Building #1 is provided by a 7.5 kW electric unit heater that is mounted from the ceiling. The unit heater is controlled by a thermostat located on the pump control switchgear, opposite the front door. The unit heater is beyond its expected service life but is still in good condition.

Electric Unit Heater In Deep Well (Left) and Electric Baseboard in Clear Well

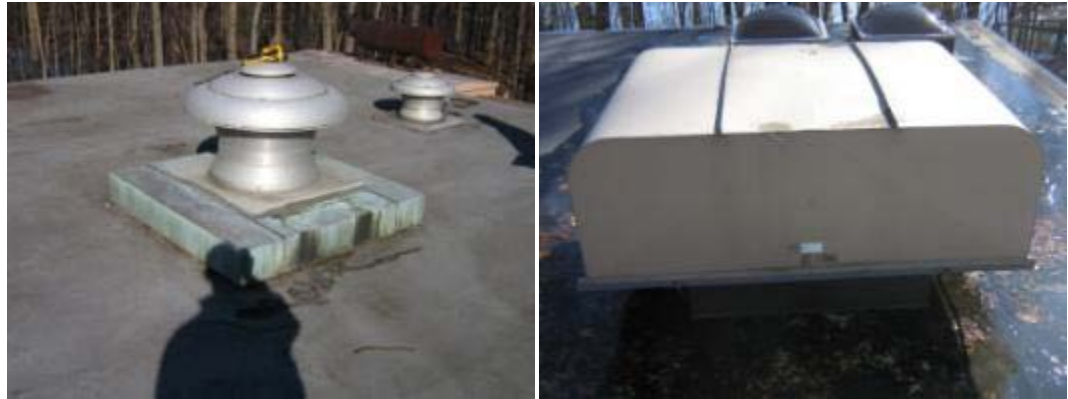
Ventilation for the buildings is provided by a roof-mounted exhaust fan with makeup air provided via window-mounted louvers. Each fan is controlled a wall-mounted thermostat. The louvers and fan on Building #1 are original to the building. The louvers are in good condition, but the fans are in fair to poor condition. The louvers on Building #2 are original to the building and are in fair to good condition. The rooftop fan appears to have been replaced recently and is in good condition.

Rooftop Exhaust Fans for Deep Well (Left) and Clear Well Buildings

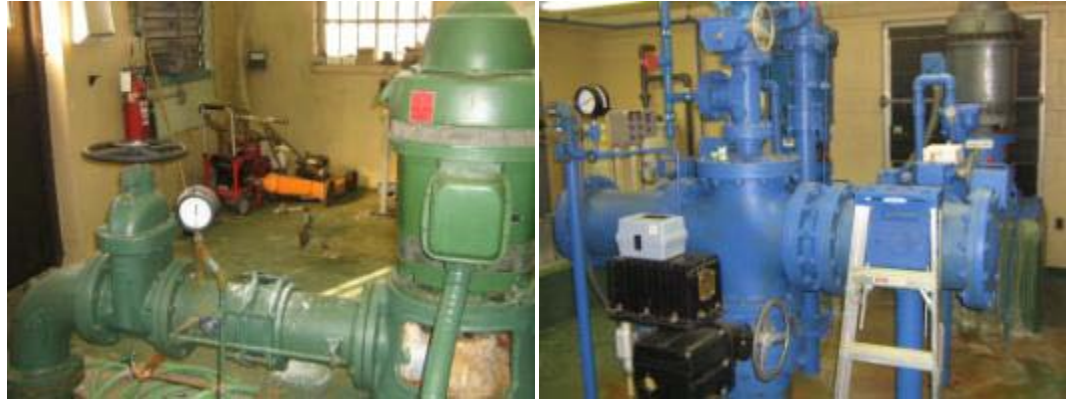
Deep Well Pump (Left) and Clear Well Pumps (Right)

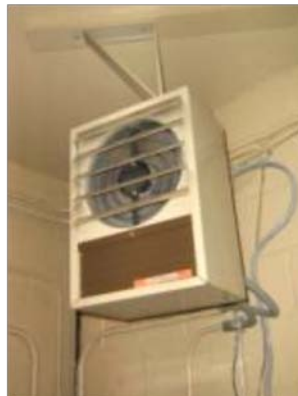
The Clear Well building is heated by a 10 kW electric unit heater that is suspended from the ceiling. The unit heater is beyond its expected service life but is still in good condition. The Deep Well building is heated by a 7.5 kW electric unit heater that is suspended from the ceiling. The unit heater was installed in 1967 and is in fair to poor condition.

Photo – Electric Unit Heater (circa 1967) in Deep Well Building

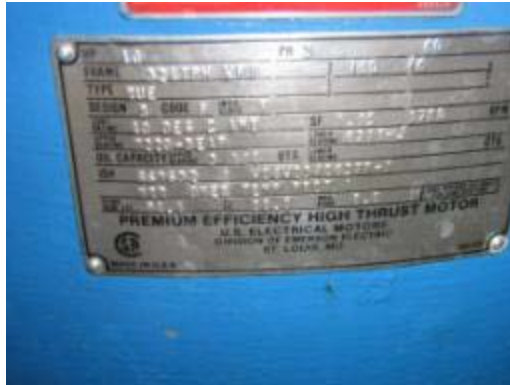
The Clear Well Building contains one (1) 40 HP well pump that was installed in 1993. The pump motor is a premium efficiency unit. In addition, there are two (2) small, fractional horsepower chlorine injection pumps. Aside from this equipment, this facility contains one (1) blower ducted to an exterior stripper tower and also to a dedicated intake louver. This blower had no visible nameplate, but it is estimated that it is served by a standard efficiency, 5 HP motor.

Clear Well Pump Nameplate

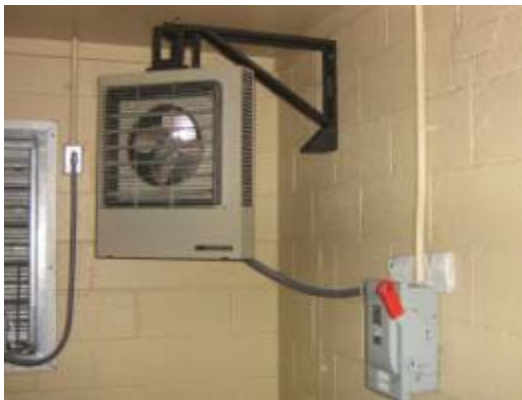
The Clear Well and Deep Well portions of the building are each heated by a 10 kW electric unit heater. In addition, there is a blower closet with a 3.3 kW electric unit heater, and an equipment closet with a 3 kW electric unit heater. The heaters are mounted on wall brackets. The heaters are in very good condition and can be retained. Since there is no natural gas service at the facility, the option of converting the unit heaters to the natural gas type was not investigated.

Electric Unit Heater

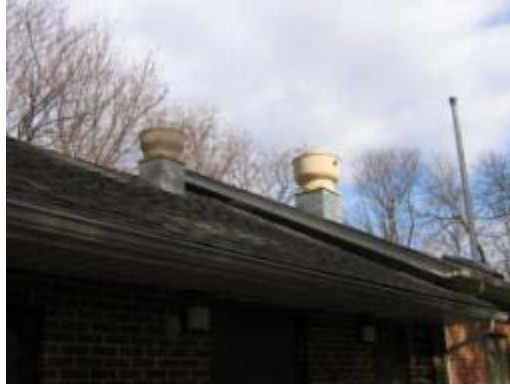
Ventilation for each of the buildings is provided by two (2) roof-mounted exhaust fans, with makeup air provided via (3) wall-mounted louvers in the Deep Well area, and an additional wall louver adjacent to the Clear Well pump (four (4) louvers total).

Rooftop Exhaust Fans

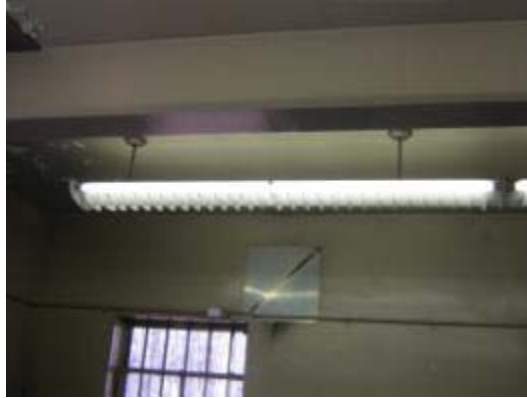
Suspended T12 Fluorescent Light Fixture

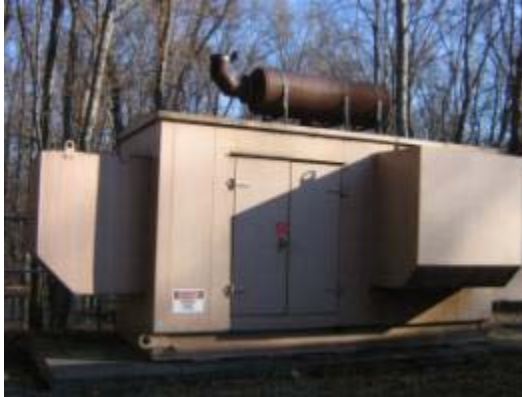
There is one (1) 558.5 KW diesel emergency generator on site. The generator serves the entire facility to provide continuous service during a power outage. This generator was installed in 1993 and is in good condition.

Emergency Generator at Well House #3

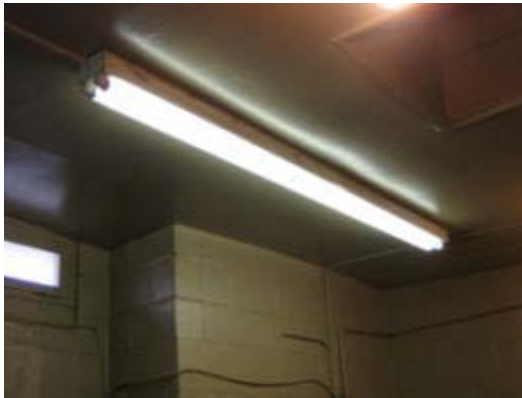
Interior Lighting – The lighting for the Clear Well Building consists of eleven (11) 8 ft long fluorescent fixtures, three (3) of which are in the attic. The lighting for the Deep Well Building consists of one (1) 8 ft long fluorescent fixture and two (2) incandescent fixtures, approximately 100W each. Each fluorescent fixture utilizes a magnetic ballast and two (2) T12 lamps. SWA recommends replacing the fluorescent fixtures with more efficient T8 lamp fixtures (ECM #1), and the incandescent lamps with compact fluorescent lamps. SWA also recommends installing an occupancy sensor to control the light fixture to avoid the possibility of the fixtures being energized when the building is unoccupied.

Surface-mounted fluorescent Light Fixture

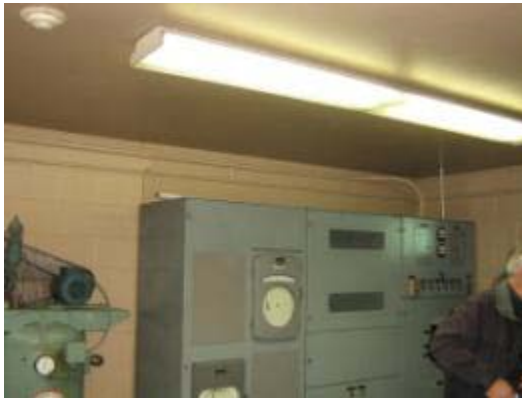
Surface-Mounted Fluorescent Light Fixture Above Pump Control Panel

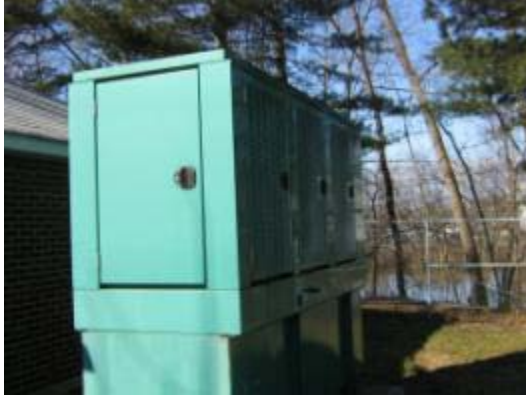
There is one (1) 125KW diesel emergency generator located outside the Deep Well Building. The generator serves the entire facility to provide continuous service during a power outage. This generator was installed in 2004 and is in good condition.

Diesel Generator at Well House #9

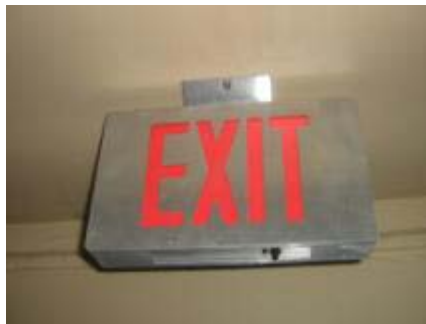
Exit Lights – There are three (3) exit lights in the facility.

Exit Sign

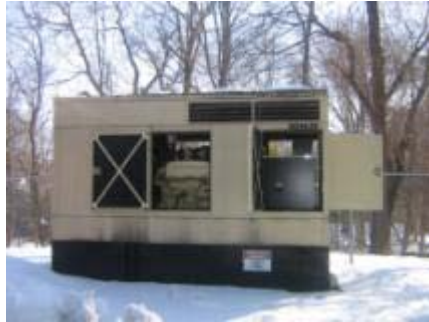
There is one (1) 205 KW diesel emergency generator located outside the Clear Well Building. The generator serves the entire facility to provide continuous service during a power outage. This generator was installed in 2001 and is in good condition.

Diesel Generator
