**Local Government Energy Program  
Energy Audit Final Report**

***Township of Lower  
Department of Public Works Garage  
771 Seashore Road  
Erma, NJ 08204***

***Project Number: LGEA31***

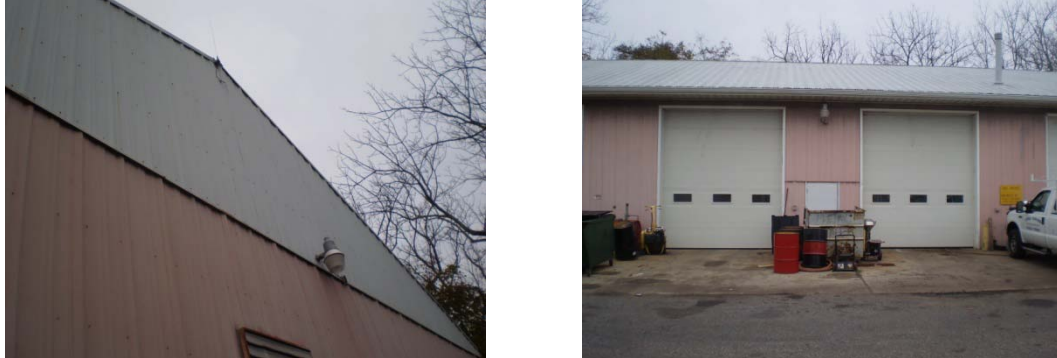
During the field audit exterior and interior wall surfaces were inspected. They were found/ reported to be in overall good/ age appropriate condition with no signs of uncontrolled moisture, air-leakage and/ or other energy-compromising issues detected on all facades.

Typically found aluminum exterior walls

1. Insulate original and uninsulated exterior wall sections during the next major building renovation.
2. Regularly inspect the existing exterior wall with a focus on the condition of the aluminum panels and any signs of water damage or outside air infiltration.

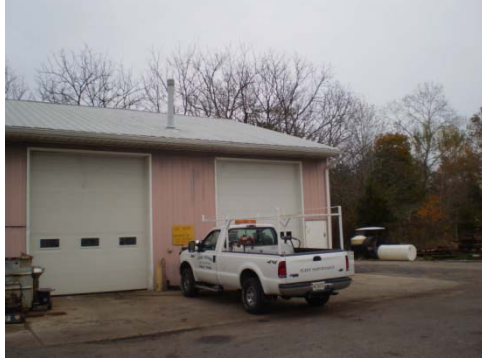
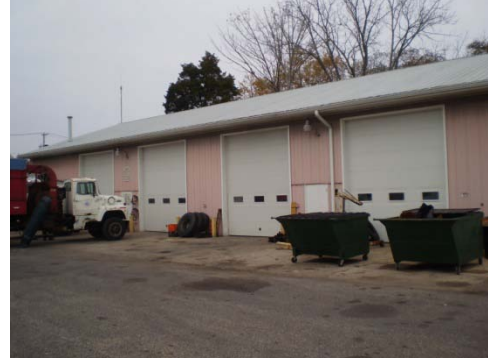
The building's roof is predominantly a medium-pitch shed type over a metal roof deck with a standing-seam aluminum finish. It is original/ has never been replaced. No insulation was observed in either the ceiling or roof.

During the field audit roofs, related flashing, gutters and downspouts were inspected. They were found/ reported to be in overall good/ age appropriate condition with no signs of uncontrolled moisture, air-leakage and/ or other energy-compromising issues detected on all roof areas.

1. Insulate original and uninsulated roof/ ceiling sections during the next major building renovation. SWA suggests applying spray-foam and/ or rigid foam board insulation (R-30 min.) under and/ or on top of the metal decking surface.
2. SWA recommends biannual maintenance inspections with a focus on the drainage, penetrations, flashing and seams of the roof.

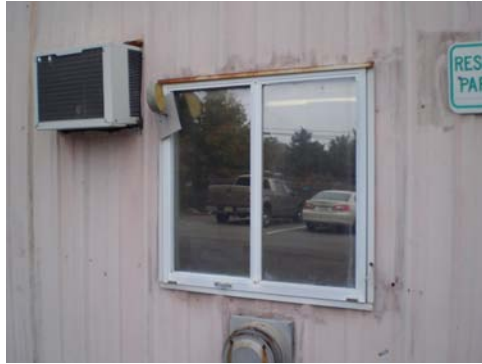
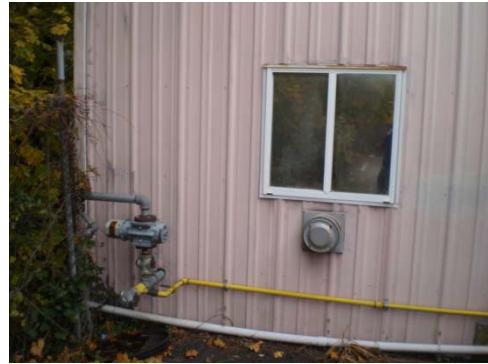
Windows, shading devices, sills, related flashing and caulking were inspected from the exterior and interior as far as accessibility allowed. Based on signs of moisture, air-leakage and other energy compromising issues, overall the windows were found and/or reported to

be in poor condition with numerous signs of uncontrolled moisture, air-leakage and/ or other energy-compromising issues.

Damaged/ aged window frame and air-leakage at sleeved wall air-conditioning units

1. Install operable interior shading devices on windows
2. Replace or repair damaged window units and frames
3. Openings around window/ sleeved air conditioning units need airtight gaskets/ sealants for optimal all year performance. Insulated hoods should be installed during winter months if removing the units is not an option.
4. Regularly inspect all exterior windows with a focus on damaged frames, water damage, properly operating hardware and airtight seals.

- Replace or repair damaged window units – There were several windows that were observed to have damaged window units and frames. These units were observed to allow air to infiltrate the building shell as well as showed signs of water damage. These windows should be replaced or repaired immediately.

- Install airtight gaskets around window air conditioning unit and install insulated hood during winter – The building contained a window AC unit that did not form proper seals to the window that it was mounted in. SWA recommends adding gaskets to form a tight seal to prevent air infiltration and moisture damage. In addition, this unit was observed to be left in the window during the winter months. SWA recommends installing an insulated hood that covers the unit during the winter. Window AC units contain vents that allow air and heat to constantly pass through them. Installing a winter hood will help thermally protect the building during winter months.

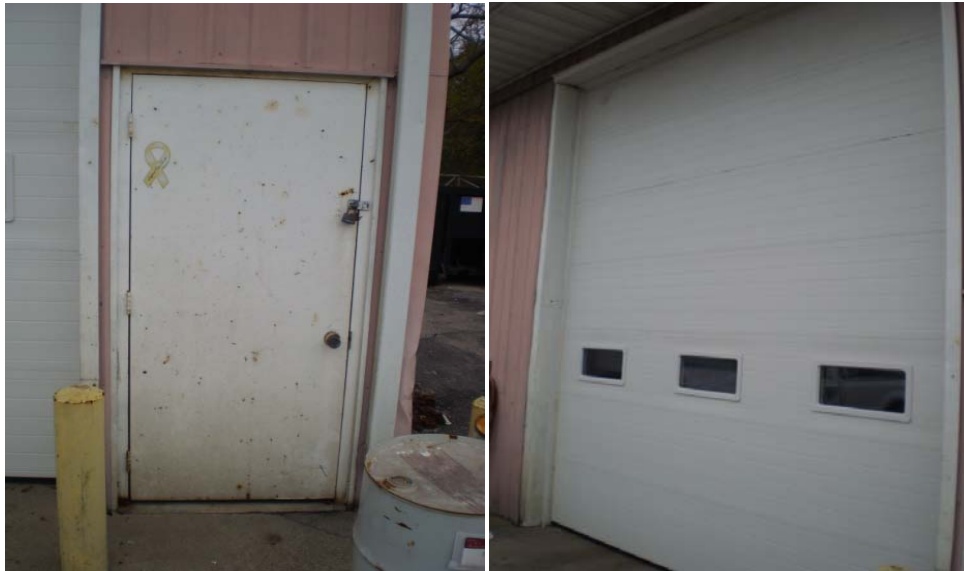
All exterior doors, thresholds, related flashing, caulking and weather-stripping were inspected. Based on signs of moisture, air-leakage and other energy compromising issues, overall the doors were found/ reported to be in acceptable/ age appropriate condition with some signs of uncontrolled moisture, air-leakage and/ or other energy-compromising issues.

Missing/ worn weather stripping and damaged/ warped/ aged door frame

1. Replace/ repair and maintain broken/ non-closing/ damaged door units.
2. Install/ replace/ maintain weather stripping around all exterior doors and roof hatches.
3. Regularly inspect and maintain all exterior doors with a focus on the condition of weather-stripping, properly closing hardware, warped or damaged frames, water damage and outdoor air infiltration.
