**Local Government Energy Program
Energy Audit Final Report**

***Township of Lower
Millman Center
209 Bayshore Road
Villas, NJ 08251
Project
Number: LGEA31***

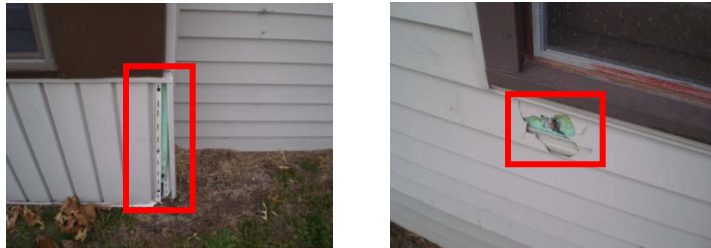
Damaged exterior wall finishes with missing vinyl siding to be replaced

1. Install new vinyl siding at locations where it is missing
2. Biannual maintenance inspections to inspect the exterior walls with a focus on damaged or missing siding, and locating sources of water and air leakage.

- Install new vinyl siding at locations where it is missing – SWA observed several areas of the building that had missing or damaged vinyl siding. This siding should be replaced immediately.

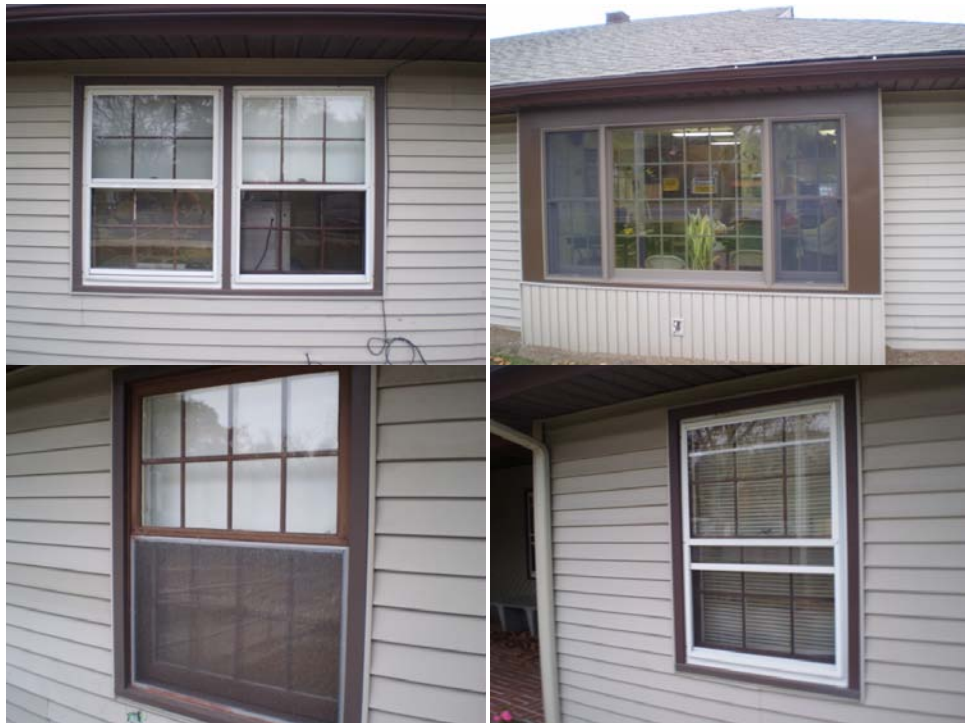
Typically installed windows with wooden frame unit showing signs of advanced age and some damage to the frame.

- Regularly inspect and maintain existing windows – The Millman building was observed to contain windows that had frames with minor frame damage, cracked glazing, improperly functioning hardware and water damage. SWA recommends performing routine maintenance

1. Replace all original/ single glazed windows with a low-E, double glazed type during the next major building renovations.
2. Regularly inspect and maintain existing windows with a focus on damage frames, cracked glazing, improperly functioning hardware, water damage and leaks, and lack of an airtight seal.

- Replace all original/single-glazed windows – SWA recommends considering an upgrade from all the existing windows to low-E, double-glazed type during the next major building renovation. Replacing the windows would not be cost-effective based on energy savings alone at this point in time.

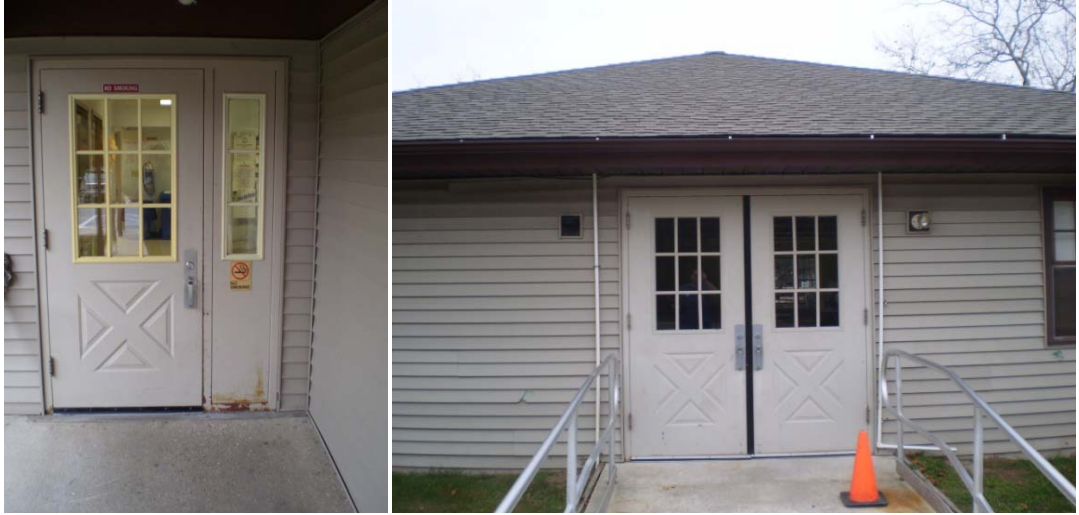
Exterior doors exhibiting worn weather stripping and damaged door frame

1. Maintain and replace any missing weather stripping around all exterior doors.
2. Regularly inspect all exterior doors with a focus on the condition of the weather-stripping, physical condition of the exterior door surface, warped door frames, water damage, proper closing of the door, and an airtight seal.

- Provide weather stripping / air sealing – SWA observed that all windows and doors had proper weather-stripping and air sealing due to their age. As a best practice, SWA recommends that each window and door is inspected twice per year for deficiencies. Any time that a seal has been compromised, building maintenance staff should repair and replace the seal immediately to ensure that thermal barriers are not breached.
