**Local Government Energy Program
Energy Audit Final Report**

***Public Library
Borough of Metuchen
Metuchen, NJ 08840***

Project Number: LGEA18

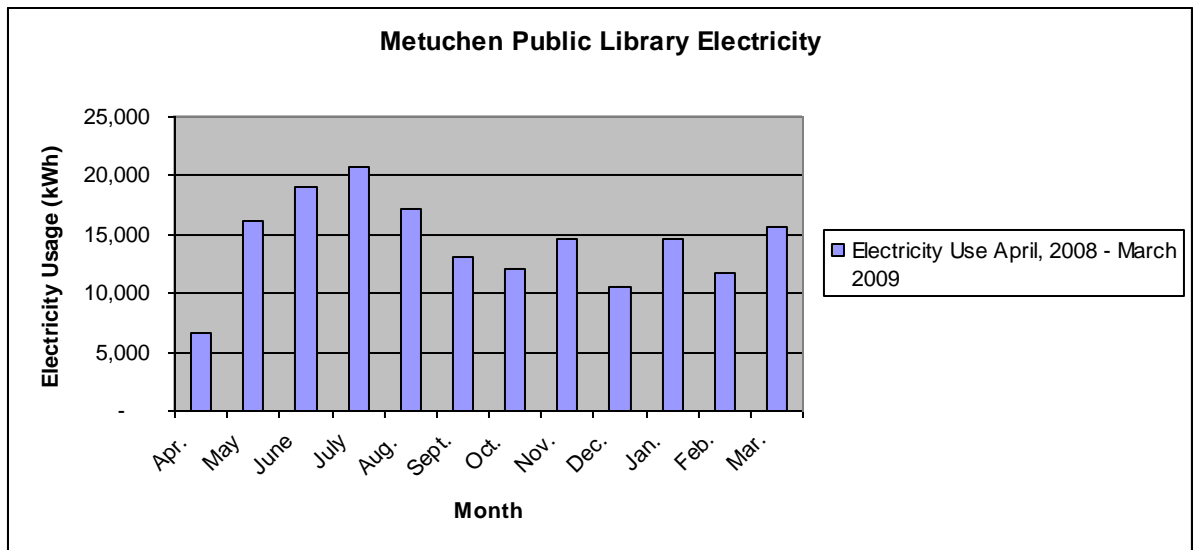
The following chart shows electricity usage for the Municipal complex based on utility bills for January 2008 through December 2008.

In the above chart, the electricity spikes upwards during the summer months reflect the cooling load as expected.

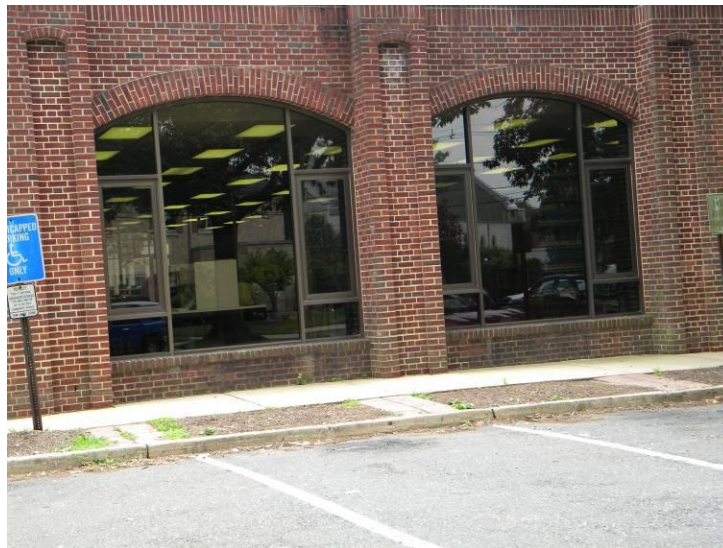
Addition Existing Windows

The existing windows at both sections of the Library are single glazed with very little insulating qualities. Due to seasonal conditions at the time of the site visit, SWA could not review the actual performance of the windows during cold weather but single glazed windows are a poor performance energy option. New windows would be extremely expensive and cosmetically would actually detract from the appearance of the older section, which has large, very attractive old windows.

Installation of new windows would not be economically viable. There are interior and exterior retrofit strategies that would provide increased comfort for building occupants and significant energy savings. One alternative may be the installation of an interior storm window system manufactured using two layers of high strength plastic film on an aluminum frame. This type of system has been shown to lower the u-value (u-value is a measure of transmission of heat through a material or assembly; lower numbers indicate better performance) of single pane windows from about .9 to .31, almost triple the insulating value. These systems have also been shown to reduce drafts and minimize radiation from cold surfaces. It is difficult to verify the rated energy performance of site-built assemblies, as a result, it is difficult to guarantee energy savings and any associated economic payback. Selection of the appropriate alternative should be made with consideration to comfort, durability, window functionality, and aesthetics as well as possible energy savings. Also the large windows at the southwest side of the addition should be equipped with a solar control film either applied directly to the existing glazing or as part of the storm window system. The solar gain from these windows can be felt at more than 25 feet away from the window and this kind of extra load causes the cooling system to labor, wasting electricity.

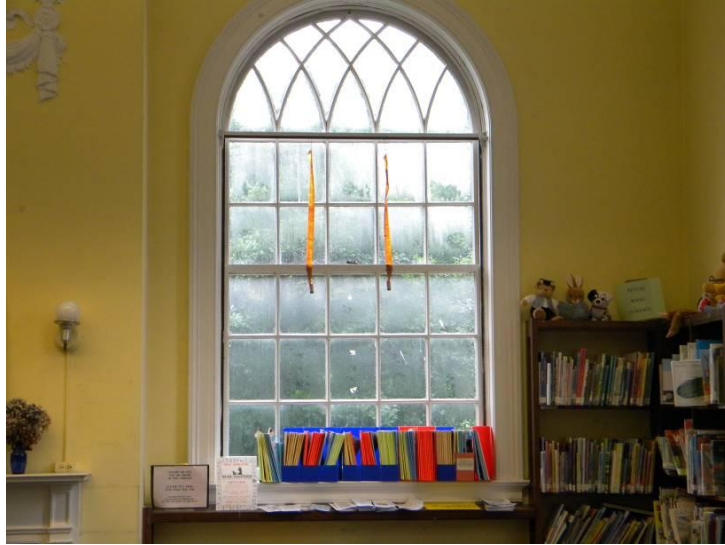
Original Building Existing Windows

The operable windows, especially the single hung windows in the older section, were extremely difficult to open if they could be opened at all. They were obviously covered with Plexiglas at one time and were not used at all for ventilation. Several of the larger windows in the newer section had small operable casement type panels framed into the glass and these did operate well. As a best practice, SWA recommends that all windows be inspected at least once a year. Any gaps, cracks, or damage to weather-stripping or caulking should be repaired or replaced, as needed, to minimize energy loss around those openings. Building staff should also verify that windows open and close properly and have them repaired, as needed.

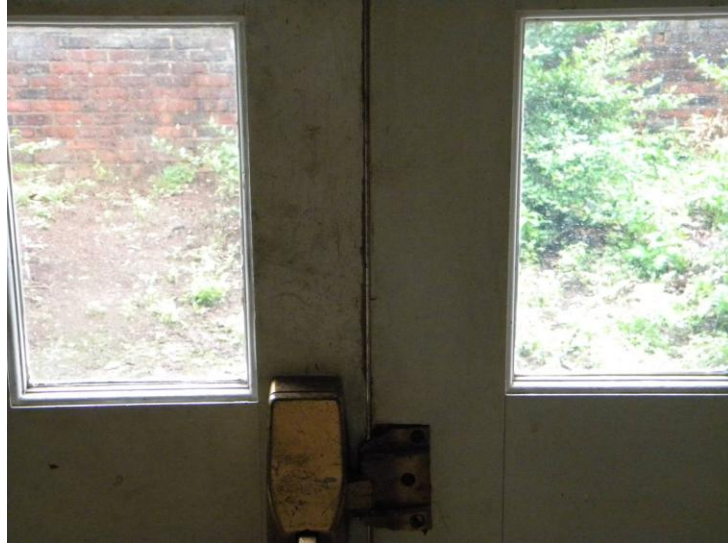
Some of the exterior doors are in satisfactory condition with much of the weather-stripping still intact. But some of the doors in the old section are older wood doors and the weather-stripping on these is failing and needs to be replaced. If not properly maintained, exterior doors can become major sources of heat loss and infiltration. As a best practice, SWA recommends checking the weather-stripping of each door on a regular basis and replacing any broken seals immediately. This will help optimize comfort and energy performance.

Daylight can be seen between two emergency egress doors at old section

- Weather Stripping/Air Sealing – As a best practice, exterior/overhead doors and vestibules should be observed annually for deficient weather-stripping and replaced as needed. The perimeter of all window frames should also be regularly inspected and any missing or deteriorated caulking should be re-caulked to provide an unbroken seal around the window frame. Building staff should also verify that windows open and close properly and repair, as needed. Any other accessible gaps or penetrations in the thermal envelope should also be sealed with caulk or spray foam. Particular attention should be paid to penetrations and doors connecting the main building to the garage to prevent transfer of combustion product.

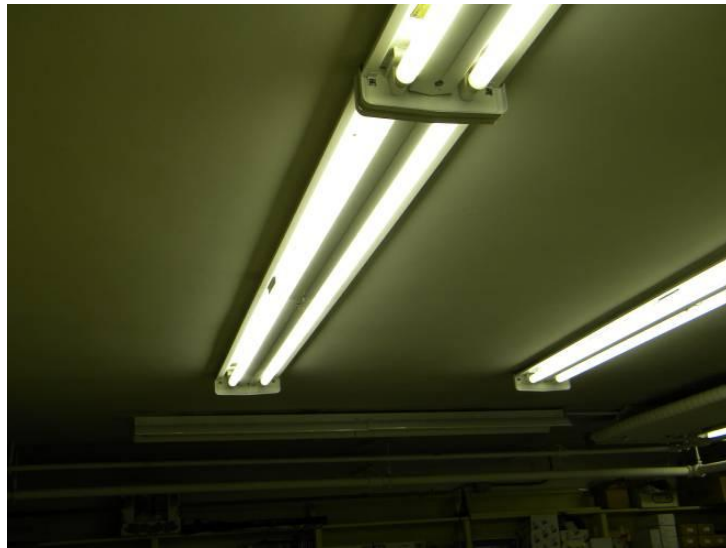
The lighting in the addition, however, contains mostly fixtures with magnetic ballasts and T12 (inch and a half diameter) lamps.

T12 Fluorescent Lamps in Processing Room

The lighting at the newer section of the Library is mostly comprised of older technologies. There are some incandescent lighting and some compact fluorescent lighting. The bulk of the lighting is provided by linear fluorescents using magnetic ballasts and T12 diameter lamps. Almost all of the linear fluorescent lighting should be replaced, or retrofitted where possible, with electronic ballasts and T8 diameter lamps.

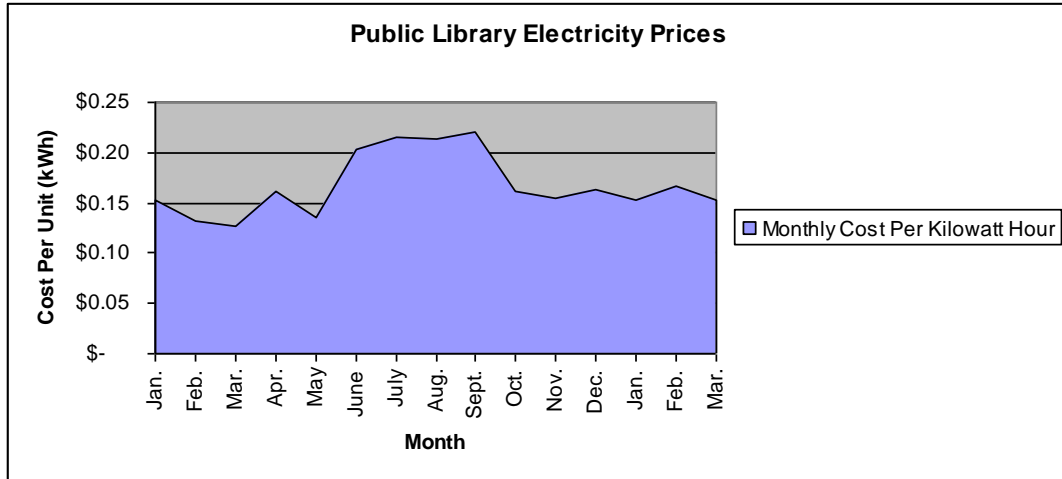
Electric account

Bill analysis shows prices fluctuation of over 20% for both electricity and for natural gas over the course of January 2008 through March 2009 and April 2008 and June 2009 respectively.

We recommend contacting the NJ Energy Choice program and deciding if a third party energy supplier for both the gas and the electricity would benefit the Township.
