**Local Government Energy Program
Energy Audit Final Report**

South River Appleby Avenue Firehouse
South River, NJ 08882

Project Number: LGEA48

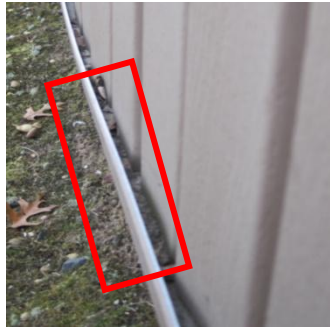
Faulty construction detail at vinyl panel termination that can promote water / moisture penetration into the wall cavity by clogging or wind driven rain.

- Repair / seal wall cracks and penetrations - SWA recommends as part of the maintenance program to install proper flashing, seal wall cracks and penetrations wherever necessary in order to keep insulation dry and effective.

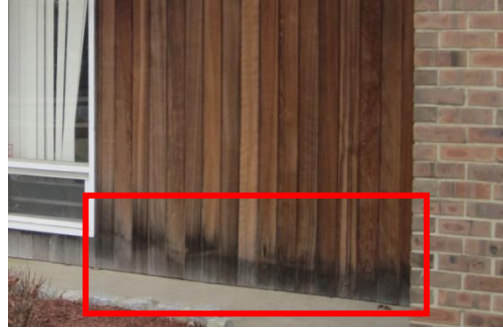
Signs of water damage at perimeter walls due to missing / ineffective site drainage.

- Slope perimeter grade away from building to maximize site drainage.
- Maintain / repair garage doors so that they fully close and are sealed all around.
- Thoroughly and evenly insulate space above the ceiling and plug all ceiling penetration.

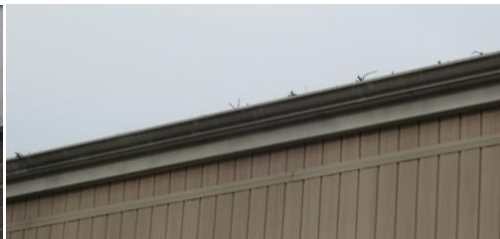
Clogged/ ineffective gutters

3. Repair / patch flat roof finish.
4. Clean gutters and downspouts.

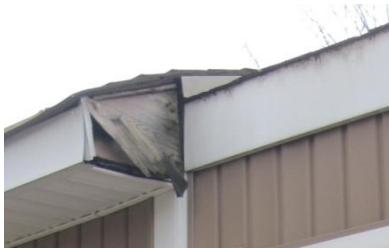
Missing / deteriorating wood trim / moldings

1. Replace asphalt shingle roof finish due to age and condition.
2. Install / repair and maintain roof fascia / wood trim and moldings.

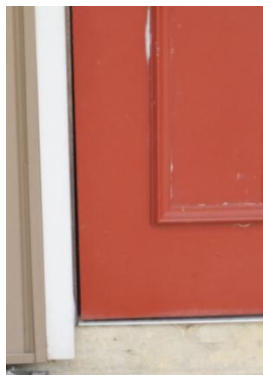
*Missing / worn
weather stripping*

1. Install / replace / maintain weather stripping around all exterior doors.

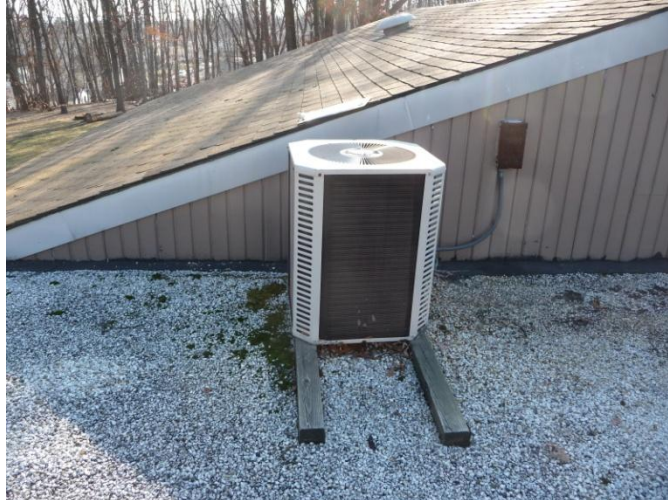
The lounge and bar are cooled by a York split system with an evaporator in the furnace discharge ductwork and a rooftop mounted condenser, which was installed in 2000 and has approximately 30% left of its expected service life of 15 years.

Lounge / bar rooftop condenser
