**Local Government Energy Program
Energy Audit Final Report**

South River George Street Firehouse
South River, NJ 08882

Project Number: LGEA48

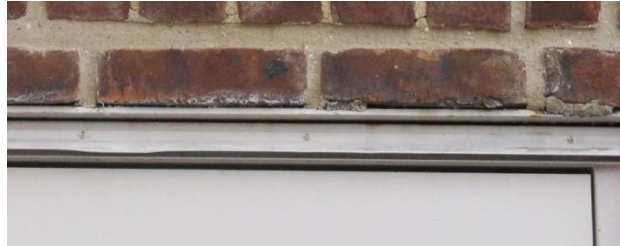
Cracked / deteriorated mortar joints

1. Re-point deteriorated mortar joints soon to prevent possible water / moisture penetration into cavity walls.
2. Rusted / deteriorated steel lintels need to be repaired or replaced before water / moisture can penetrate further into the wall cavity.
3. Apply appropriate air-sealing strategies around all exterior wall penetrations (incl. electrical, plumbing and HVAC).

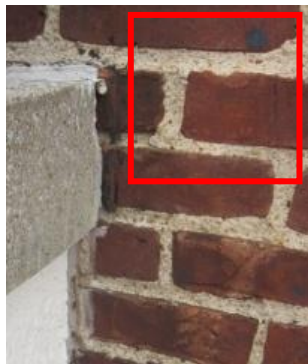
Deteriorated mortar joints

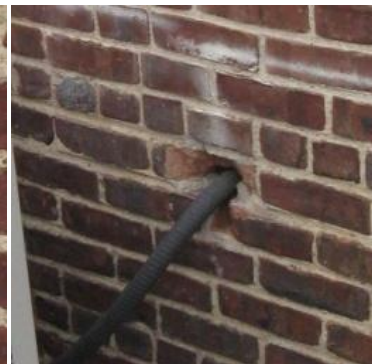
Un-caulked / unsealed exterior wall penetrations

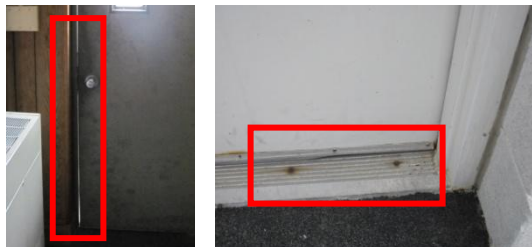
Missing / worn weather stripping

1. Install / replace / maintain weather stripping around all exterior doors and roof hatches.

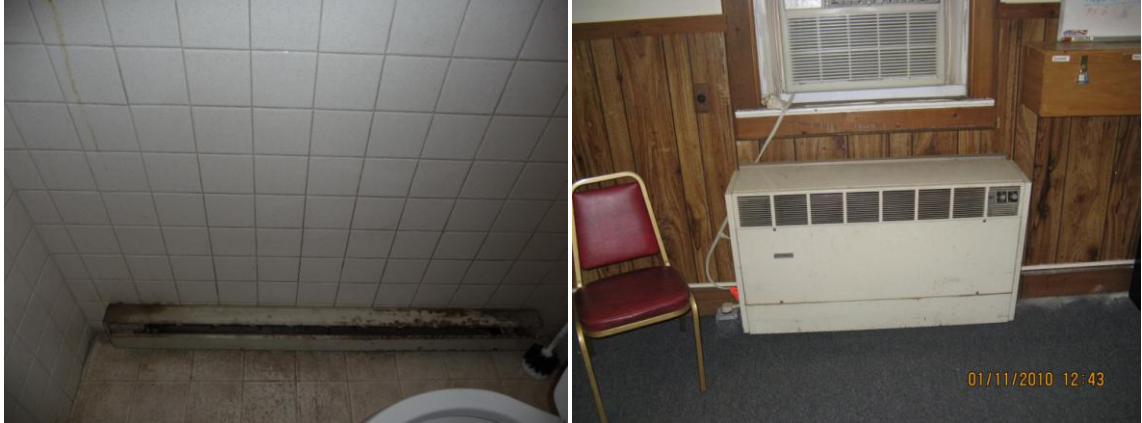
The building is heated by approximately 9 wall electric heaters, each controlled by local manual knobs. These emitters are located in the meeting room, offices, bathrooms, stairwell and corridors. They are very old and past their expected useful operating lives. There weren't many complaints about the ability of the heating system to provide adequate comfort to the building occupants. SWA recommends replacement with updated units controlled by programmable thermostats. The building, including the truck bays, is generally maintained at 62 deg F when unoccupied. SWA was told that this is the optimum temperature to startup the truck diesel engines and also provide an easy recovery to higher temperatures as activities may need to ramp up.

Rusted and old wall electric coil heating emitters

- Replace common area heating equipment - such as finned tube radiation and cabinet unit heaters in the toilet rooms, vestibules, corridors and meeting room. This equipment is in fair condition, but age and wear have reduced the heat transfer capacity. This equipment should be replaced with more modern equipment suited for the intended use. These changes cannot be justified based on energy savings alone. However, replacement is strongly recommended along with programmable thermostats and upgrades to other portions of the heating system. This is a replacement in kind recommendation which offers negligible energy savings.

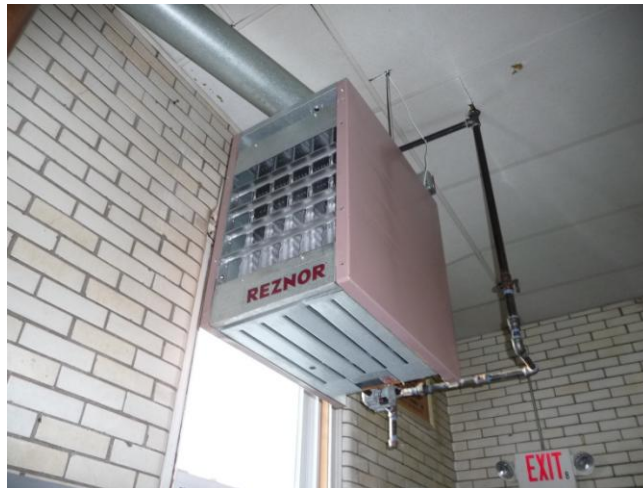
Heating to the truck bays is provided by 4 Reznor ceiling hung gas fired heaters, each capable of 100 MBtu/hr input, 80% efficient, installed in 2008 and having approximately 90% left of their expected service lives of 15 years.

Truck bay Reznor gas heaters

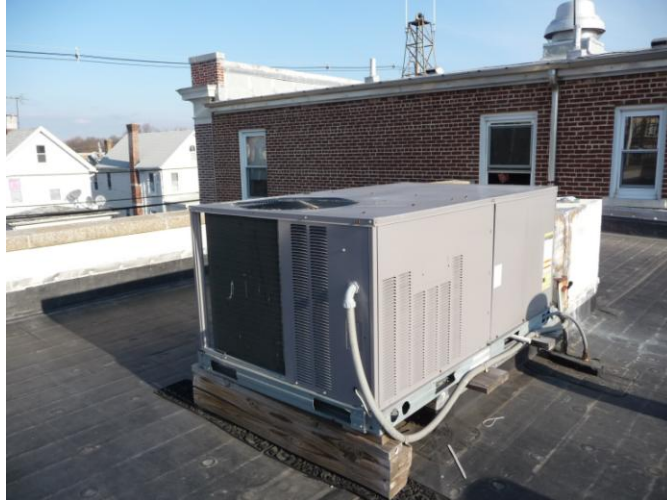
The first floor lounge / bar is heated / cooled by a Carrier rooftop heat pump system. It was installed in 2009 and has approximately 90% left of its expected service life of 15 years.

Lounge / bar rooftop Carrier heat pump

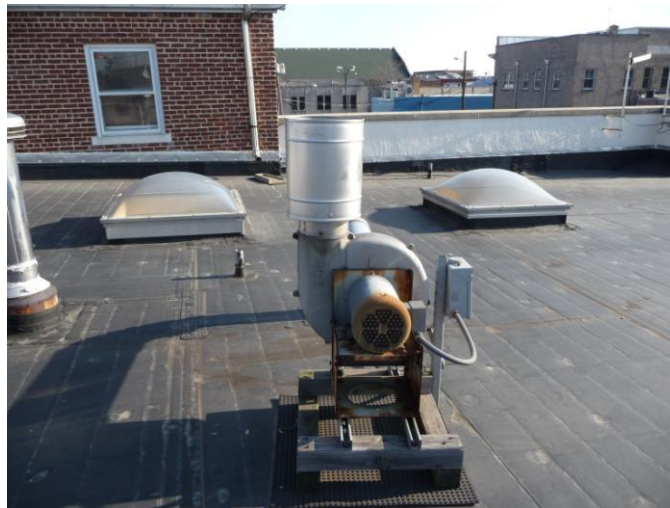
Rooftop fan to vent fire truck exhaust
