**Local Government Energy Program
Energy Audit Final Report**

South River War Memorial Building
South River, NJ 08882

Project Number: LGEA48

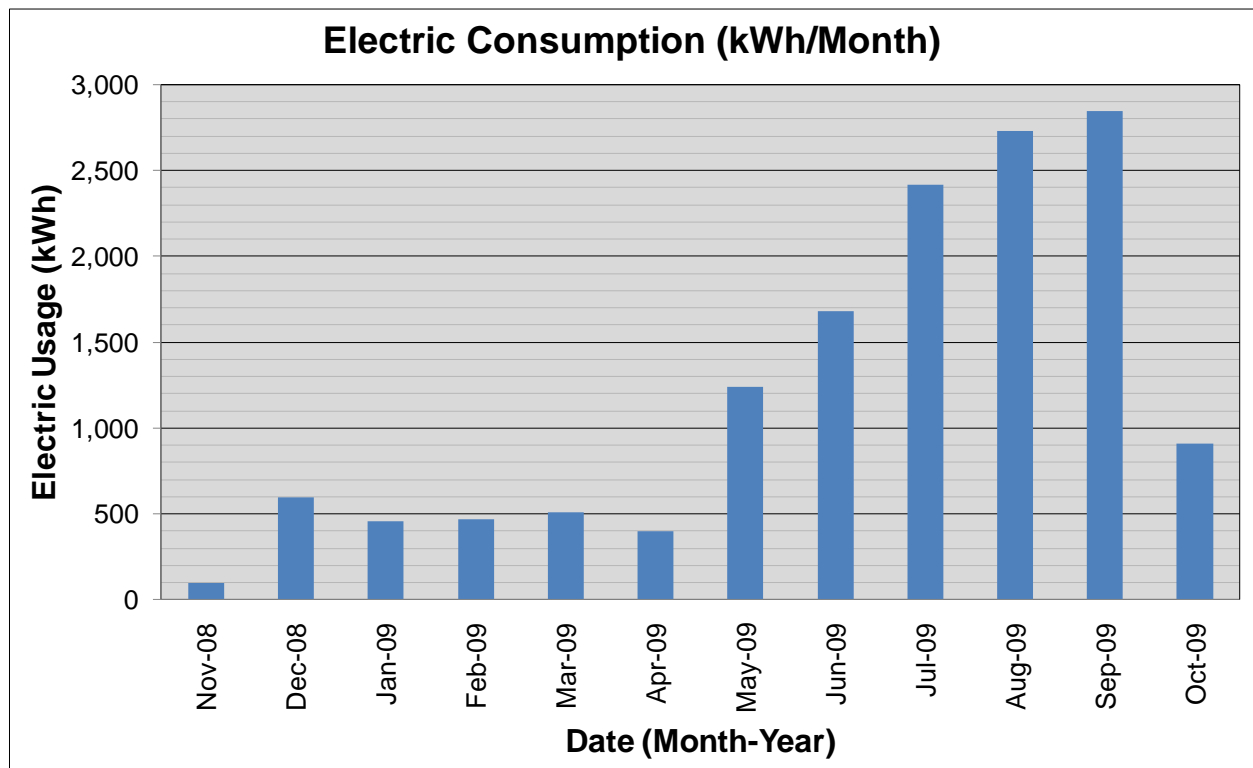
The following chart shows electricity use for the War Memorial Building based on estimates for the 12 month period of November 2008 through October 2009.

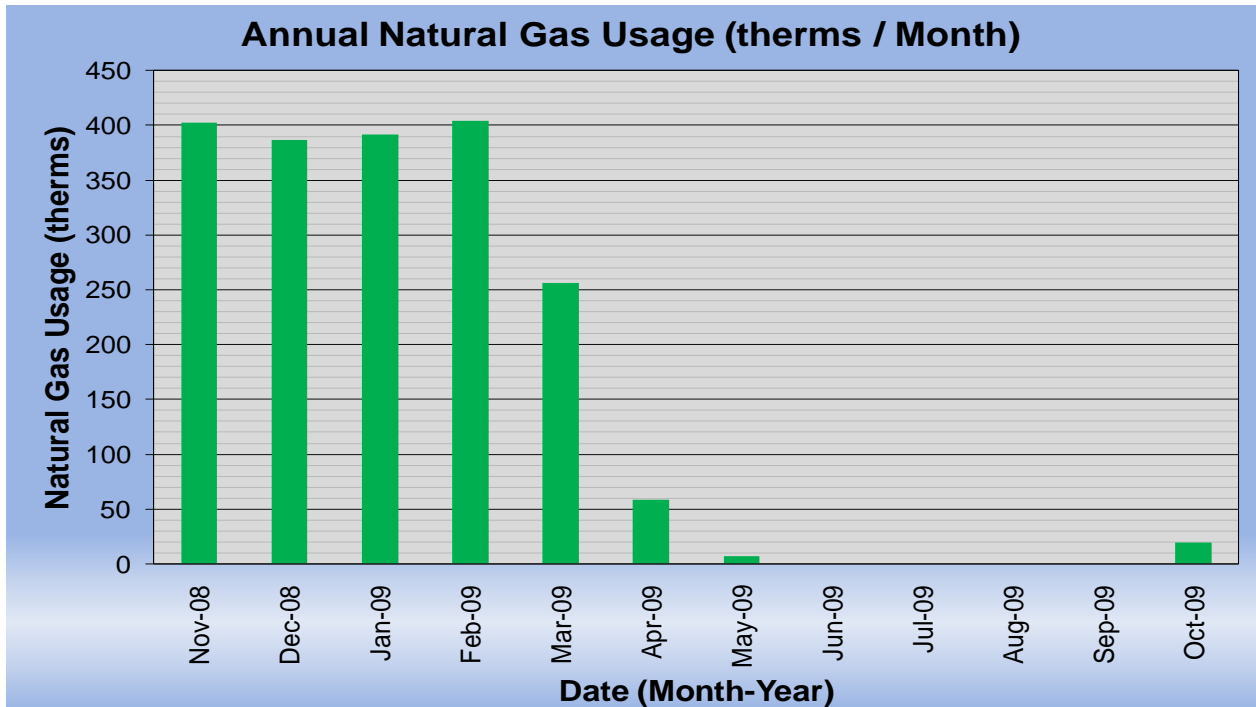
The following chart shows the natural gas consumption for the War Memorial Building based on natural gas bills for the 12 month period of November 2008 through October 2009.

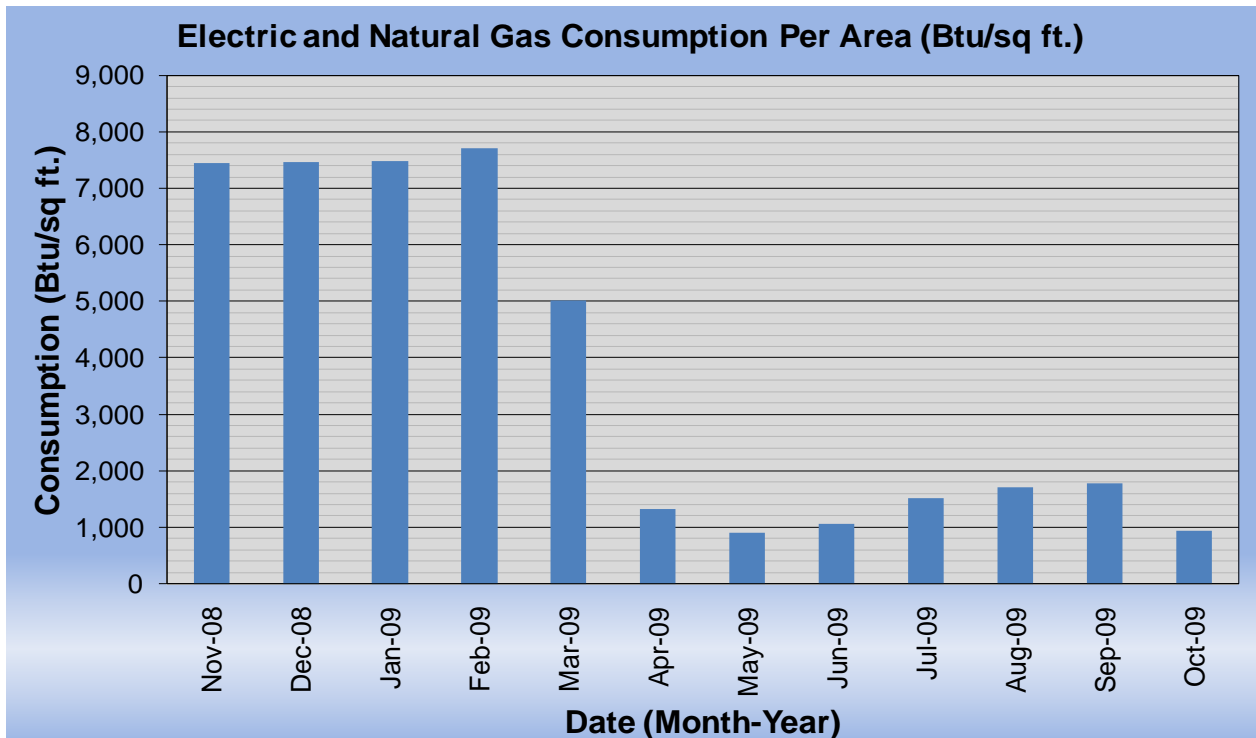
The following chart shows combined natural gas and electric consumption in Btu/sq ft for the War Memorial Building based on estimates and utility bills for the 12 month period of November 2008 through October 2009.

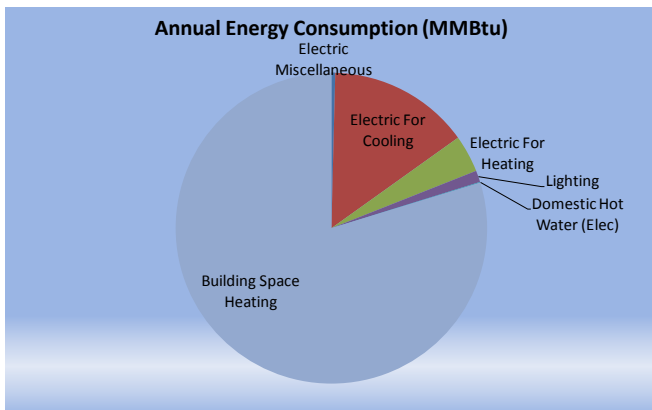
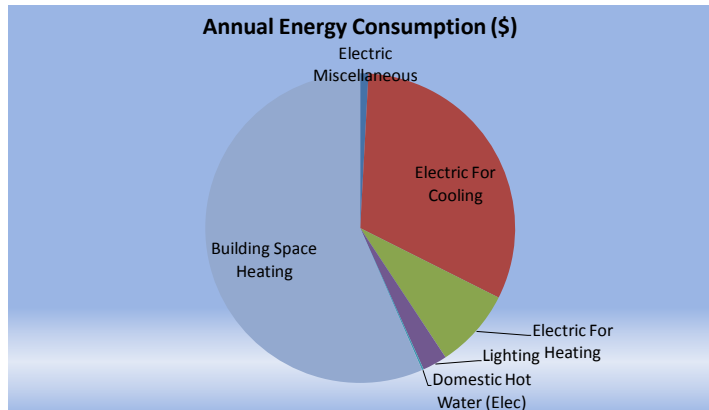
The following table and chart pies show energy use for the War Memorial Building based on utility bills for the 12 month period of November 2008 through October 2009. Note electrical cost at \$38/MMBtu of energy is 3 times as expensive to use as natural gas at \$13/MMBtu.

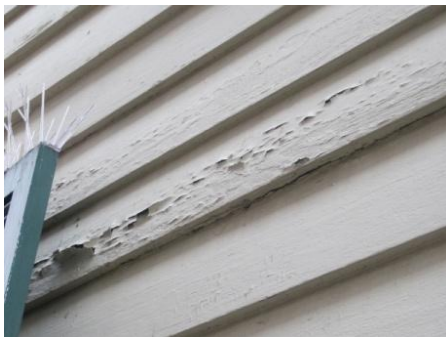
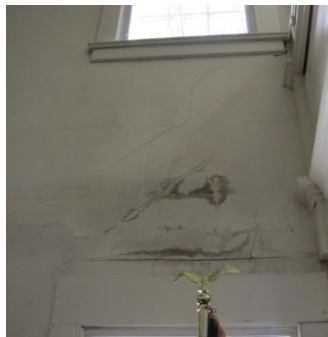
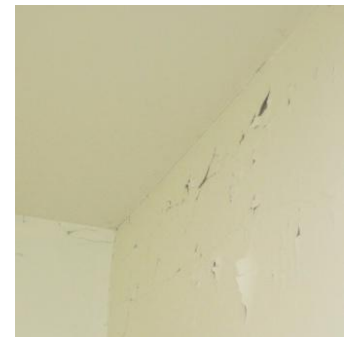
Deteriorating interior and exterior wall finishes due to water / moisture presence inside the wall cavity.

1. Inspect and replace cracked / ineffective caulk and head flashing around all windows in the affected areas and also inspect roof finishes and flashing in the building's rear to prevent leaks.

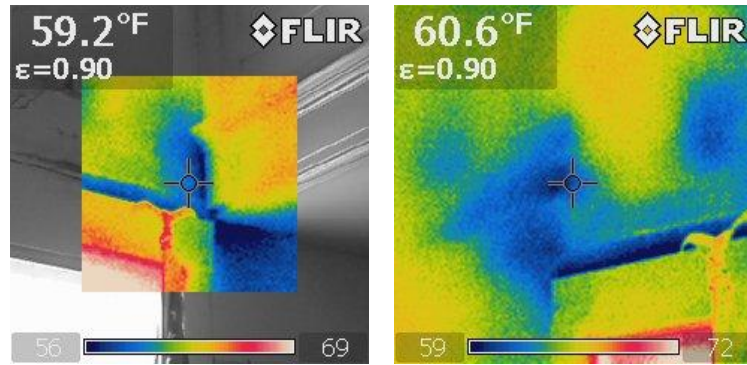
Water / moisture issues within the exterior wall assembly.

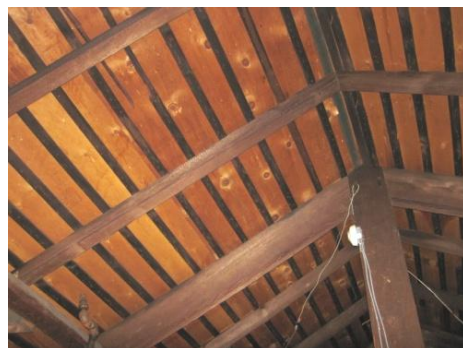
Missing soffit and ridge vent system

- Maintain roofs - SWA recommends regular maintenance to verify water is draining correctly. Install soffit and ridge vent system for effective attic ventilation.

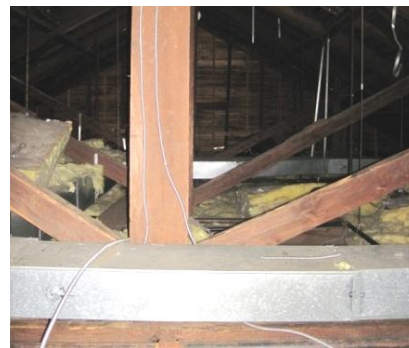
Uneven / ineffective attic insulation found.

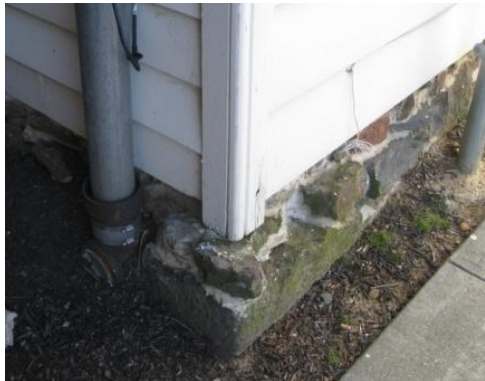
Missing cap flashing for exposed foundation wall.

1. Install cap flashing with drip edge on top of exposed footing to deflect water away form foundation wall.

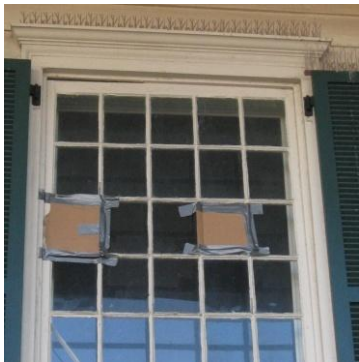
Broken / missing glazing

1. Replace all original / single glazed windows and frames with historically / architecturally accurate low-E, double glazed type during the next major building renovation.

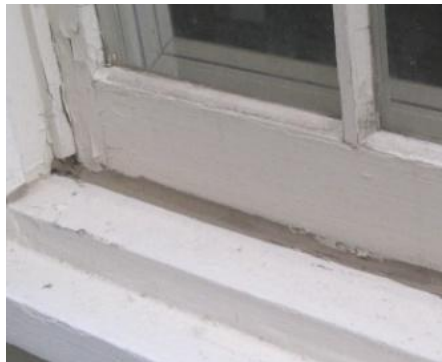
Damaged / aged window frame

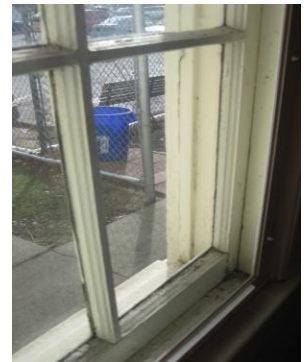
Single glazed window with ineffective frame

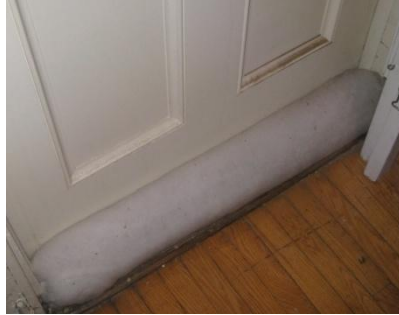
Damaged / warped / aged door frame

1. Replace doors and frames with historically / architecturally accurate units during the next major building renovation. Should the doors be original then SWA suggests only replacement of the frames and restoration of doors as necessary to minimize air-leakage.

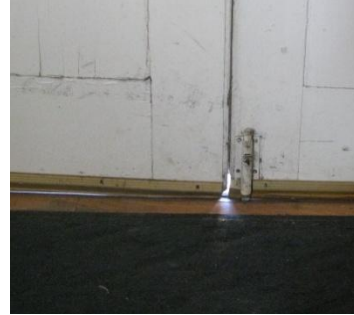
Missing / worn weather stripping

- Provide weather stripping / air sealing - SWA observed that exterior door weather-stripping in places was beginning to deteriorate. Doors and vestibules should be observed annually for deficient weather-stripping and replaced as needed. The perimeter of all window frames should also be regularly inspected and any missing or deteriorated caulking should be re-caulked to provide an unbroken seal around the window frames. Any other accessible gaps or penetrations in the thermal envelope penetrations should also be sealed with caulk or spray foam.

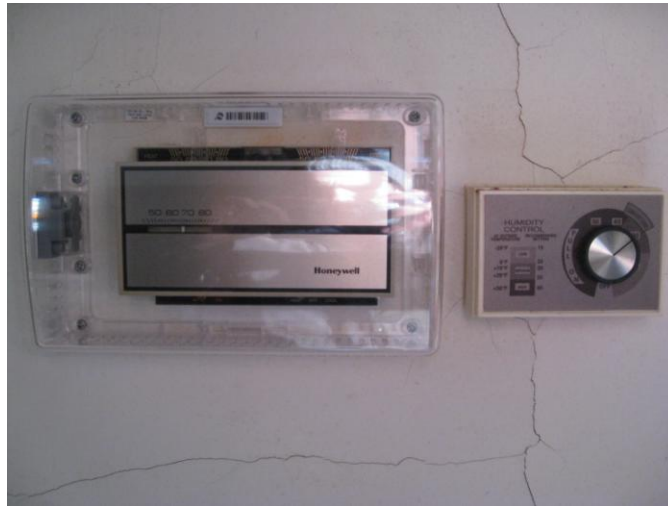
War Memorial building wall mounted programmable thermostat and humidity controller

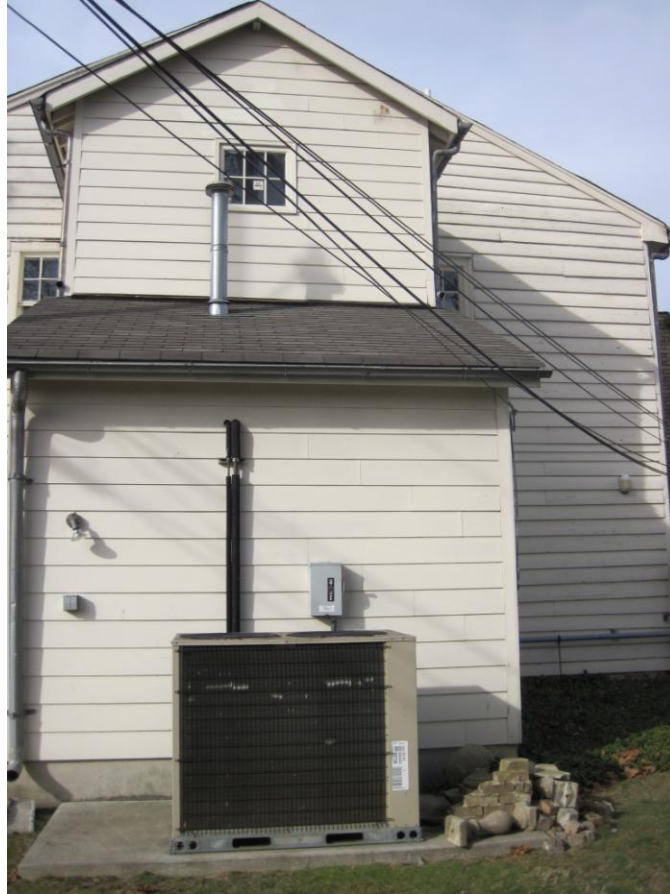
Condenser in back of the furnace / evaporator attached enclosure

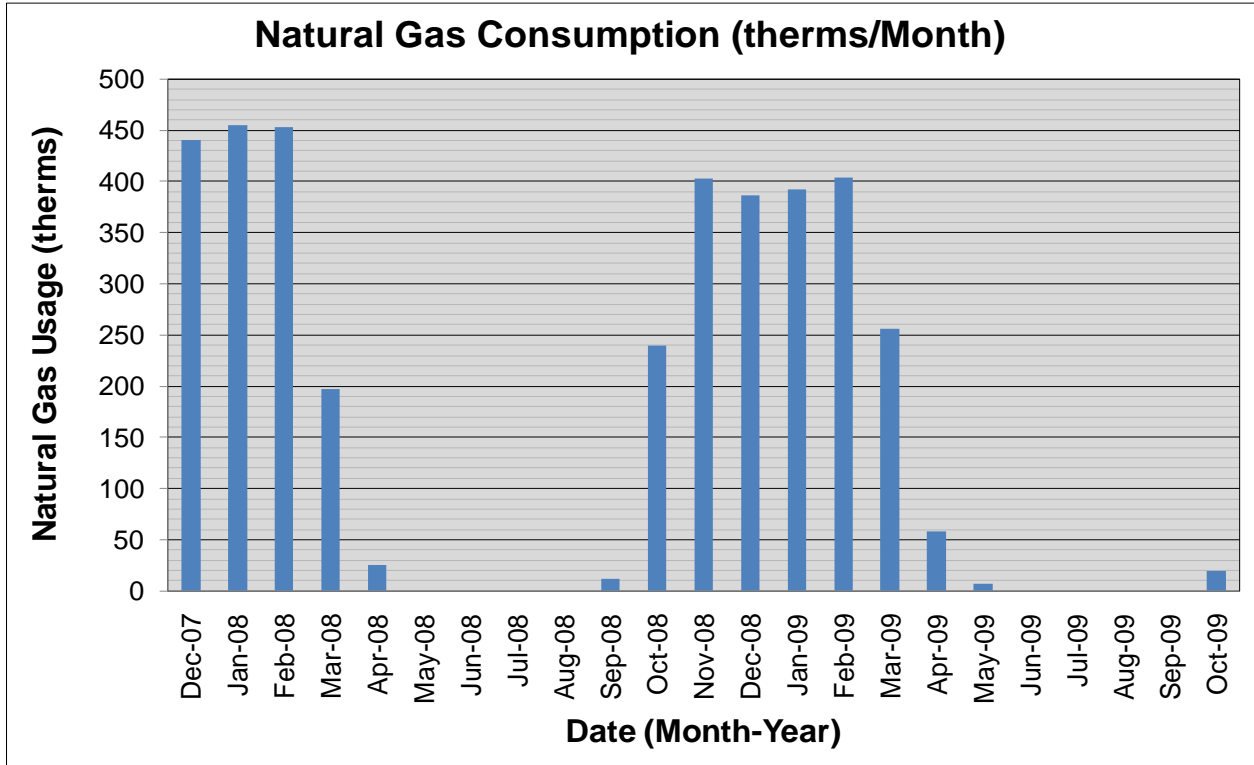
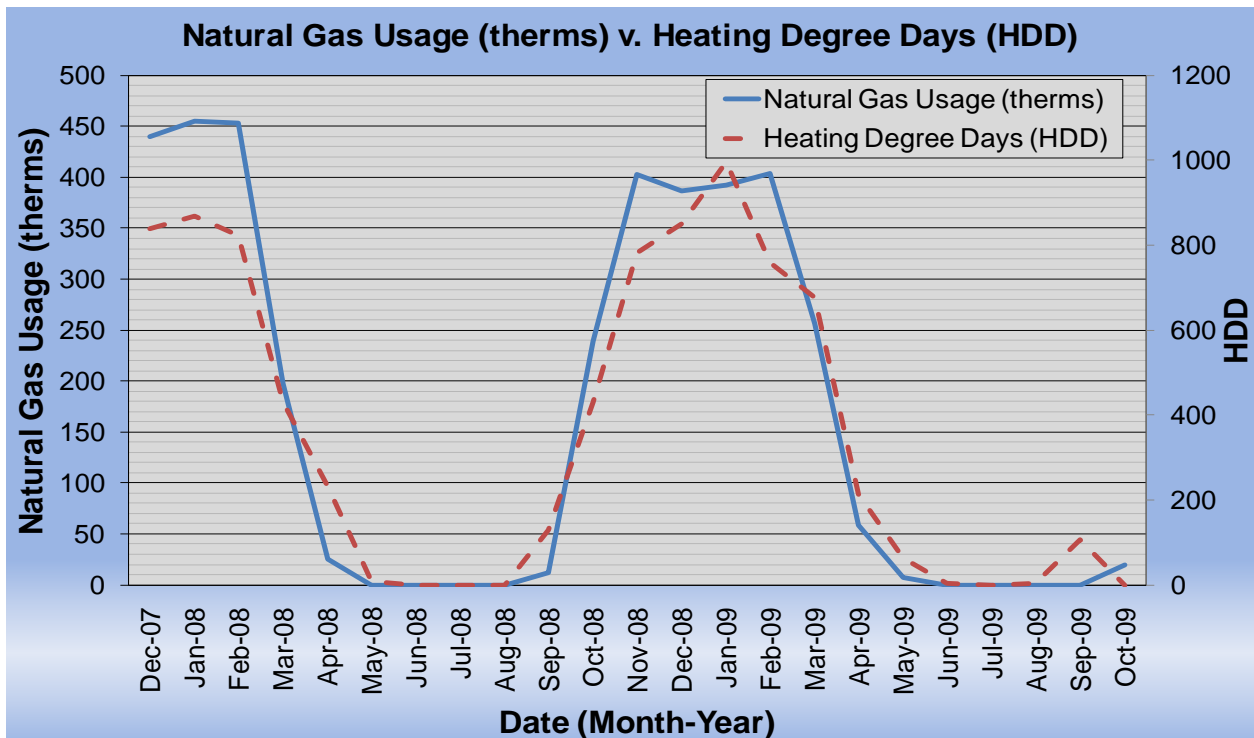
The following is a chart of the natural gas load profile for the building, peaking in the coldest months of the year and a chart showing natural gas consumption following the “heating degree days” curve. Some utility bills have more than one month estimated and combined.

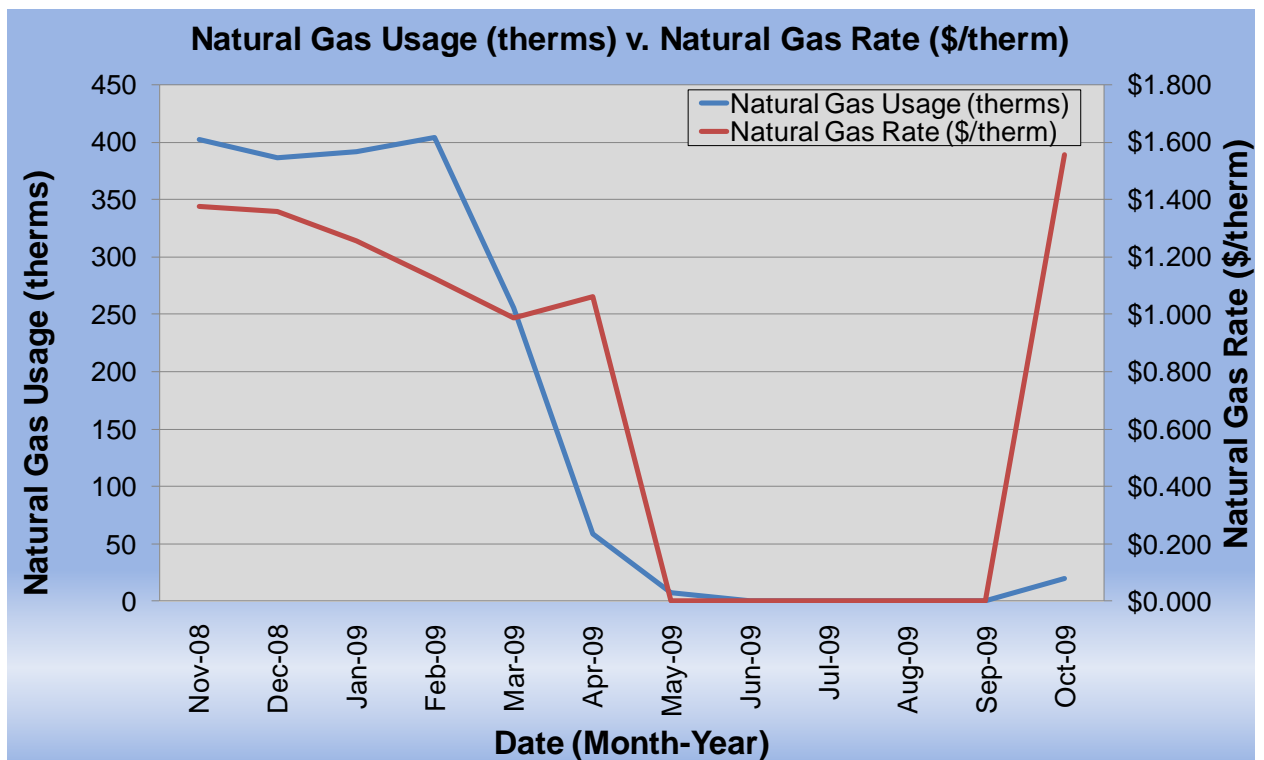
Currently, natural gas is provided to the War Memorial Building via one gas meter with the PSE&G acting as the supply and also the transport company. Gas is provided by PSE&G at a general and very competitive service rate. The suppliers' general service rate for natural gas charges a market-rate price based on use and the War Memorial Building billing does not breakdown demand costs for all periods. Demand prices are reflected in the utility bills and can be verified by observing the price fluctuations throughout the year. Typically, the natural gas prices increase during the heating months when natural gas is used by the furnace units. Some high gas price per therm fluctuations in the summer may be due to high energy costs that recently occurred and low use caps for the non-heating months. Thus the building pays for fixed costs such as meter reading charges during the summer months. Some of the cap payments are excluded from the following chart.

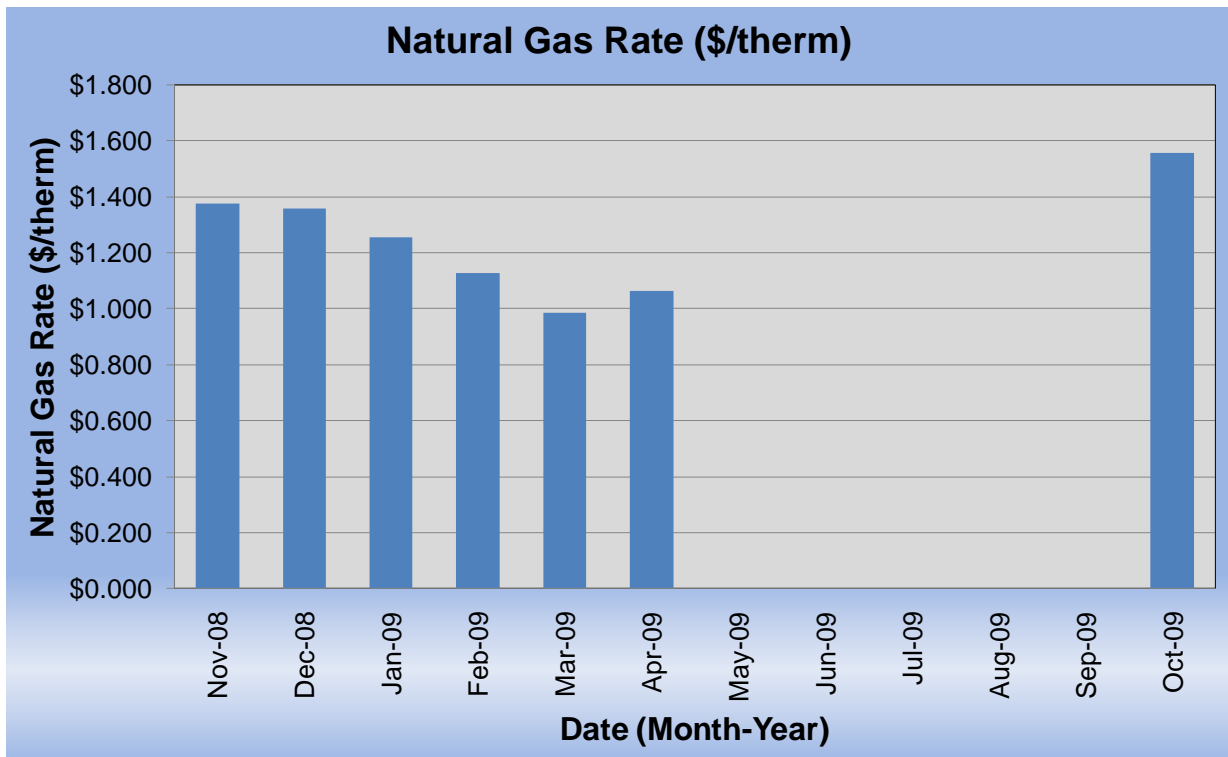
Company (ESCO) is a consultancy group that engages in a performance based contract with a client firm to implement measures which reduce energy consumption and costs in a technically and financially viable manner. Electricity is also purchased via one incoming meter directly for the main War Memorial Building from South River Electricity Company without an ESCO. SWA analyzed the utility rate for natural gas and electricity supply over an extended period. Electric usage was estimated over the most recent 12 month period since meter readings are not recorded. Natural gas bill analysis shows fluctuations up to 24% over the most recent 12 month period. Some of these fluctuations may have been caused by adjustments between estimated and actual meter readings; others may be due to unusual high and recent escalating energy costs. The average estimated NJ commercial utility rates for electric and gas are \$0.150/kWh and \$1.550/therm respectively. The War Memorial Building annual utility costs are competitive when compared to the average estimated NJ commercial utility rates. SWA recommends that the Borough of South River further explore opportunities of purchasing both natural gas and electricity from ESCOs in order to reduce rate fluctuation and ultimately reduce the annual cost of energy for the War Memorial Building. Appendix B contains a complete list of third party energy suppliers for the Borough of South River service area. The Borough of South River may want to consider partnering with other school districts, municipalities, boroughs and communities to aggregate a substantial electric and natural gas use for better leveraging in negotiations with ESCOs and of improving the pricing structures. This sort of activity is happening in many parts of the country and in New Jersey. Also, the War Memorial Building would not be eligible for enrollment in a Demand Response Program, because there isn't the capability at this time to shed a minimum of 150 kW electric demand when requested by the utility during peak demand periods, which is the typical threshold for considering this option. The following chart show the War Memorial Building monthly natural gas spending per unit of energy in 2009. Electric rates were estimated at a constant rate of \$0.130/kWh.
