**Local Government Energy Program  
Energy audit report**

***Tewksbury Township Board of Education  
Old Turnpike School  
171 Old Turnpike Road  
Califon, NJ 07830***

***Project Number: LGEA23***

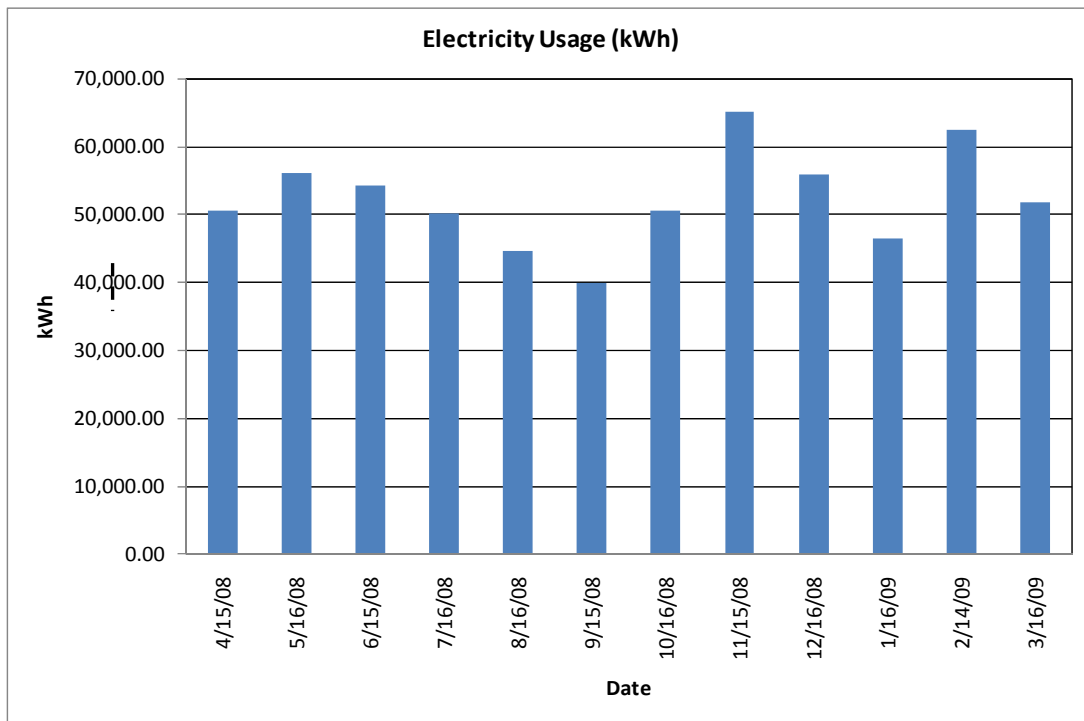
The following chart shows electricity usage for the Old Turnpike School based on utility bills for the 2008 - 2009 billing period.

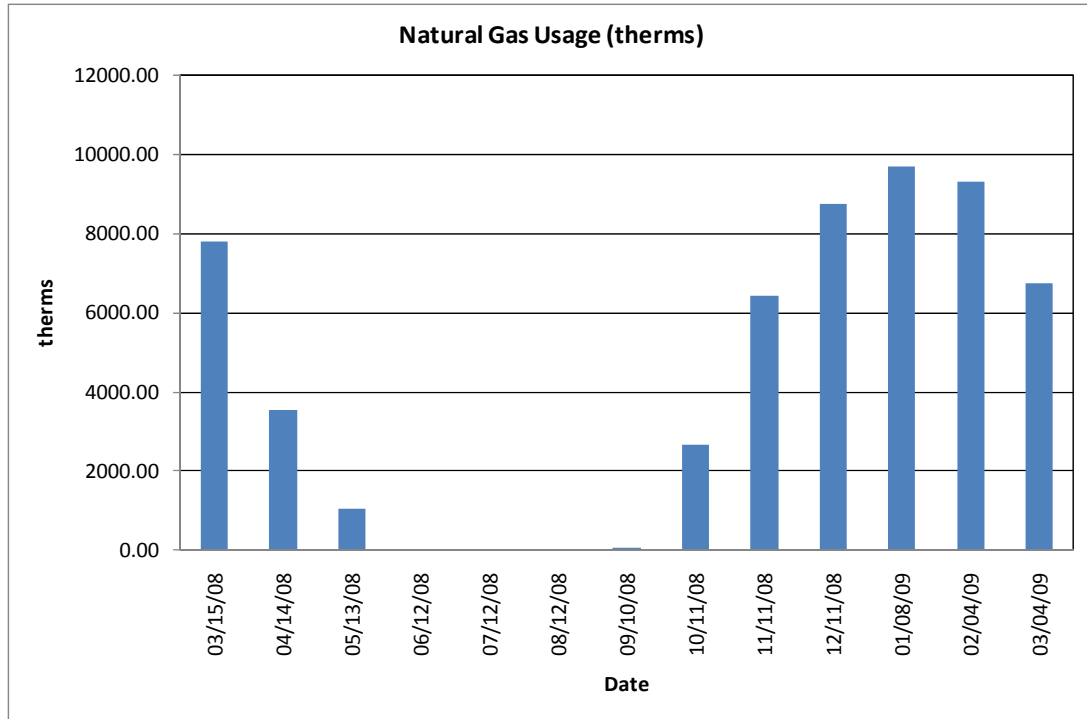
The following chart shows the natural gas usage for the Old Turnpike School based on utility bills for the year March 2008 to March 2009.

In the above chart, the natural gas usage follows a heating trend as expected. During the summer it is clear that the natural gas usage is very minimal which reflects that heat is not being used and the DHW load is minimal.

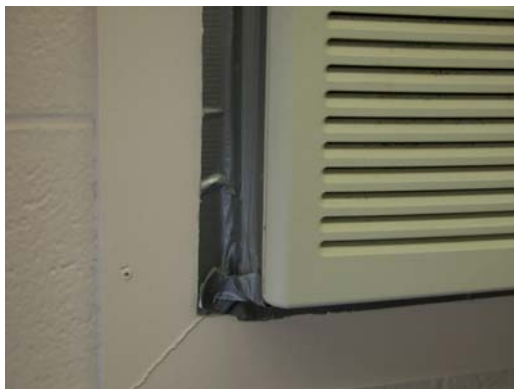
SWA also recommends removal of window air conditioner units if possible in order to reduce the loss of conditioned air. Duct tape is currently installed on some measures and should not be used as a permanent measure. If this is not feasible, SWA recommends a product similar to Chill Stop-R which includes a gasket seal and air barrier to prevent the loss of expensive conditioned air.

*Wall AC sleeve unit seal shows insufficient air sealing*

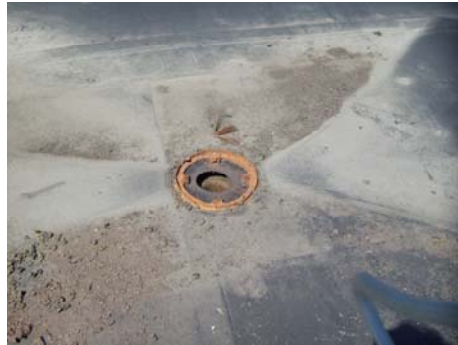
not be verified. There were signs that water has been pooling on the roof. This can be addressed by forming proper drainage planes with rigid insulation. There were also some roof drains that were either clogged or missing screens, allowing dirt and other obstructions cause more standing water.

*Drain missing screen and allowing debris to gather on roof*

SWA recommends installing new light colored rubber membrane roofing with 3” min. XPS rigid insulation to replace original and leaking roof sections.

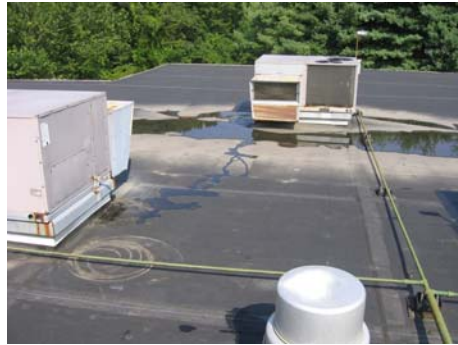
The flat roof was constructed at different times (1975, 1994, 2004, and 2006) and consists of various materials but mostly gray colored rubber membrane with some parapets decorated with standing seam metal mansard type roofing attached to exterior walls. Roof leaks were reported and noticed during the field audit in the area of the original 1975 roof section. During the audit it was mentioned that in 2004 and 2006, 2-3" of rigid insulation was added to parts of the roof but could

*Pooling on older roof section*

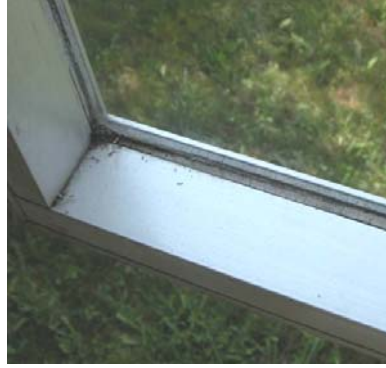
*Original single glazed aluminum framed windows*

The building contains fixed and operable aluminum-framed windows some with single-glazing. SWA recommends replacing single pane aluminum windows with double pane low-E on the 1969 and 1975 wings of building. SWA also recommends either professionally installed retrofit window foils applied to the inside or operable commercial blinds to control the amount of natural light to enter in an effort to improve thermal and / or glare control.

- Window replacement – The existing windows are single pane windows provides a thermal weakness in the building envelope. It is currently not cost-effective to replace the windows but is recommended that the windows be considered. Single pane glass is conductive to heat transfer and becomes a cold surface during winter and a warm surface during summer. SWA recommends upgrading to windows that are double pane windows that contain a low-e coating as well as frames that provide a thermal break.

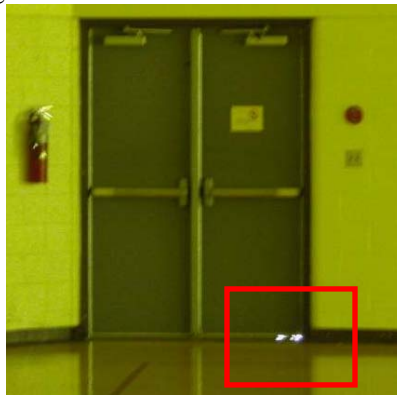
The metal framed exterior doors were observed to be in good condition except for some missing or worn weather-stripping in the gym area. SWA recommends that the exterior doors of the building be weather-stripped in order to decrease the amount of conditioned air that is lost around each door. SWA also recommends checking the weather-stripping of each door on a regular basis and replacing any broken seals immediately. Tight seals around the doors will help ensure that the building is kept continuously tight and insulated.

*Worn or missing weather-stripping in gymnasium*

- Weather Stripping/Air Sealing - SWA observed that exterior door weather-stripping was beginning to deteriorate. Doors and vestibules should be observed annually for deficient weather-stripping and replaced as needed. The perimeter of all window frames should also be regularly inspected and any missing or deteriorated caulking should be re-caulked to provide an unbroken seal around the window frame. Any other accessible gaps or penetrations in the thermal envelope penetrations should also be sealed with caulk or spray foam.

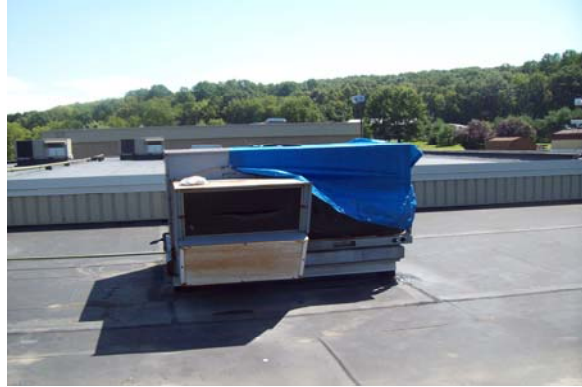
Most of the rooftop units are in fair to good condition and appear to be working properly. The newest rooftop unit, located in the back corner, away from the parking lot, is currently de-commissioned due to a roof leak where the unit is installed. According to building maintenance staff, the unit is operable but currently covered with a tarp and shut off since it has an installation defect that allows water to enter the building envelope and causes water damage in a bathroom located directly below the unit.

*Rooftop unit shut-off and covered with a tarp*

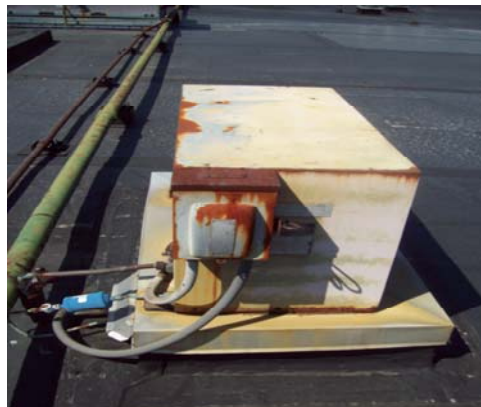
There was one American Air Filter condensing unit located on the roof near center of the original roof, near the parking lot that appears to be de-commissioned. This unit was originally serving a smaller utility room. This unit either needs to be replaced or removed and the roof properly sealed. This unit is currently rusting and not only provides air to freely enter and exit the building but also damages the roof surface by allowing rust to sit on the roof. SWA recommends that this condensing unit is removed and the roof properly repaired. Based on observations, this unit has not been operated and there have been no corresponding complaints.

*De-commissioned condensing unit*

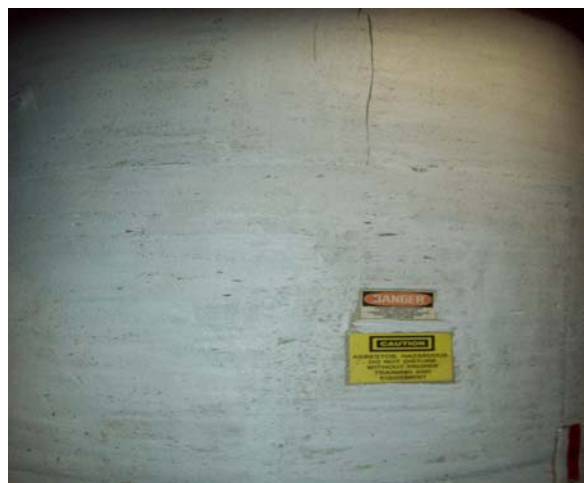
Domestic Hot Water for the building is provided by a hot water storage tank that is estimated at approximately 500 gallons. The storage tank stores hot water that is heated via a coil located inside of Boiler #1. Since hot water tank is not directly-fired, it relies on Boiler #1 to be operational to be able to provide domestic hot water to the building. Since Boiler #1 is currently not operational, the building has not had domestic hot water since March. When a system uses a hot water storage tank with a coil inside of a boiler, the boiler is required to run during warm months as well as cool months. Schools typically have a relatively small demand for domestic hot water and this storage tank appears to be oversized.

This storage tank is currently wrapped in asbestos. Although this assessment focuses on energy efficiency, the health and safety concerns associated with asbestos should be noted. Asbestos abatement is primarily a safety issue and is not directly associated with a cost payback. However, the existence of asbestos very often impacts the ability of building operators to perform routine maintenance procedures without undertaking appropriate safety measures and incurring associated costs.

thorough investigation of the existing systems and equipment. To protect the welfare and staff, SWA recommends that asbestos abatement be addressed prior to undertaking any other significant investments in capital improvements.

SWA recommends taking appropriate measures for asbestos remediation before any work is undertaken in the boiler room. When all asbestos issues have been solved, SWA recommends that the existing main domestic hot water tank is removed and replaced with a properly sized, direct gas-fired hot water heater. This heater should be direct-fired in order to be able to completely shut down the heating boilers during the summer without the loss of domestic hot water. SWA recommends that the Tewksbury Board of Education hire an engineer to perform domestic hot water load calculations for the building. It may be possible to move the oversized hot water heater from the pre-kindergarten wing to the main boiler room, if the hot water heater is deemed to have a large enough capacity for the general hot water use of the building. If the pre-kindergarten hot water heater is of appropriate size, then the school can re-use this equipment for the main domestic hot water load and install a smaller, appropriately sized electric hot water heater for the four pre-kindergarten classrooms. Since the domestic hot water load is small for the pre-kindergarten wing, then a small electric domestic hot water tank can reduce standby losses that currently exist with the larger, over-sized existing unit.

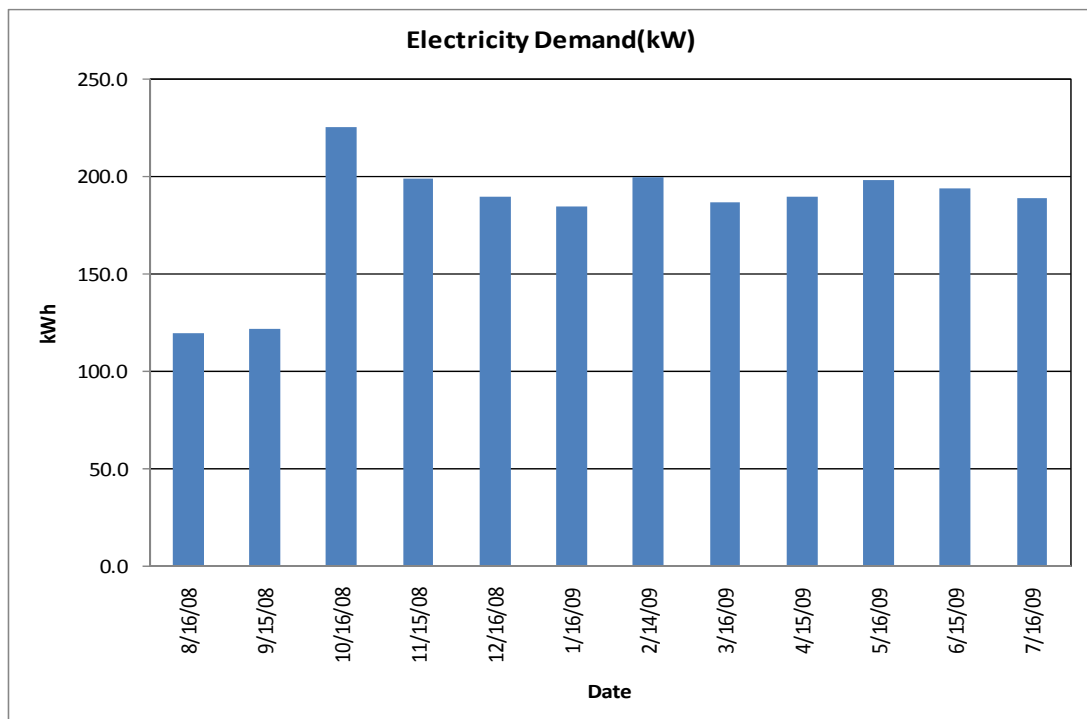
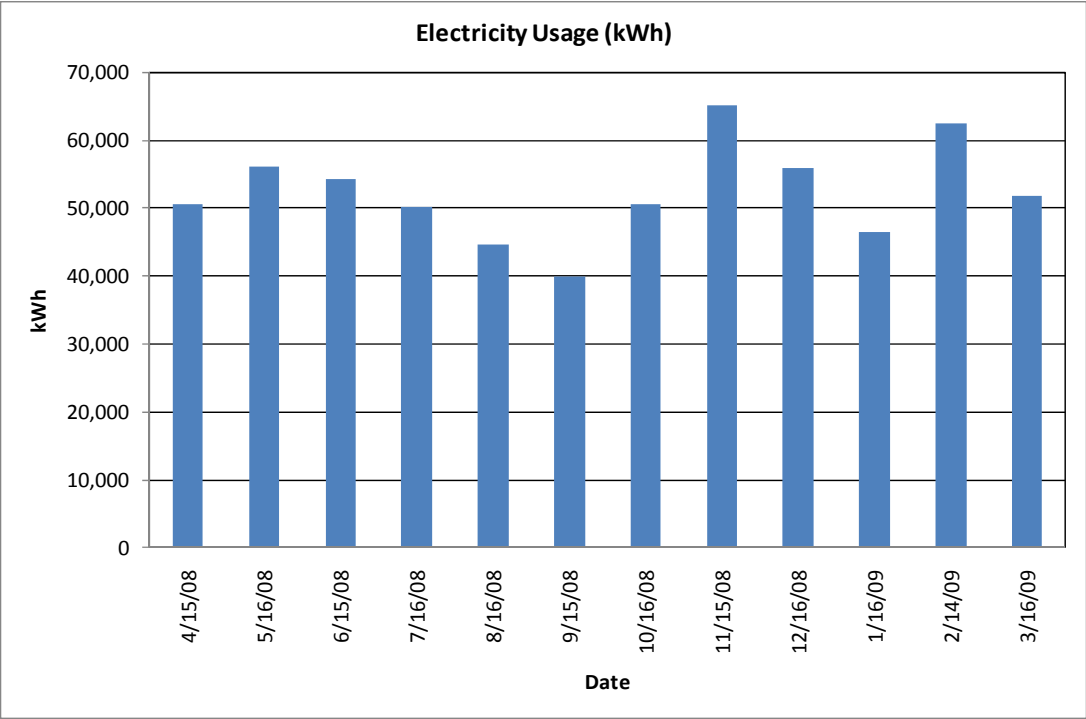
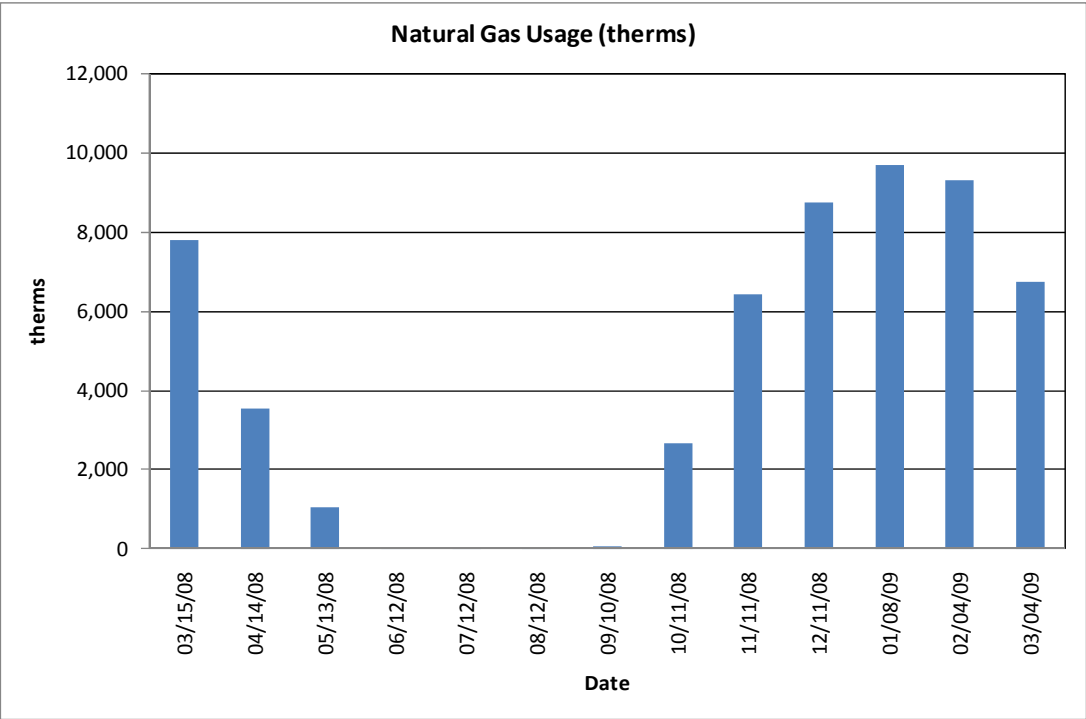
The average electrical peak demand for the previous year was 187.5 kW and the maximum peak demand was 225 kW. The electric and gas load profiles for this project are presented in the following charts. The first chart shows electric demand (in kW) for the previous 12 months and the other two charts show electric and gas usage (in kWh), respectively.

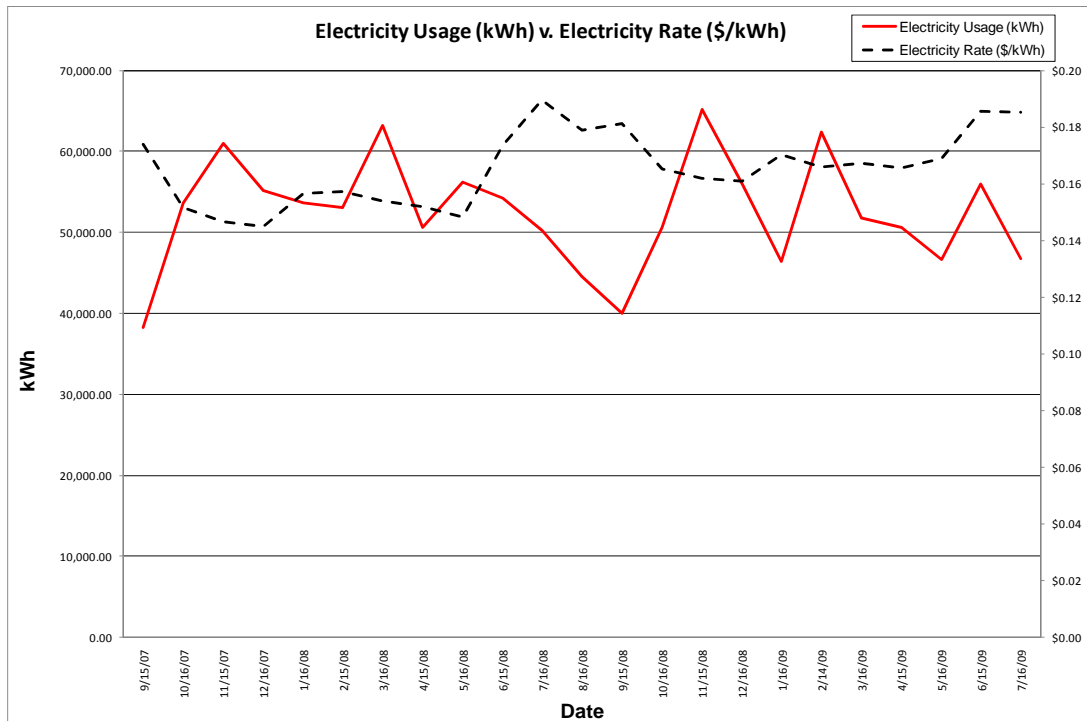
*Electricity prices reflect electricity usage*

Billing analysis shows price fluctuations of over 20% over the course of the year for the building electrical and natural gas accounts. Customers that have a large variation in monthly billing rates can often reduce the costs associated with energy procurement by selecting a third party energy supplier. Contact the NJ Energy Choice Program for further information on Energy Services Companies (ESCOs) that can act as third party energy suppliers. Purchasing electricity from an ESCO can reduce electric rate fluctuation and ultimately reduce the annual cost of energy for the school. Appendix B contains a complete list of third party energy suppliers.

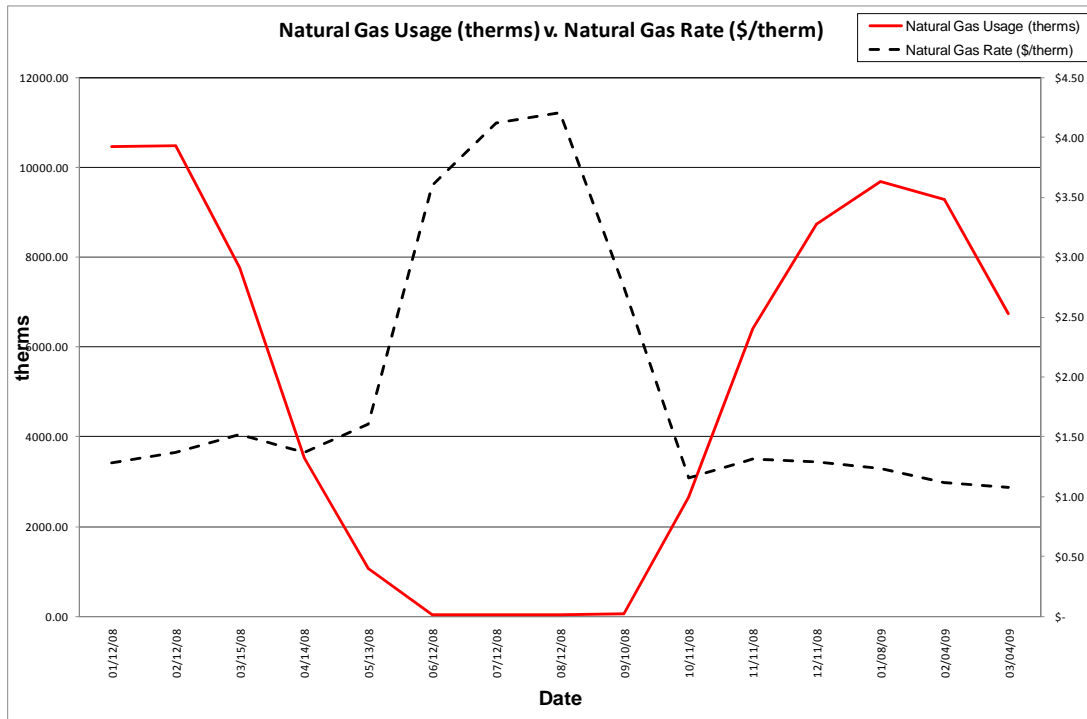
*Natural gas prices fluctuate as expected with usage*
