**Local Government Energy Program  
Energy Audit Report**

***Township of Vernon  
Municipal Building  
21 Church Street  
Vernon, NJ 07462***

***Project Number: LGEA28***

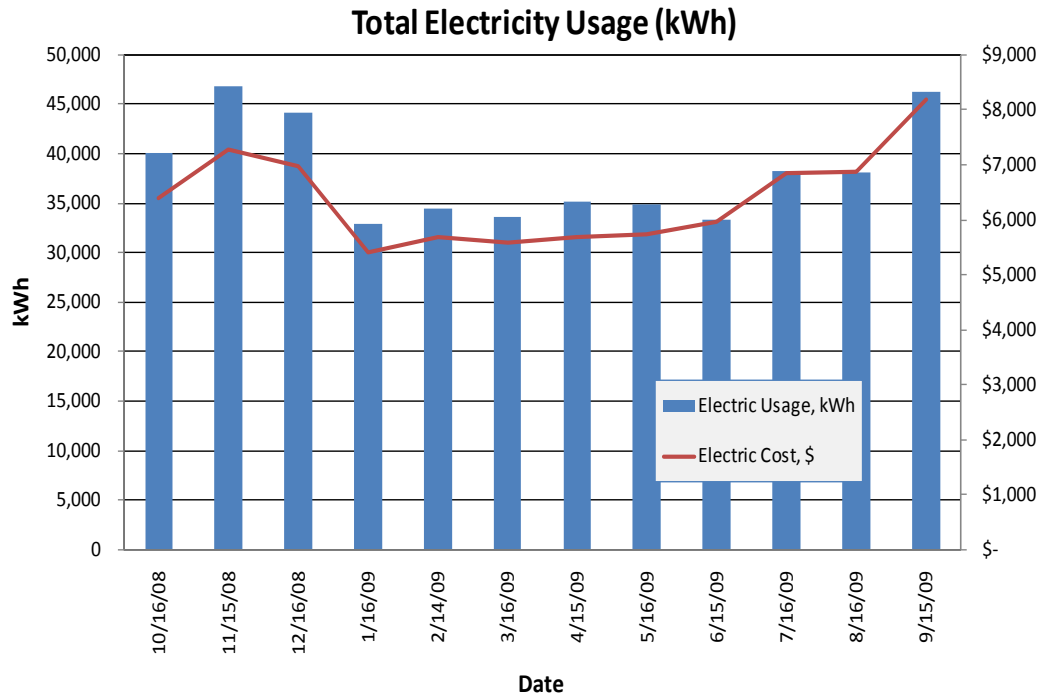
The following chart shows electricity use versus cost for the Municipal building based on utility bills for the 12 month period of October 2008 to October 2009.

Electricity costs follow a trend as expected, based on the electricity usage. There are no unusually spikes or gaps in electricity data.

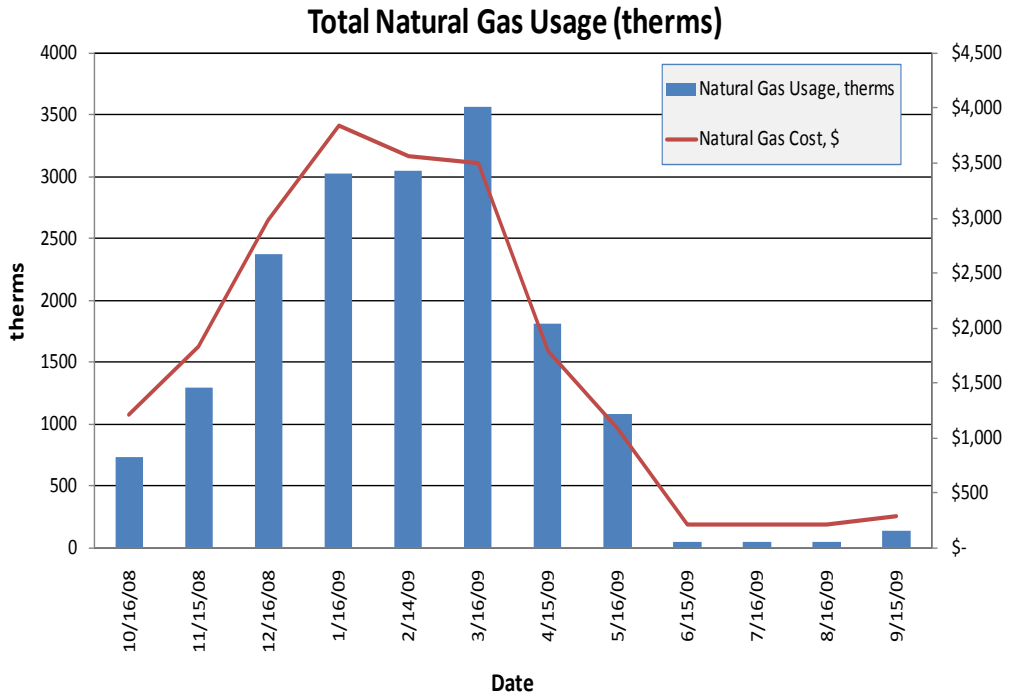
The following is a chart of the natural gas annual load profile for the building versus natural gas costs, peaking in the coldest months of the year.

In the above chart, the natural gas use follows a heating trend as expected. During the summer it is clear that the natural gas use is very minimal which reflects that heat is not being used and the domestic hot water (DHW) load is minimal. March 2009 was colder than usually compared to previous years and therefore natural gas usage shows a spike in the chart. In addition, the utility bills may show fluctuations due to actual readings being blended with estimated readings from the utility company.

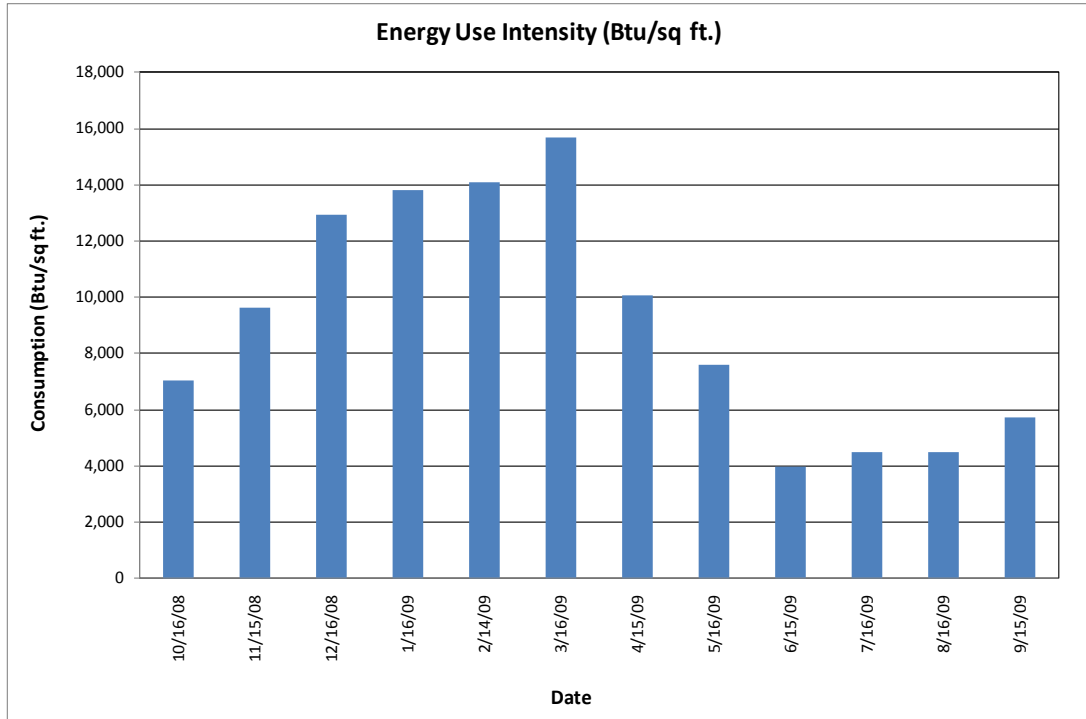
The following chart shows combined natural gas and electric consumption in Btu/sq ft for the Municipal building based on utility bills for the 12 month period of October 2008 to October 2009.

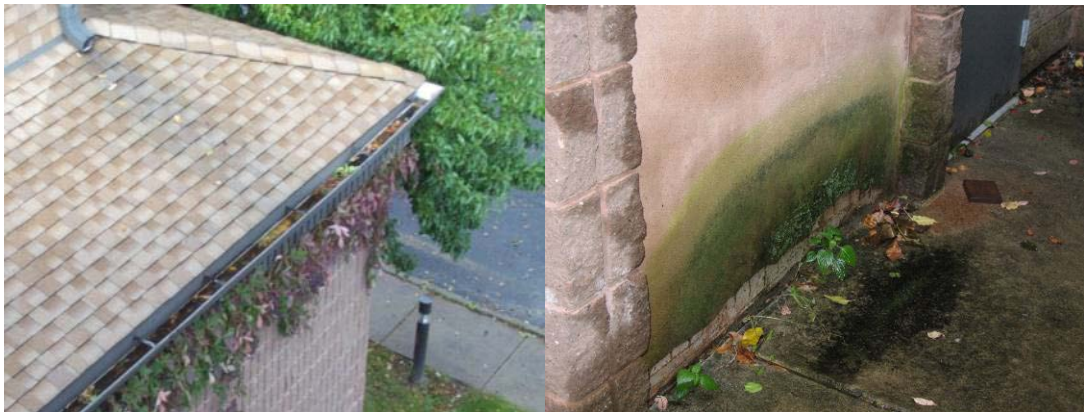
There are signs of water damage to walls around the building due to clogged gutters. On the day of the audit there were leaves that completely clogged the gutters, allowing water to build up and also drip down the side of the exterior wall. In addition to water running down the exterior walls, water is allowed to drip from the gutter and splash on the base of the wall. SWA recommends that gutters are cleaned on a monthly basis, or whenever debris is noticed in the gutters/downspouts. Proper maintenance will prevent water from backing up and will allow rainwater and melted snow to be diverted away from the building.

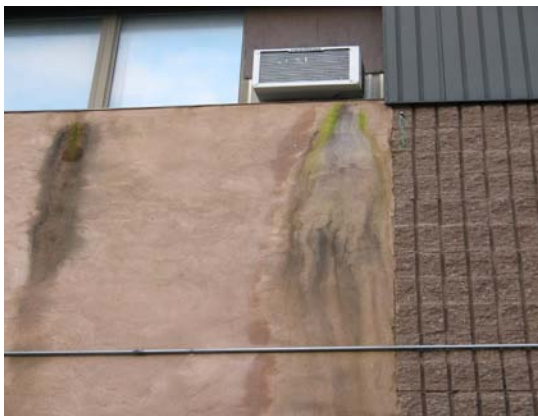
The chillers located behind the building are beyond their useful life and therefore window air-conditioning units have been installed throughout the building to provide comfort. These window units are installed for the warm months only. The existing windows are horizontal slide windows that are slid to the open position during the warmer months to allow a window air conditioning unit to be

mounted directly on the interior of the frame. The window units are installed using a piece of painted OSB board drilled into the window frame to block of the remaining portion of the open window. OSB board does not provide a thermal break to protect the expensive conditioned air inside the building, nor does it protect against water such as rain and humidity. The way that the window units are mounted, most of the units were observed to not be leveled properly in the window frame. When window AC units are mounted they should only have a slight tilt towards the exterior surface. Window AC units produce condensate as a by-product that needs to evaporate by spreading out on the flat condensate drain pan inside of the unit. When the AC unit is mounted at to much of an angel, condensate is allowed to drip out of the pan and down the wall that the window unit is mounted on. Below shows a picture of condensate allowed to drip out of the AC unit and damage the exterior wall. SWA recommends that if any window AC units are used for this building, that they are mounted using a level to ensure that condensate is allowed to drip into the condensate pan at a slight angle away from the building but not so far that water drips behind the unit and causes water damage to the exterior side of the building.

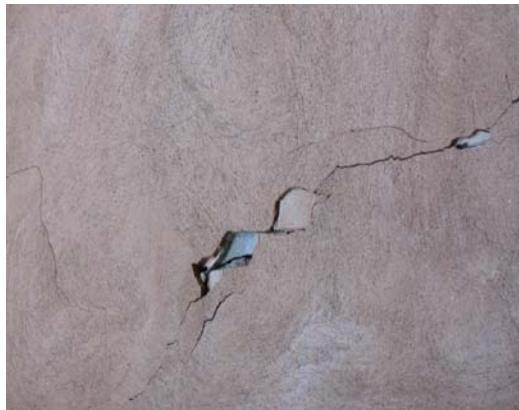
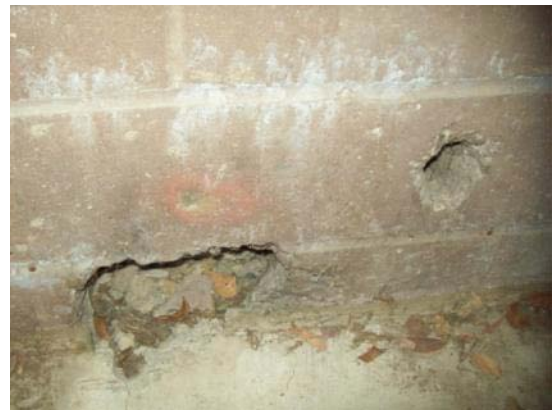
In addition to water damage, there are also several penetrations across the entire envelope of the building. These penetrations are in the form of holes or cracks in the outer wall that have the potential for allowing cold air as well as water to penetrate the shell of the building causing further damage. SWA recommends that Vernon Township repairs these penetrations so that the exterior surface provides a consistent thermal and vapor barrier across the entire building.

Based on a visual inspection, the building was observed to contain several major penetrations to the shell that can allow expensive, conditioned air escape out of the building. SWA recommends that appropriate steps are taken to ensure that these trouble spots are taken care of. The noted spots of penetration include; piping penetrations on backside of building from chiller unit, bent/damaged window frames from previously installed window AC units, weather-stripping around exterior doors and windows, a cracked skylight, a broken steel door and other damages to the exterior surface of the building.

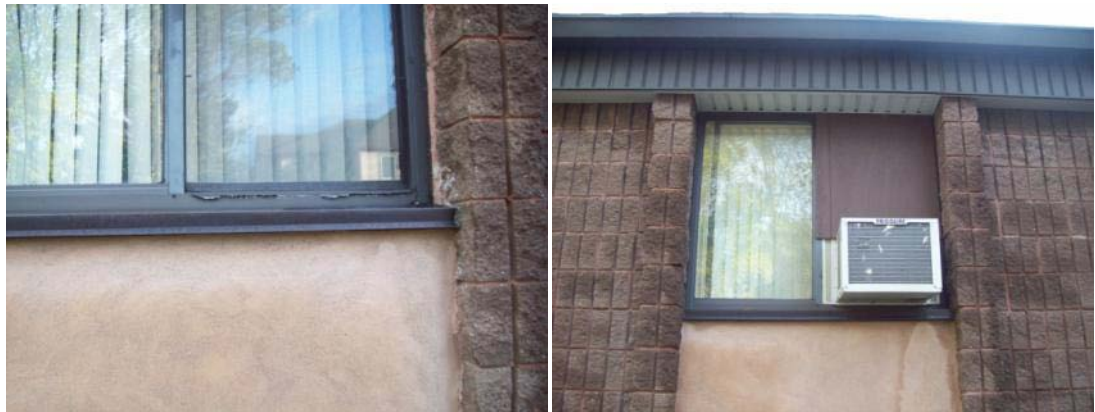
The building contains mostly horizontal sliding windows with aluminum frame. Each of these windows contains two panels; one that is allowed to slide horizontally and one that is fixed. The windows contain double-glazed glass with no effective low-e coating. The windows are in poor condition and some of the weather-stripping is in deteriorating condition. Windows contain three components that are important to the energy efficiency of the building; glass panes, frames that hold

the panes in place and weather-stripping that provides a seal between the window panes and frame. For the existing windows, the glass is double-paned glass which is good but does not contain an effective low-emissivity (low-e) coating. The low-e coating helps reflect solar radiation from penetrating through the glass and increasing the heat load within the building. The aluminum window frames are un-insulated and create a “thermal bridge” that allows heat to transfer into the building during warm months and allows heat to escape during cold months. In addition to a lack of insulation, window AC units are installed into some of the windows. Each AC unit is secured to the window frame by inserting multiple screws to hold the window in place. Every hole that exists in the frame adds to the risk of heat transfer across the frame as well as the possibility of water penetrating into the frame. Energy savings alone will not justify the cost of replacing windows. SWA recommends that window replacement is considered as a capital improvement plan to help seal the building both from a water standpoint as well as an energy standpoint. Holes in the window frame can also allow water to penetrate the window frame and cause rusting and rotting from the inside out.

As a best practice, SWA recommends that all windows be inspected at least once a year. Any gaps, cracks, or damage to weather-stripping or caulking should be repaired or replaced, as needed, to minimize energy loss around those openings. Building staff should also verify that windows open and close properly and repair, as needed. The two pictures below show the current condition of many of the windows inside of the building. The first picture shows a damaged frame that once held a window AC; the second picture shows a window with an AC unit currently installed using plywood and screws.

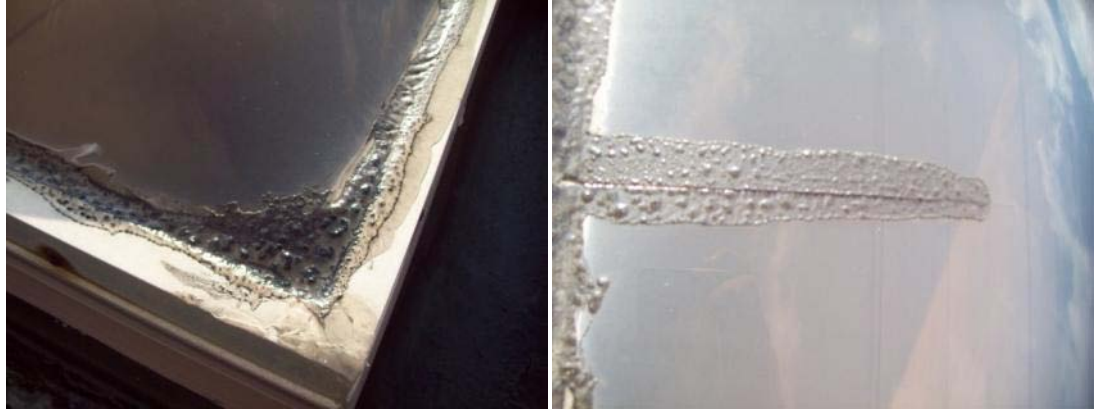
The roof contains one skylight that is no longer sealed properly. The roof inspection revealed that the skylight has several cracks that are not sealed properly as well as air spaces along the outside edge of the glass. SWA recommends that this skylight is replaced with a similar skylight, containing a low-e surface, and sealed properly to prevent cold air and moisture from penetrating the roof surface. Below are pictures showing areas of the skylight, where the seal has been compromised.

- Replace skylights – the skylights in the building showed signs of aging and small cracks. SWA recommends that these be investigate further. There were no reported water leaks; however the skylights do show signs of deterioration.
