**Local Government Energy Program
Energy Audit Final Report**

***The Public Works Garage
Township of Hopewell
Titusville, NJ 08560***

Project Number: LGEA16

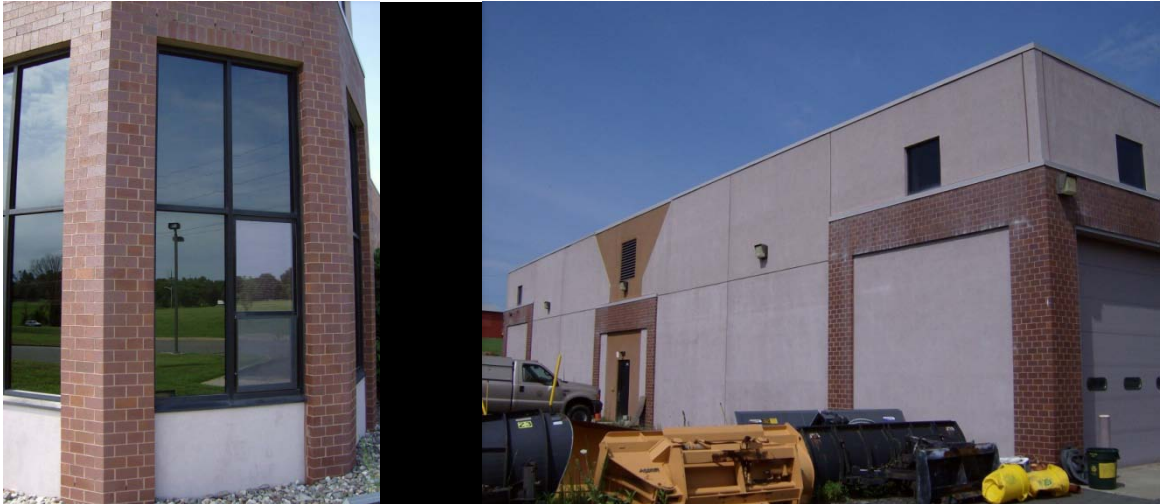
The exterior walls consist of 12" CMU block with 1-1/2" rigid insulation on the exterior side of the wall assembly with either a 4" brick veneer or EIFS (Exterior Insulated Finishing System) façade. Exterior walls appear to be in good condition with proper drainage including weep holes and flashing.

Due to warm temperature conditions at the time of the field visit, insulation levels could not be verified with help of infrared technology. If desired, the Municipality could contract a separate envelope inspection during cooler months.

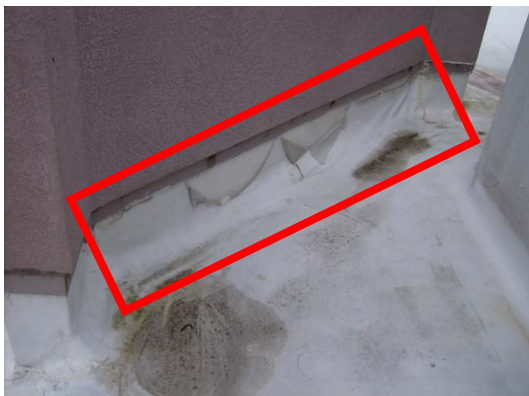
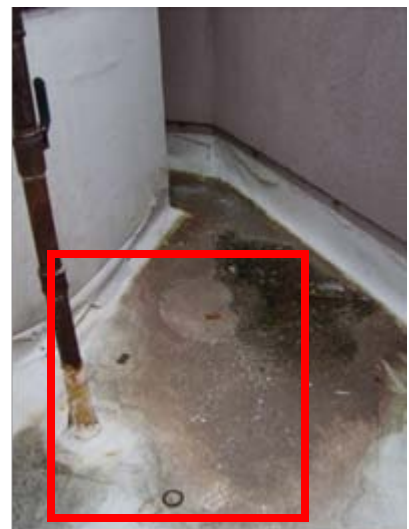
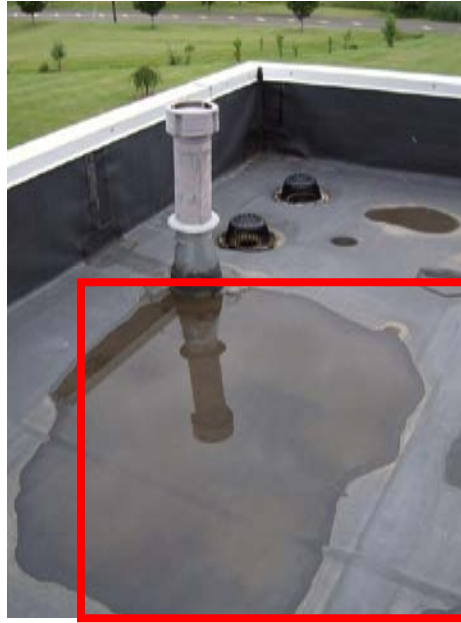
There are three different roofing materials: a standing-seam metal pitched roof, a black rubber membrane roof painted white, and a black rubber membrane. The black rubber membrane roof section was installed in 2000 and the section painted white was installed in 2006. There were obvious soft spots detected in the white painted membrane. There appeared to be a few areas where water has pooled due to insufficient slope. SWA suggests verifying the terms of the roof warranty and contacting the roofing installer to correct areas with insufficient slope. There are other areas (as seen in the image below) where the membrane is not sealed to the wall surface. Extra attention should be provided to these areas, as water may be entering the wall assemblies, leading to future mold and mildew issues. SWA noted a dehumidifier in use in the administrative offices. Extra precautions and care should be taken to avoid excess moisture entrapment within the building ceiling and wall cavities, because insulation loses thermal protective properties when wet.

According to the building drawings, the roof insulation varied from 1 ½” to 3” in different roof sections. Roof insulation could not be verified at the time of the inspection without the help of infrared technology. SWA recommends as part of a capital improvement plan to increase insulation levels throughout the roof assembly for a consistent R value. As noted during the kickoff meeting, there isn’t any insulation in the roof above six of the garage bays. As these areas are heated throughout the winter, SWA suggests a continuous insulation layer be added with any roof improvements or upgrades.

- Upgrade Roof Insulation - SWA recommends as part of a capital improvement plan to increase insulation levels throughout the roof assembly for a consistent R value. There isn't any insulation in the roof above six of the garage bays. As these areas are heated throughout the winter, SWA suggests a continuous insulation layer be added with any roof improvements or upgrades.

- Roof insulation - There are roof areas where the membrane is not well sealed to the wall surface. Extra precautions and care should be taken to avoid excess moisture entrapment within the building ceiling and wall cavities, because insulation loses thermal protective properties when wet.

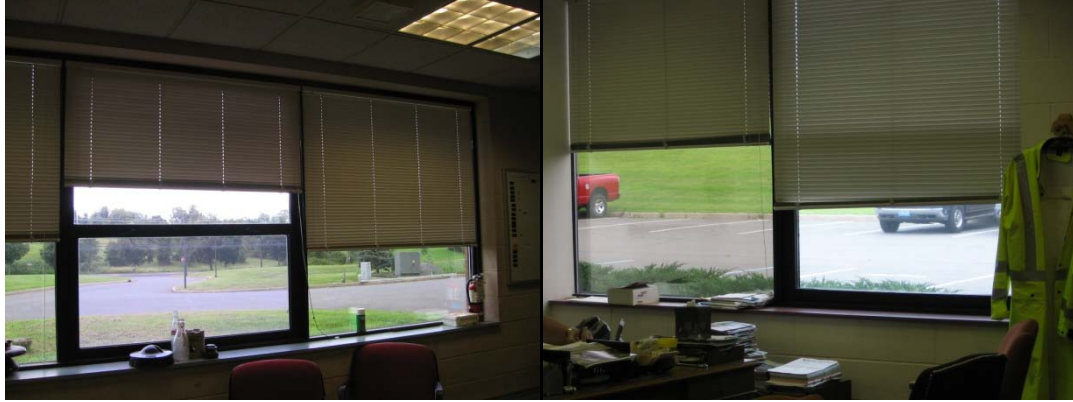
The building contains fixed and casement aluminum-framed windows with double-glazing. The windows appeared to be in good condition. Certain windows were missing tinted glazing allowing those areas to receive additional solar heat gain. SWA recommends installing window tinting to windows missing film. When replacement of windows is needed, SWA suggests insulated, low-e windows.

- SWA recommends installing window tinting to windows missing film. When replacement of windows is needed, SWA suggests insulated, low-e windows.
- Weather Stripping / Air Sealing - SWA observed that exterior door weather-stripping in places was beginning to deteriorate. Doors and vestibules should be observed annually for deficient weather-stripping and replaced as needed. Garage overhead door bottom rubber weather strips should be filling any gap at the bottom of the doors when they are fully down and closed. The perimeter of all window frames should also be regularly inspected and any missing or deteriorated caulking should be re-caulked to provide an unbroken seal around the window frames. Any other accessible gaps or penetrations in the thermal envelope penetrations should also be sealed with caulk or spray foam.

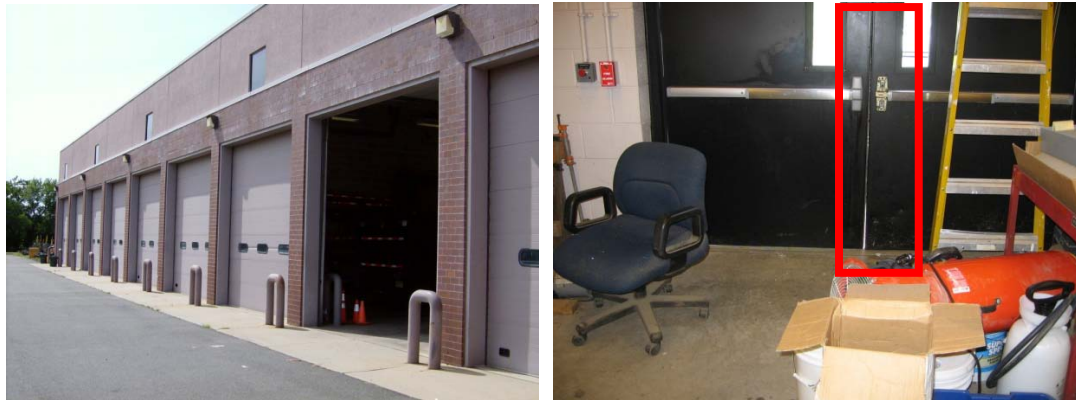
The aluminum framed exterior door and metal doors were observed to be in good condition except for some missing or worn weather-stripping. SWA also recommends checking the weather-stripping of each door (including garage doors) on a regular basis and replacing any broken seals immediately. Tight seals around the doors will help ensure that the building is kept continuously tight and insulated.

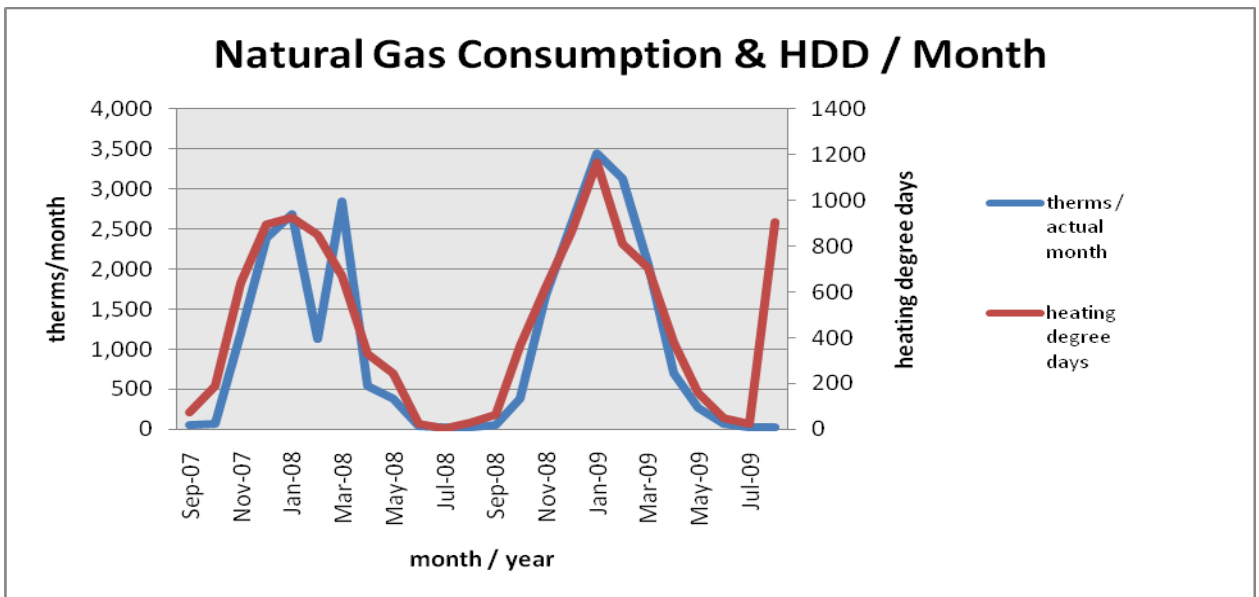
The following is a chart of the natural gas annual load profile for the building, peaking in the coldest months of the year and a chart showing gas consumption following the “heating degree days” curve.
