**Steven Winter Associates, Inc.**  
Architects and Engineers

**Local Government Energy Program  
Energy Audit Final Report**

***Livingston High School  
Livingston, NJ 07039***

***Project Number: LGEA37***

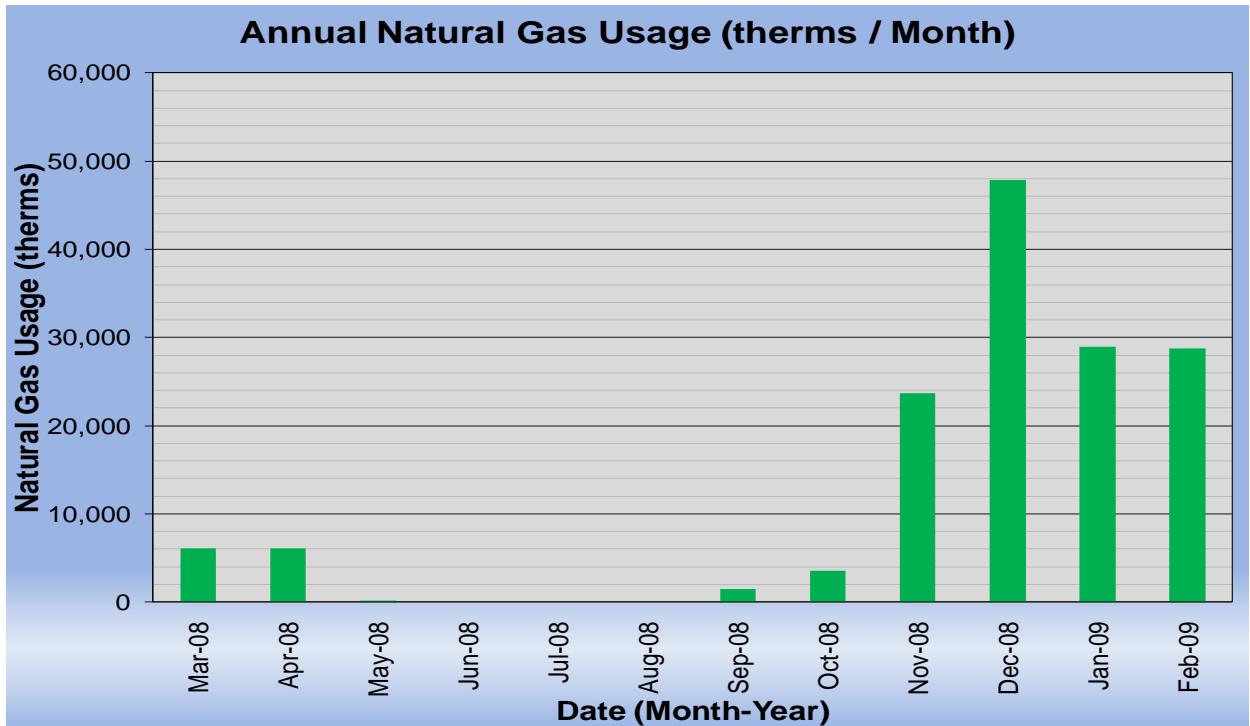
The following chart shows the natural gas consumption for the High School building based on natural gas bills for the 12 month period of March 2008 to February 2009.

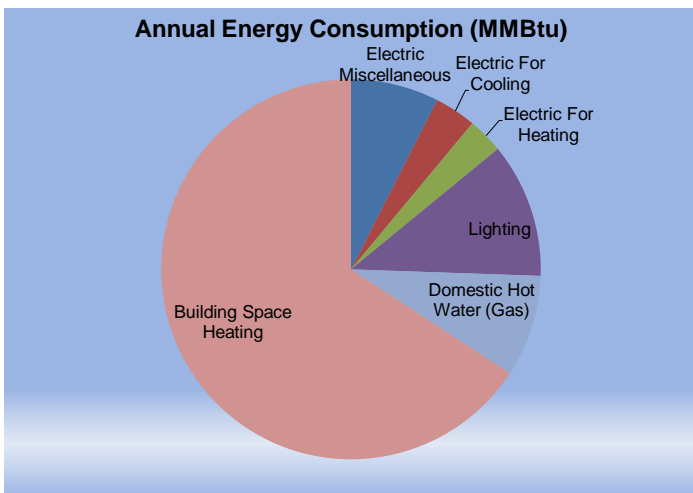
The following table and chart pies show energy use for the High School building based on utility bills for the 12 month period of March 2008 to February 2009. Note electrical cost at \$46/MMBtu of energy is 3.5 times as expensive to use as natural gas at \$13/MMBtu.

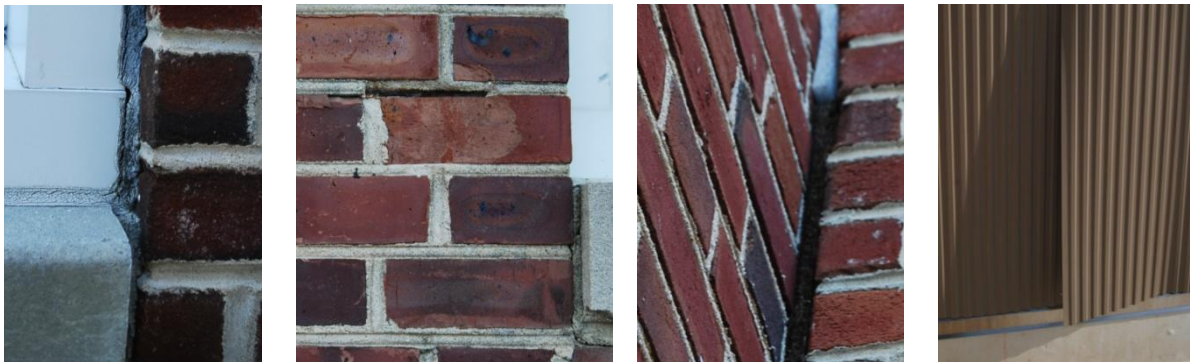
The exterior wall envelopes of the main building and its various additions over time consist of brick veneer with split block / lime stone or clapboard accents in some areas. Interior finishes are mostly painted CMU (Concrete Masonry Units) or gypsum wall board. In most areas the veneer wall is acceptable condition except in older sections of the building some cracks in brick and mortar, isolated areas of cracked or missing caulk and algae growth on the veneer due to uncontrolled roof water runoff and leaking cap flashing. Otherwise the exterior walls seem to be in age appropriate condition overall.

*Cracked caulk, bricks and mortar and loose parapet metal wall panels were found*

Besides a standard inspection and maintenance program, SWA recommends caulking and re-pointing the veneer with appropriate materials to prevent further cracking due to moisture and water infiltration, especially around window sills and all other wall penetrations. Fascia and cap flashing failures need to be inspected and fixed to prevent further water damage potentially leading to structural compromising and energy loss issues.

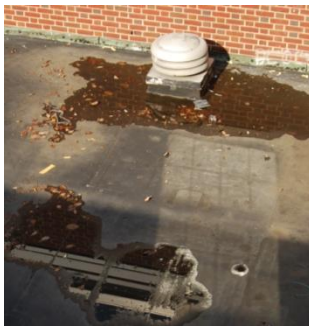
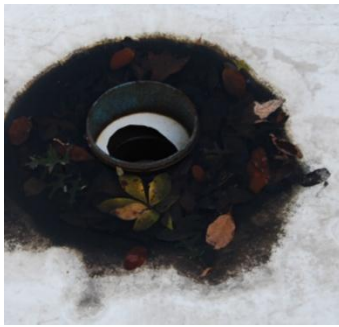
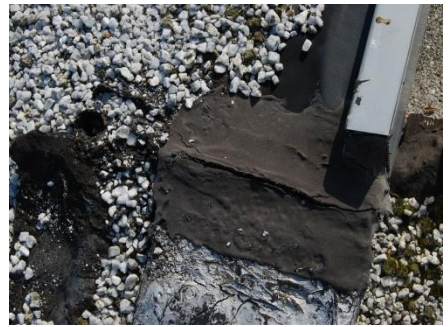
The roof finishes vary in material, condition and time of installation. The dark colored, light gravel covered built up roof sections were installed 1993 / 1996 and need to be replaced due to age and condition. Light colored EPDM roofs were installed in 2008 and appear to be in good condition, except some signs of pooling and the clogged roof drains found. In 1990 there were also dark colored EPDM roof sections installed, according to personnel, which also need to be replaced due to age. Access to those parts of the roof was not possible at the time of inspection. Sloped roofs, installed in 1996 were inspected and found to be finished with asphalt shingles and in good condition.

*Signs of pooling, drain issues and cracked built-up roofing seams found*

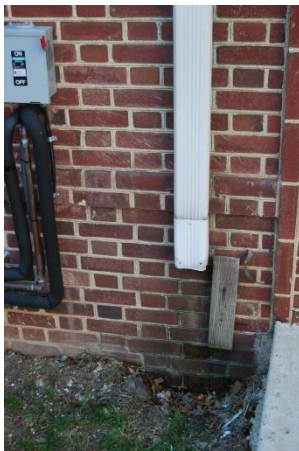
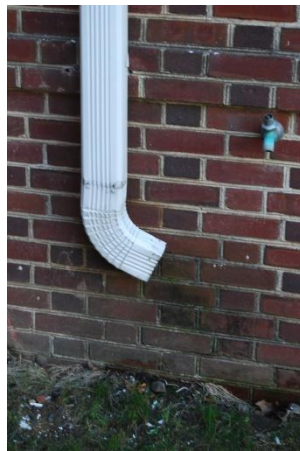
Besides the roof surface and insulation conditions, SWA noticed uncontrolled roof water runoff at the already mentioned cap flashing under 2.2.1. Exterior Walls. Some downspouts were found to be ineffective, not leading water away from the perimeter. SWA recommends having all downspouts, scuppers and roof drains inspected and cleaned or repaired as necessary.

*Ineffective downspout / discharge directions in various locations*

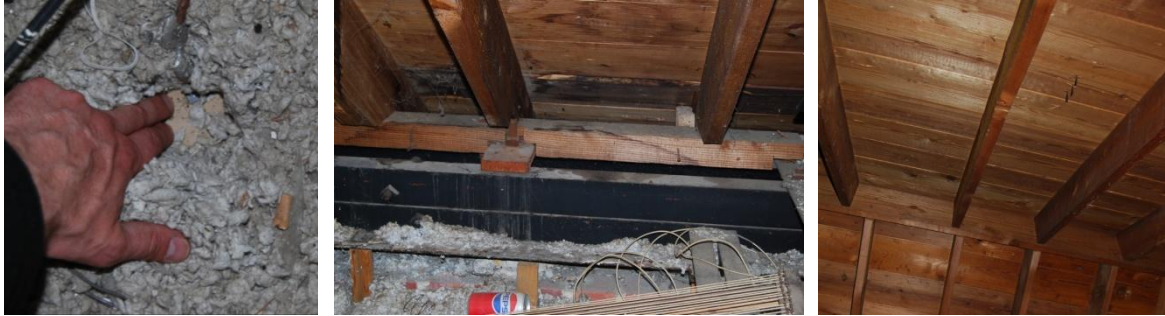
Roof / ceiling insulation was found to be insufficient in the original parts of the clustered building. Blown-in cellulose levels were less than 2” and unevenly distributed. Only gable-end vents were found. SWA recommends adding 8-10” of cellulose insulation to ceilings and the installation of soffit and ridge vents in an effort to maximize winter heat loss and minimize summer cooling loads.

*Insufficient ceiling insulation and no-existent attic ventilation in the original building sections*

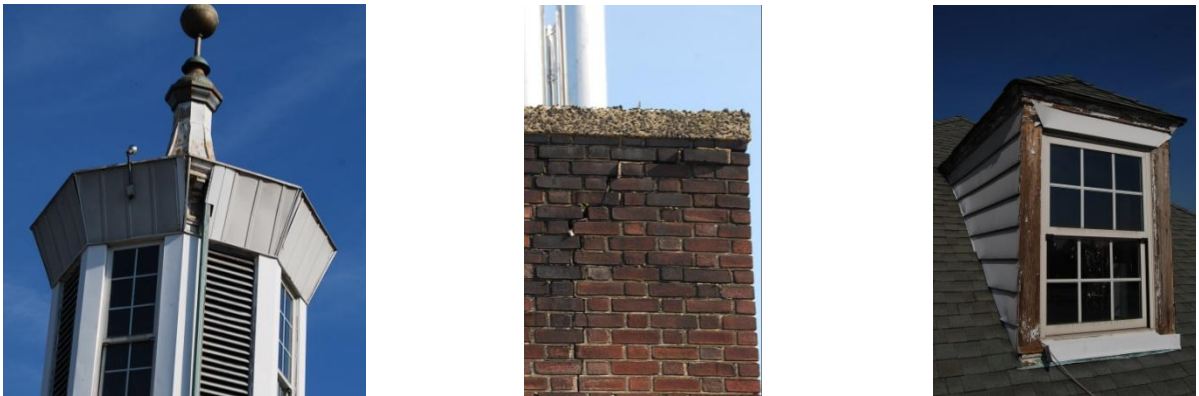
Additionally, the auditors found the main center cupola, the chimney veneer and cap and some of the dormers to be in need of repair. Water infiltration at those locations could potentially cause major energy losses.

*Center cupola, chimney and some dormers in need of repair*

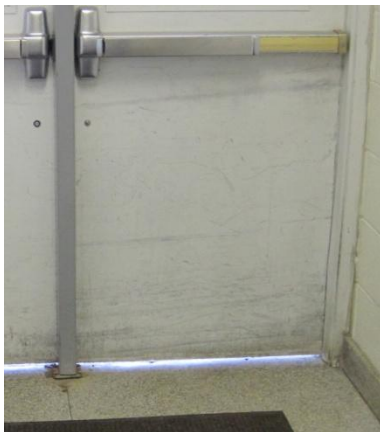
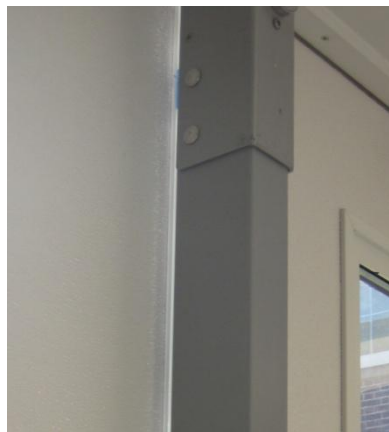
The aluminum and vinyl exterior doors were inspected and observed to be in good condition except for some weather-stripping that started to show wear and tear at the time of the inspection. SWA recommends that the exterior doors of the building be weather-stripped in order to decrease the amount of conditioned air that is lost around each door. SWA also recommends checking the weather-stripping of each door on a regular basis and replacing any broken seals. Tight seals around doors will help ensure the building to be is kept continuously insulated.

*Signs of worn or missing weather stripping at doors and roof hatch*

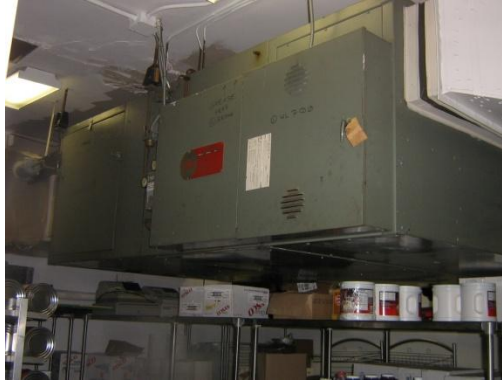
The Kitchen is heated and ventilated by an original steam heating Herman Nelson H&V unit mounted from the ceiling of a food storage room, directly adjacent to the main cooking line. There are also steam unit heaters in this room and near the exterior doors.

*Original Steam H&V Unit Serving the Kitchen*

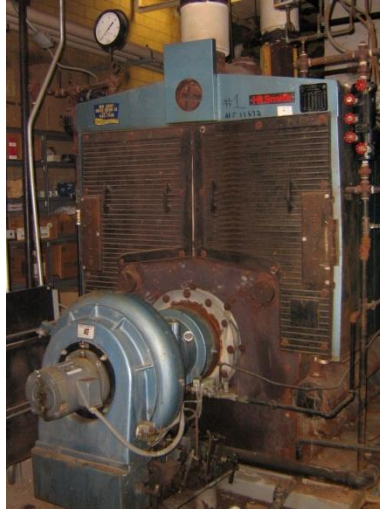
The steam heating is produced by three (3) HB Smith cast iron sectional boilers located in the North Boiler Room. Each boiler has 18 sections and is rated for 3,525 MBH output. The boilers were installed in 1989 and are approximately 70-75% through their useful life. In addition, the steam supply lines are served by various steam traps to remove steam condensate that collects in the supply lines. This practice is typical for a steam heating system, although it should be noted that these traps are often the source of operations and maintenance issues within the system.

*One of the Three Steam Boilers in the North Boiler Room*

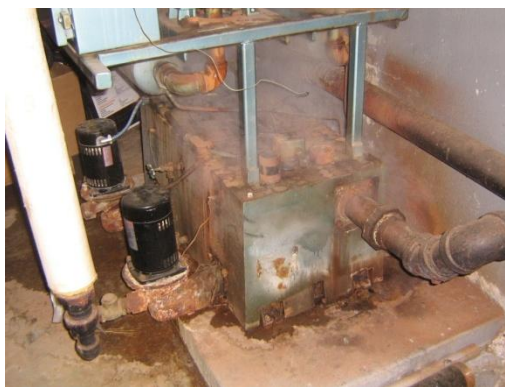
There is also a vacuum condensate return pump in the Storage Room below the stairs near the rear of the Auditorium. The purpose for these intermediate vacuum pumps is to elevate the condensate returning from the further reaches of the building since the required pitch of the condensate piping would not allow for this condensate to enter the boiler room. The condensate receivers were all seen to leak steam at some point during the surveys, and have at least some rust on the tank bodies. SWA recommends that this equipment is replaced in kind as part of a capital improvement plan in the Livingston Public Schools since they are nearing the end of their service life.

*Condensate Receiver Pump Set with Rusted Body, Leaking Steam*

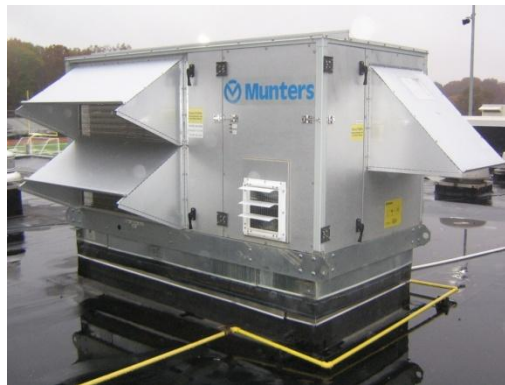
*Energy Recovery Unit Serving the Gym Area*

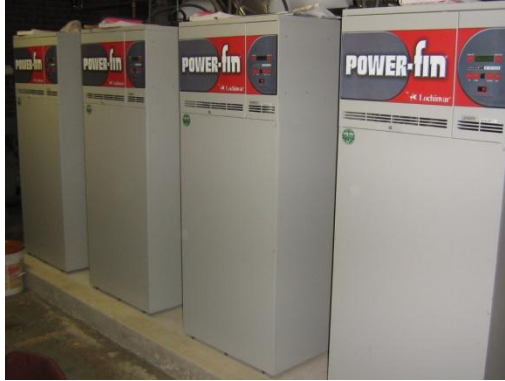
The heating hot water is produced by four (4) Lochinvar non-condensing boilers of equal capacity located in the South Boiler Room. The boilers were installed in the year 2008 approximately. These units and the associated flue piping are in very good condition. The burners are integral to these boilers. The heating water is circulated by (2) 15 Hp pumps and (2) 1 Hp pumps which operate in a lead-lag fashion.

*Hot Water Boilers In South Boiler Room*

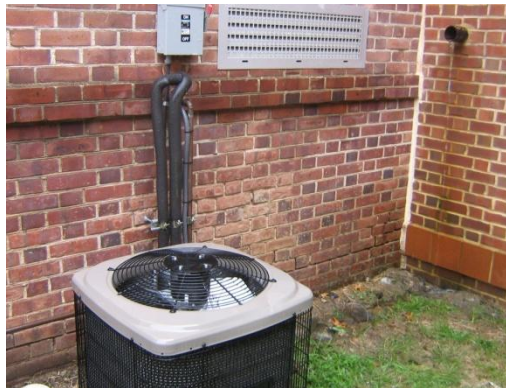
Many of the classrooms in the building are cooled by unit ventilators with DX cooling coils and condensing units located either on grade or on the roof directly above the classroom, depending if the room is located on the top floor of its respective wing.

*Typical Condensing Unit Piped to Classroom Unit Ventilator*

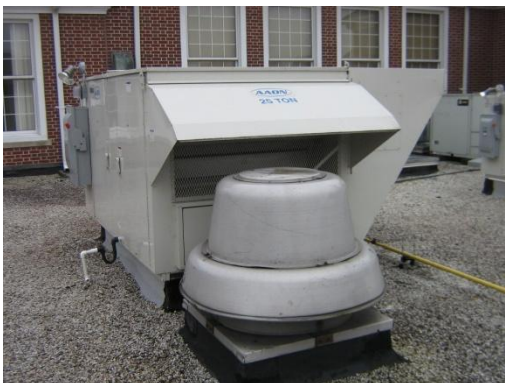
It should be noted that one of the Aeon units serving the Cafeteria is installed with its outside air intake directly adjacent to an exhaust fan. This fan should be replaced and relocated as part of the capital improvements to provide code compliance for separation of exhaust air from outdoor air intake air.

*Exhaust Fan Located Beneath Aeon Out-side Air Intake Hood*

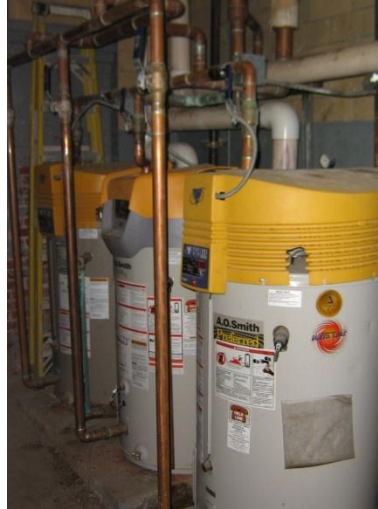
The domestic water for the High School is provided by two (3) gas-fired, A.O. Smith Cyclone, 100 gallon tank-type water heaters. These units are sealed combustion, direct-vent type, with PVC combustion flue penetrating high on the exterior wall of the Boiler Room. Two heaters were manufactured in 2004 or later (2007) and are high efficiency, so it is assumed that there aren't any energy savings opportunities available here. The third heater was manufactured in 1999.

*Domestic Water Heaters*
