**Local Government Energy Program
Energy Audit Final Report**

*For
Borough of Metuchen
Borough Hall
Metuchen, NJ 08840*

Project Number: LGEA18

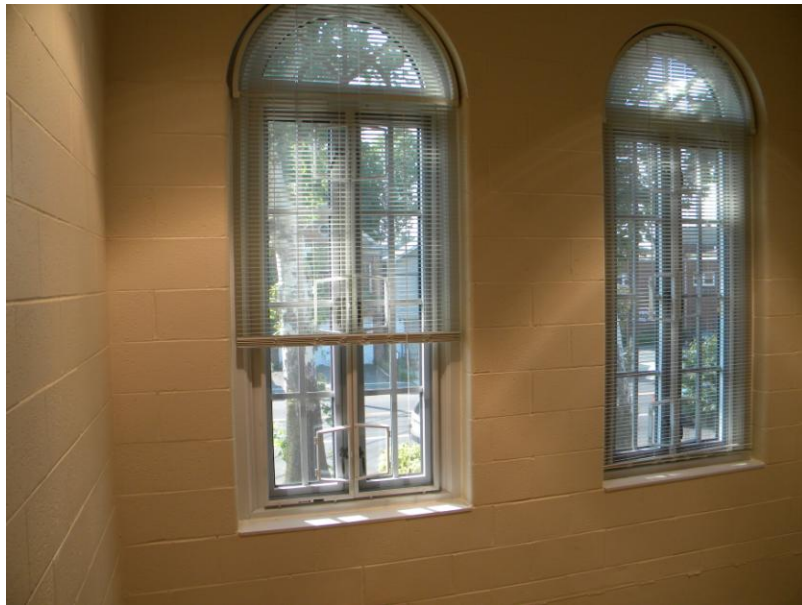
The windows are aluminum frame (with thermal isolation); double pane glazing with 3/4-inch air space with a butyl tape spacer. Considering how new the building is, the windows should perform well. Some employees, however, are not happy with the windows' performance. SWA

staff heard complaints such as: “the window frame and sill is like an iceberg” and “in winter, you can feel the breeze right through the window when the wind is right (not all the time)”.

Installation of new windows would not be economically viable. There are interior and exterior retrofit strategies that would provide increased comfort for building occupants and significant energy savings. One alternative may be the installation of an interior storm window system manufactured using two layers of high strength plastic film on an aluminum frame. This type of system has been shown to lower the u-value (u-value is a measure of transmission of heat through a material or assembly; lower numbers indicate better performance) of single pane windows from about .9 to .31, almost triple the insulating value. These systems have also been shown to reduce drafts and minimize radiation from cold surfaces. It is difficult to verify the rated energy performance of site-built assemblies, as a result, it is difficult to guarantee energy savings and any associated economic payback. Selection of the appropriate alternative should be made with consideration to comfort, durability, window functionality, and aesthetics as well as possible energy savings.

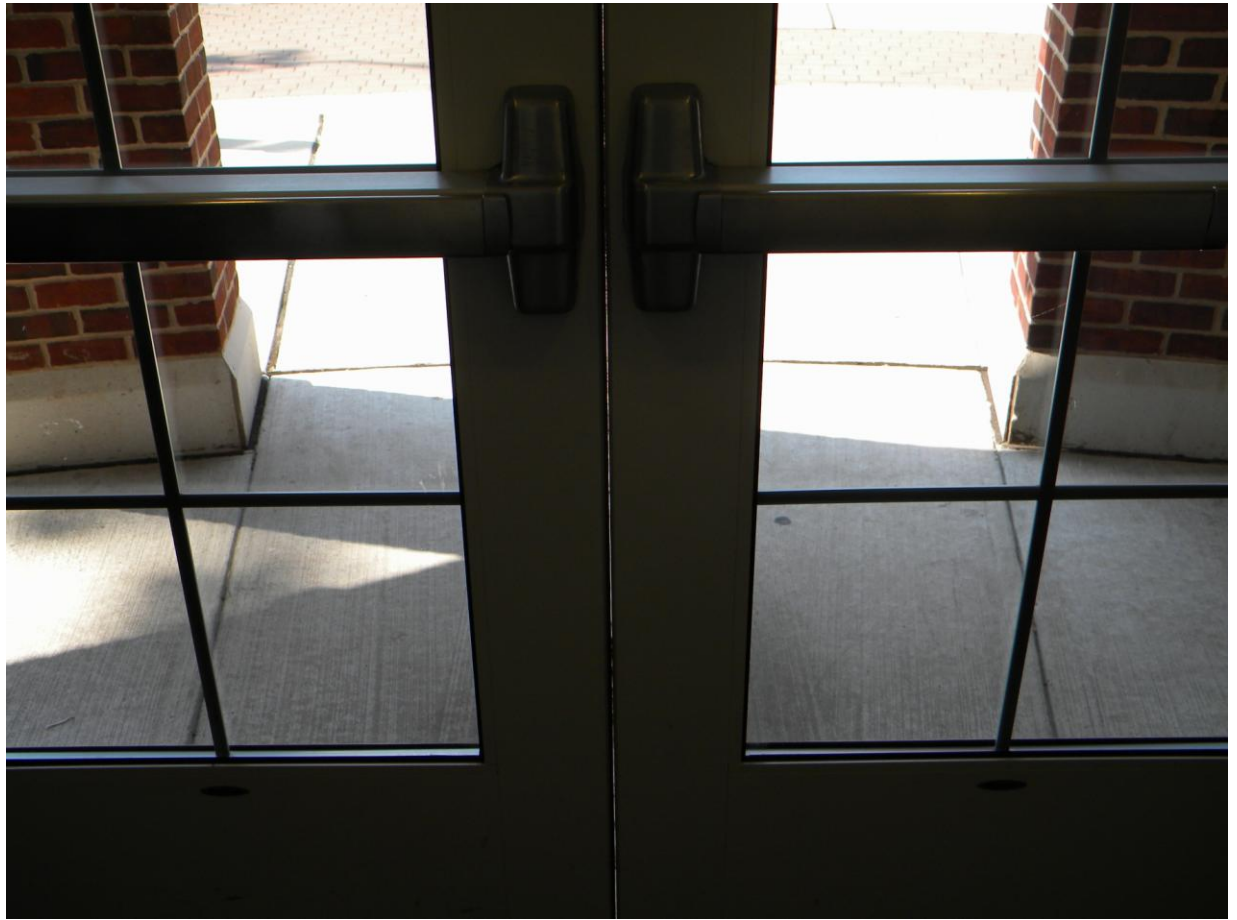
Some of the exterior doors are in satisfactory condition with much of the weather-stripping still intact. But the weather-stripping is failing or missing in some of the doors and there are areas where the perimeter of the doors is allowing constant infiltration of unconditioned air. Exterior doors can be a major source of heat loss and infiltration and should be inspected regularly and any missing or failed weather-stripping should be repaired or replaced. There is also at least one door at which the threshold is not properly installed and is lifting away from the floor allowing infiltration of unconditioned air underneath. This is also creating a trip hazard and should be repaired or replaced and properly installed as soon as possible.

Daylight can be seen between the two main entry doors
