**Local Government Energy Program  
Energy Audit Final Report**

*For  
Borough of Metuchen  
Department of Public Works  
44 Jersey Avenue  
Metuchen, NJ 08840*

*Project Number: LGEA18*

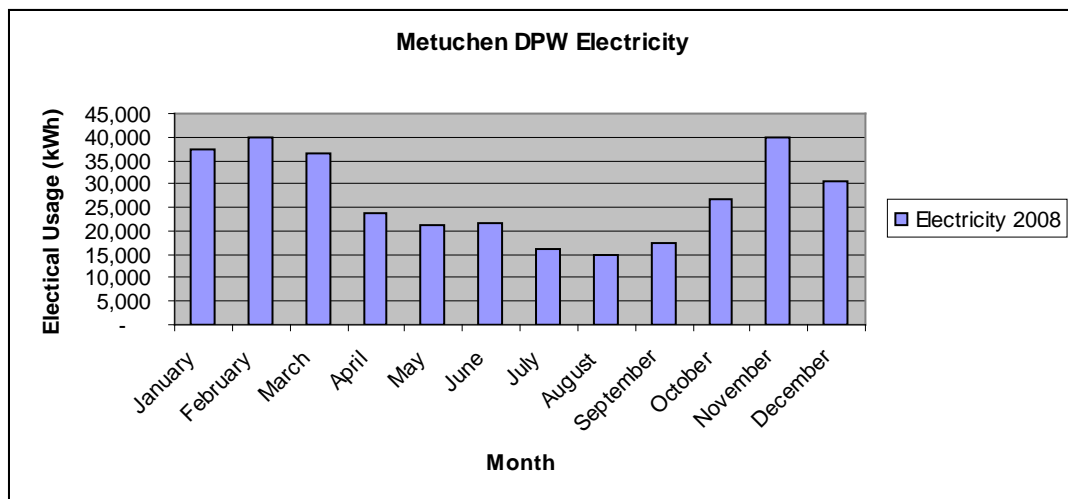
In the above chart, the electricity spikes during the winter months. This is unusual in that the building uses natural gas for heat and electricity for cooling. The intuitive curve would show the spikes in the summer months.

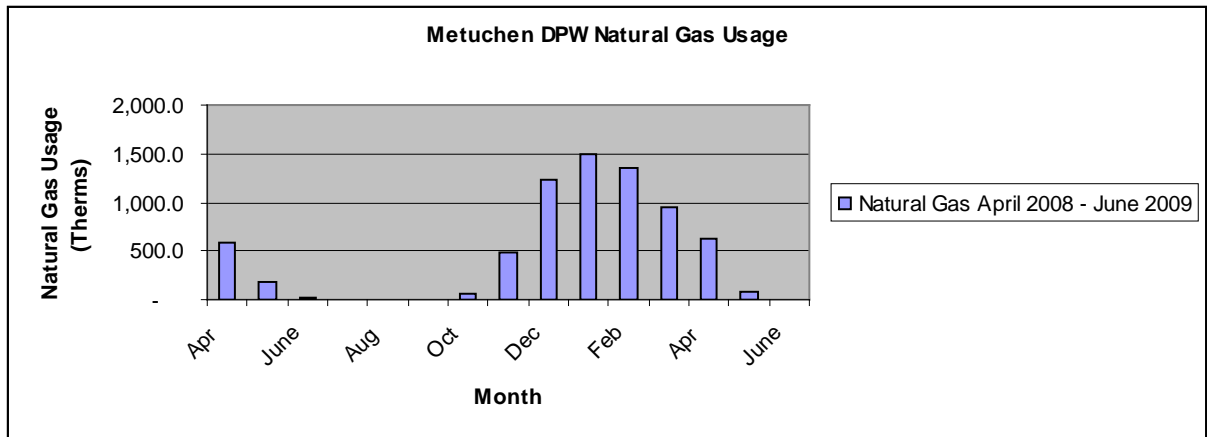
In the above chart, the natural gas usage follows a heating trend as expected with little or no gas used through the late spring, summer and early fall.

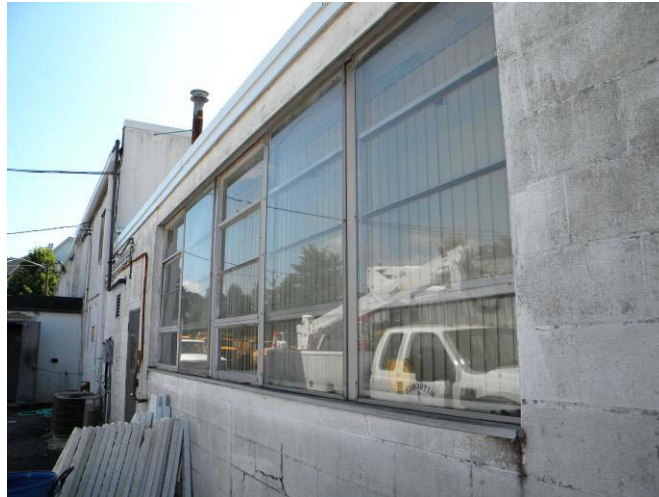
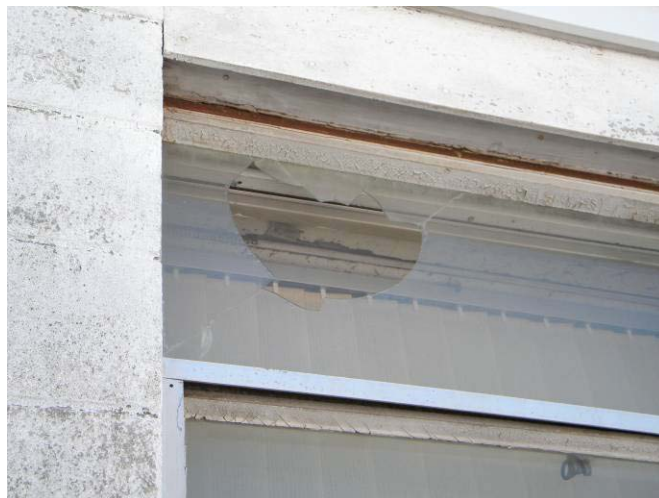
**Office Section - Existing Windows**

The existing windows throughout both sections of the DPW building are single glazed with very little insulating qualities. Due to seasonal conditions at the time of the site visit, SWA could not review the actual performance of the windows during cold weather but single glazed windows are a poor performance energy option. Some attempts have been made to improve performance by securing Plexiglas over the interior of the windows. This has not been effective as the heat buildup between the window and the Plexiglas has not only broken the seal where the Plexiglas was attached to the window frames, but in several areas has actually broken the window glass. The SWA energy auditor noted a small infestation of flying insects inside two separate offices. The operable windows, because of the ineffective Plexiglas covering, are no longer operable and therefore cannot be used at all for ventilation. New windows are needed throughout the office section. The garage area has very little window area but these windows are also in poor condition and should be replaced. As the employees who work in the garage also work outdoors much of the time and are dressed for outdoor work, replacement of the garage windows is not as imperative at this time.

- Windows - The windows in both sections of the building are old metal framed, single pane windows that offer very little in the way of insulating or air sealing qualities. Attempts to improve the window's performance by installing Plexiglas at the interior of the window frames have only succeeded in assuring that the windows are no longer operable and cannot be used to supply any fresh air. Aside from the front entry, there is no other form of supply or exhaust ventilation in the office section and only doors and exhaust fans in the garage section. SWA recommends replacing the windows with vinyl frame, dual pane windows with an argon gas filling and a low emissivity coating.

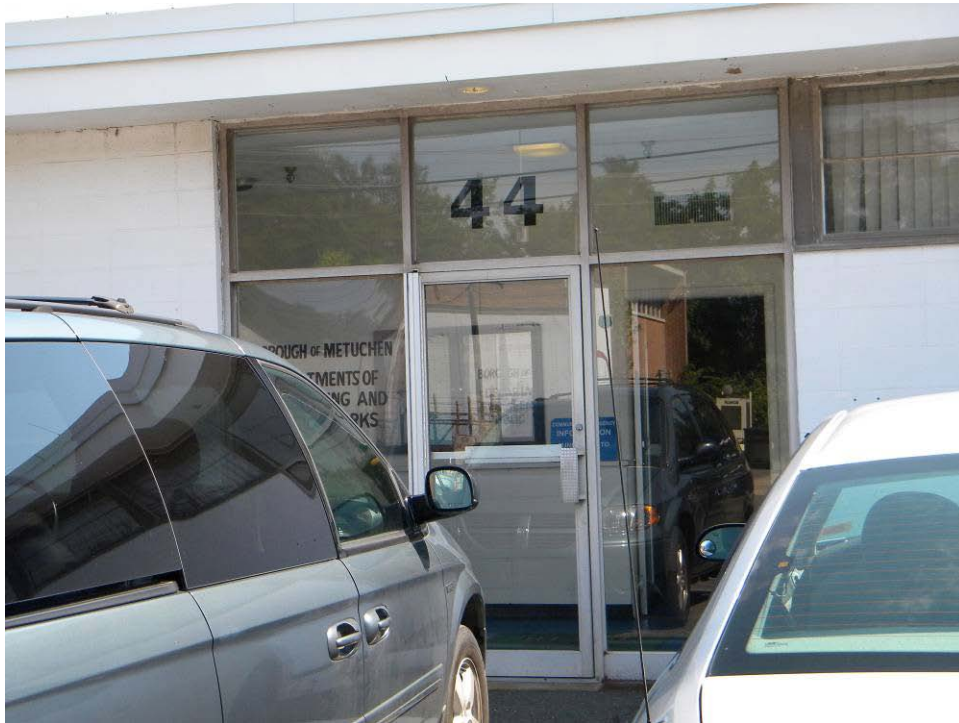
Some of the exterior doors are in satisfactory condition although there was no weather-stripping on the glass entry doors and none on some of the metal clad exterior doors. If not properly maintained, exterior doors can become major sources of heat loss and infiltration. As a best practice, SWA recommends checking the weather-stripping of each door on a regular basis and replacing any broken seals immediately. This will help optimize comfort and energy performance.

The glass is new on the entry and doors but there is no weather-stripping at all.

- Weather Stripping/Air Sealing – As a best practice, exterior/overhead doors and vestibules should be observed annually for deficient weather-stripping and replaced as needed. The perimeter of all window frames should also be regularly inspected and any missing or deteriorated caulking should be re-caulked to provide an unbroken seal around the window frame. Building staff should also verify that windows open and close properly and repair, as needed. Any other accessible gaps or penetrations in the thermal envelope should also be sealed with caulk or spray foam. Particular attention should be paid to penetrations and doors connecting the main building to the garage to prevent transfer of combustion product.

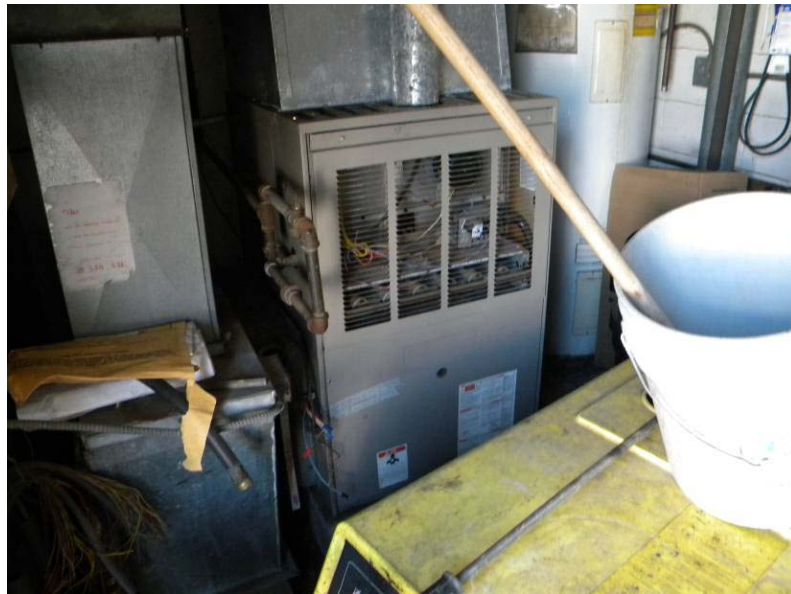
The heating plant consists of two very old inefficient furnaces both burning natural gas. They are both at the end of their estimated useful lives and the technology upon which they depend is several generations out of date.

The existing furnaces were estimated to have an operating efficiency of approximately 60% to 65%. There are newer furnace technologies, known as condensing furnaces that provide efficiencies above 90%. SWA is recommending replacing both furnaces with maximum 95.5 % efficient condensing furnaces. This will be a very cost-effective improvement.

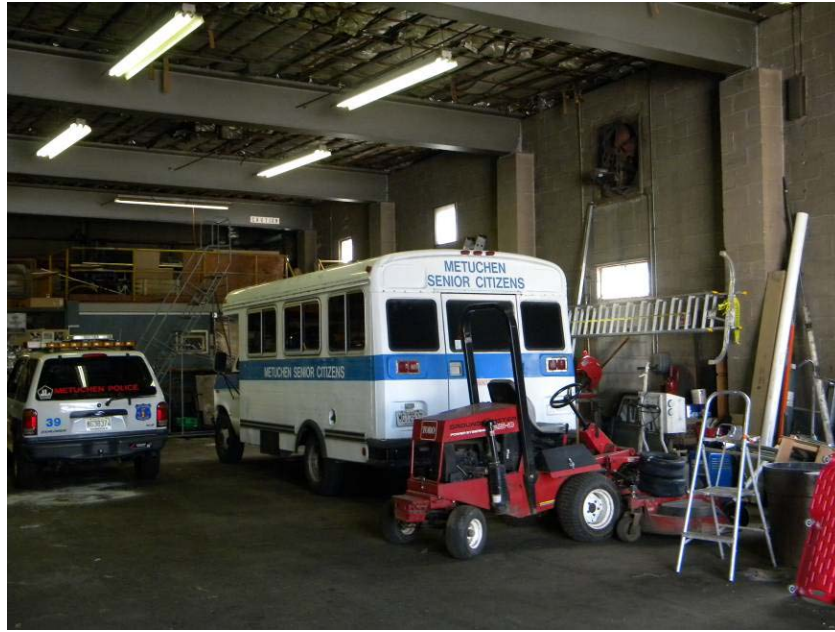
*Interior Lighting* – Most of the lighting in the building is fluorescent and consists of fixtures with magnetic ballasts and T12 (inch and a half diameter) lamps.

Almost all the magnetic ballasted fixtures lighting in the building should be retrofitted for electronic ballasts and T8 lamps with a reflective backing. The exterior lighting should be turned on and off by photocell controls that operate based on the amount of outdoor light and are more effective than timer controls in this application.
