**Local Government Energy Program
Energy Audit Final Report**

*For
Borough of Metuchen
Senior Center
Metuchen, NJ 08840*

Project Number: LGEA18

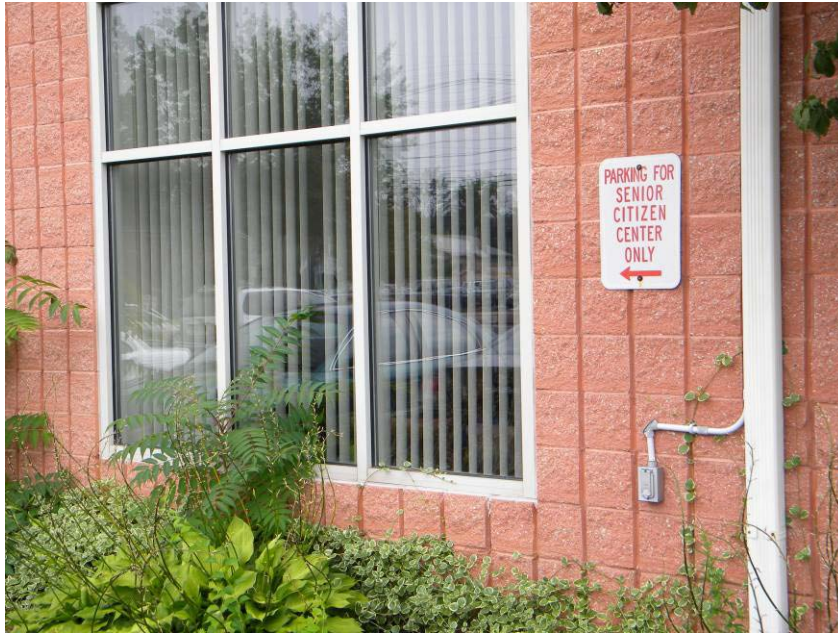
The windows are aluminum frame (with thermal isolation); double pane glazing with 3/4-inch argon filled with a butyl tape spacer and a low emissivity coating. The operable parts of the windows are casement type. The windows are for the most part state of the art and SWA has no recommendations other than a best practice procedure of regularly inspecting the window weather-stripping and replacing or repairing any missing or failing portions.

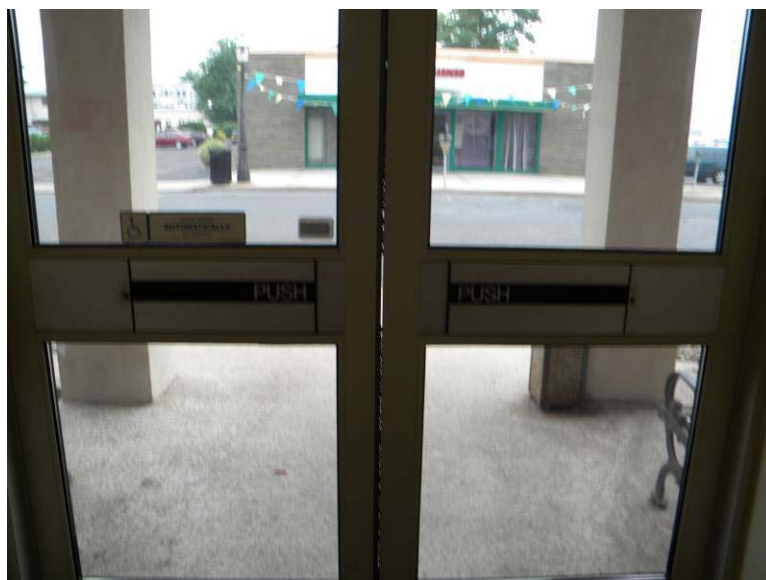
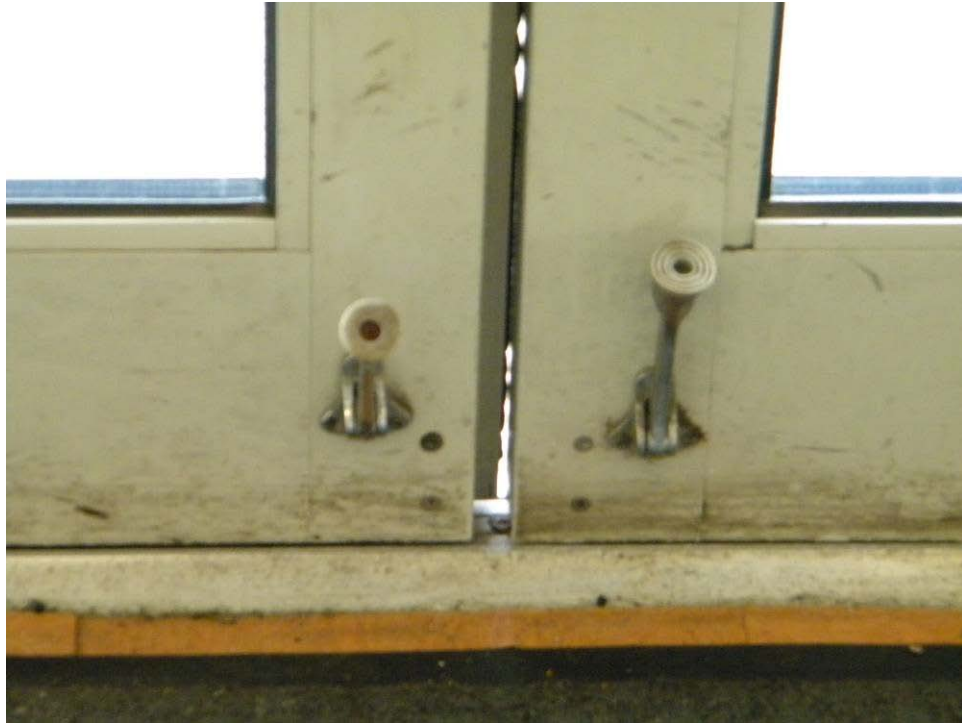
The exterior doors themselves are high quality doors but the weather-stripping is completely deteriorated on the front entry and vestibule doors. Large spaces between the interior and exterior are allowing unfettered infiltration of unconditioned air and heat transfer to the outside in winter and heat gain to the interior in summer. There is no weather-stripping at all around the insulated steel egress door at the bottom of the back stairs. The exterior door from the kitchen area is in very good condition. Exterior doors can be a major source of heat loss and infiltration and should be inspected regularly and any missing or failed weather-stripping should be repaired or replaced. This should be done as soon as possible. The photographs below show the extent of the problem.

Daylight can be seen between the two main entry doors

- Weather Stripping/Air Sealing – As a best practice, exterior/overhead doors and vestibule doors should be observed annually for deficient weather-stripping and replaced as needed. The perimeter of all window frames should also be regularly inspected and any missing or deteriorated caulking should be re-caulked to provide an unbroken seal around the window frame. Building staff should also verify that windows open and close properly and repair, as needed. Any other accessible gaps or penetrations in the thermal envelope should also be sealed with caulk or spray foam. Particular attention should be paid to penetrations and doors connecting the main building to the garage to prevent transfer of combustion product.
