New Jersey Small Wind Turbine Failure Analysis: Xzeres 442 Wind Turbine, Villas, New Jersey

Technical Report

NREL/TP-5000-56660

June 2013

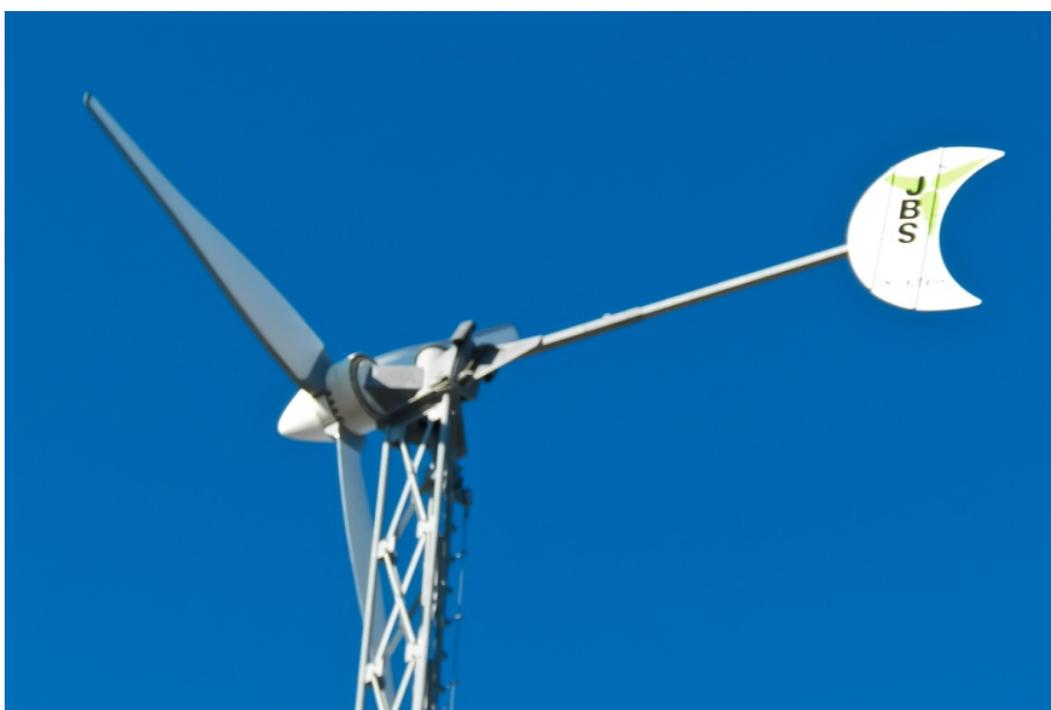
The wind turbine was a Xzeres Wind Corporation Model 442, which has a rotor diameter of 23.6 feet, a rated power of 10 kilowatts (kW) at 25 mph (11 meters per second), and a "swept area" of 442 square feet (hence the name). The turbine has been replaced with a completely new unit by Xzeres (with electrical design improvements incorporated), shown in Figure 1.

Figure 1. The replacement turbine at the Villas, New Jersey, site
(Photo by Rob Wills, Intergrid, LLC)

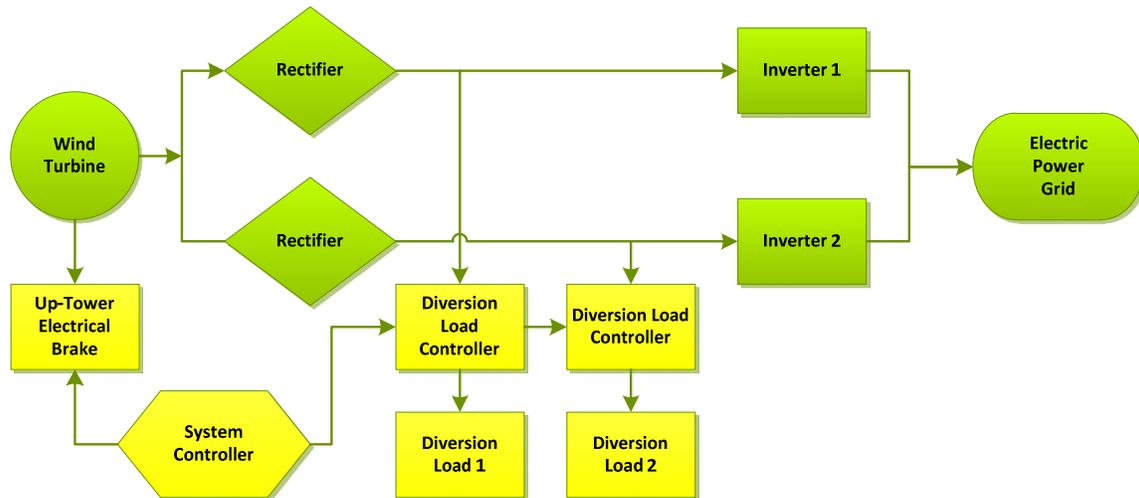
The Xzeres 442 Grid-Connected Power System consists of a 10-kW (nominal) wind turbine, rectifiers, inverters, and control system (Figure 4).

Figure 4. Xzeres 442 turbine major system components
(Illustration by Rob Wills, Intergrid, LLC)
